EWR D&I ANNOTATION

FAN-000001L104001DP132-5595

DI11-045 SEQ#132: 1 DEATH. 2007 CHEVROLET COBALT. CUSTOMER'S DAUGHTER WAS DRIVING AND AT A CURVE, THE VEHICLE WENT STRAIGHT INSTEAD OF TURNING AND RAN INTO A BOULDER. NONE OF THE AIRBAGS DEPLOYED. CUSTOMER ALLEGES THAT THE STEERING MALFUNCTION CAUSED THE COLLISION AND THE AIRBAG NON-DEPLOYMENT CAUSED THE FATALITY. CUSTOMER STATES THAT THEY RECEIVED A 'RECALL 10023' LETTER IN REGARDS TO POWER STEERING ASSIST FAILURE. ACCORDING TO THE POLICE REPORT PROVIDED, THE DRIVER OF THE VEHICLE SUSTAINED BLUNT IMPACT TRAUMA TO THE HEAD AND SUCCUMBING TO HER INJURIES PRIOR TO THE ARRIVAL OF EMERGENCY SERVICES PERSONNEL. THE POLICE REPORT FURTHER STATES THAT DUE TO THE FACT THAT THE DRIVER HAD A BAC OF 0.219% AND WAS ALSO USING A HAND HELD CELLULAR PHONE DEVICE, SHE FAILED TO MAINTAIN PROPER LANE USE CAUSING HER TO LEAVE THE PAVED ROAD AND ENTER A GRASSY AREA. THIS CAUSED HER TO LOSE CONTROL OF HER VEHICLE. THE VEHICLE OVERTURNED SEVERAL TIMES AFTER STRIKING A ROCK OUTCROP COMING TO REST UPRIGHT IN THE CENTER MEDIAN. ACCORDING TO THE EDR PROVIDED THE VEHICLE SPEED BEFORE IMPACT WAS INVALID, THE STEERING WHEEL ANGLE WAS MAINTAINED AT 0 DEGREES, AND

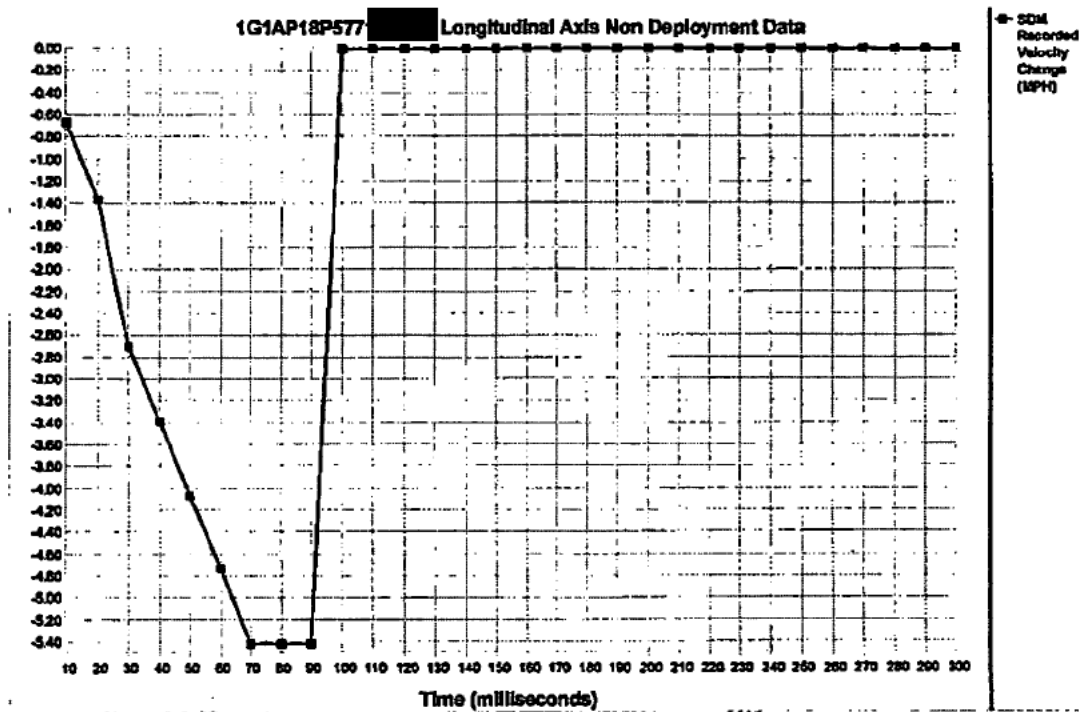
Time (milliseconds)	10	20	30	40	50	60	70	80	90	100	110	120	130	140	150
SDM Longitudinal Axis Recorded Velocity Change (MPH)	-0.68	-1.36	-2.71	-3.39	-4.07	-4.74	-5.42	-5.42	-5.42	0.00	0.00	0.00	0.00	0.00	0.00
Time (milliseconds)	160	170	180	190	200	210	220	230	240	250	260	270	280	290	300
SDM Longitudinal Axis Recorded Velocity Change (MPH)	0.00	0.00	0.00	0.00	0.00	0.00	0.00	0.00	0.00	0.00	0.00	0.00	0.00	0.00	0.00

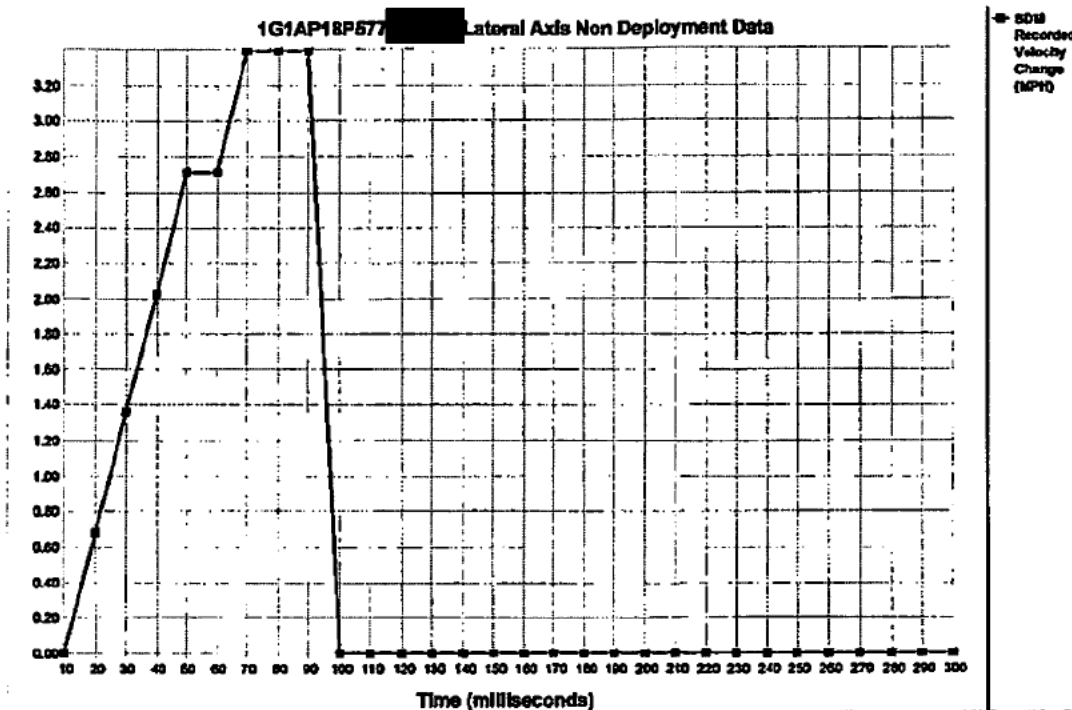
Time (milliseconds)	10	20	30	40	50	60	70	80	90	100	110	120	130	140	150
SDM Lateral Axis Recorded Velocity Change (MPH)	0.00	0.68	1.36	2.03	2.71	2.71	3.39	3.39	3.39	0.00	0.00	0.00	0.00	0.00	0.00
Time (milliseconds)	160	170	180	190	200	210	220	230	240	250	260	270	280	290	300
SDM Lateral Axis Recorded Velocity Change (MPH)	0.00	0.00	0.00	0.00	0.00	0.00	0.00	0.00	0.00	0.00	0.00	0.00	0.00	0.00	0.00
