EWR D&I ANNOTATION

FAN-000001L092001DP101-3797

Description : DI09-096. SEQ ID 101. 2009 Q2. DRIVER OF A 2007 COBALT WAS APPROACHING AN INTERSECTION WHEN ANOTHER VEHICLE ENTERED. COBALT T-BONED THE OTHER VEHICLE. FRONT END DAMAGE TO VEHICLE. PRE-CRASH DATA SHOWS VEHICLE AROUND 24 MPH. NO POLICE REPORT GIVEN. CUSTOMER ALLEGES AIR BAGS SHOULD HAVE DEPLOYED. VOQ-37. PURSUIT-0. TSB-0. RECALLS-0. *RM

DI09-096
101 278516397 – 669566
2007 CHEVROLET COBALT

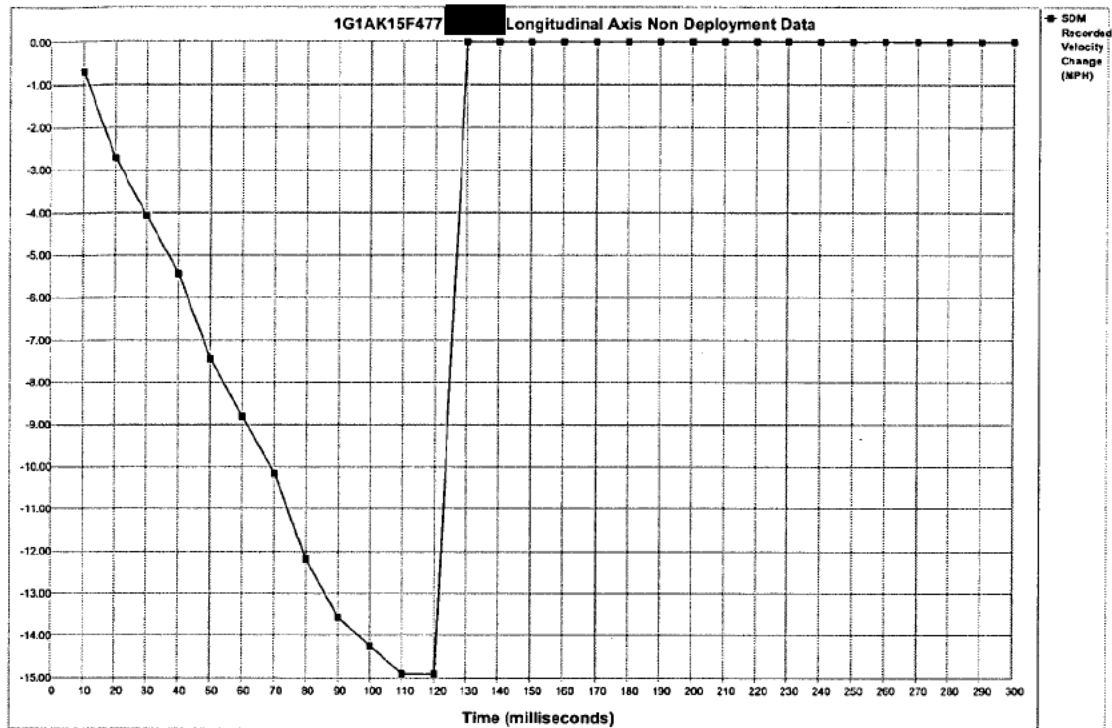
Time (milliseconds)	10	20	30	40	50	60	70	80	90	100	110	120	130	140	150
SDM Longitudinal Axis Recorded Velocity Change (MPH)	-0.68	-2.71	-4.07	-5.42	-7.46	-8.81	-10.17	-12.20	-13.56	-14.23	-14.91	-14.91	0.00	0.00	0.00
Time (milliseconds)	160	170	180	190	200	210	220	230	240	250	260	270	280	290	300
SDM Longitudinal Axis Recorded Velocity Change (MPH)	0.00	0.00	0.00	0.00	0.00	0.00	0.00	0.00	0.00	0.00	0.00	0.00	0.00	0.00	0.00

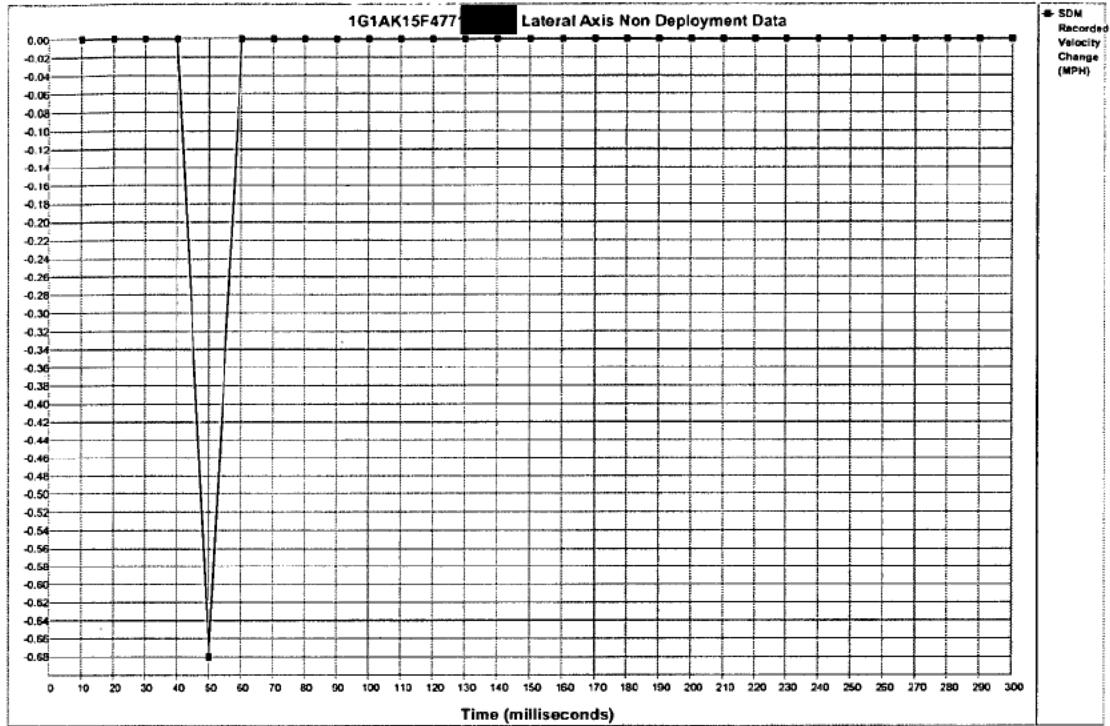
Time (milliseconds)	10	20	30	40	50	60	70	80	90	100	110	120	130	140	150
SDM Lateral Axis Recorded Velocity Change (MPH)	0.00	0.00	0.00	0.00	-0.68	0.00	0.00	0.00	0.00	0.00	0.00	0.00	0.00	0.00	0.00
Time (milliseconds)	160	170	180	190	200	210	220	230	240	250	260	270	280	290	300
SDM Lateral Axis Recorded Velocity Change (MPH)	0.00	0.00	0.00	0.00	0.00	0.00	0.00	0.00	0.00	0.00	0.00	0.00	0.00	0.00	0.00
