EWR D&I ANNOTATION

Artemis # : 000001L092001DP78**Record Created Date :** 04/14/2010**Printed Date :** 04/14/2010**Description :**

NVS-217kb
DI09-096

DI09-096
78 278516338 – 669495
2005 CHEVROLET COBALT

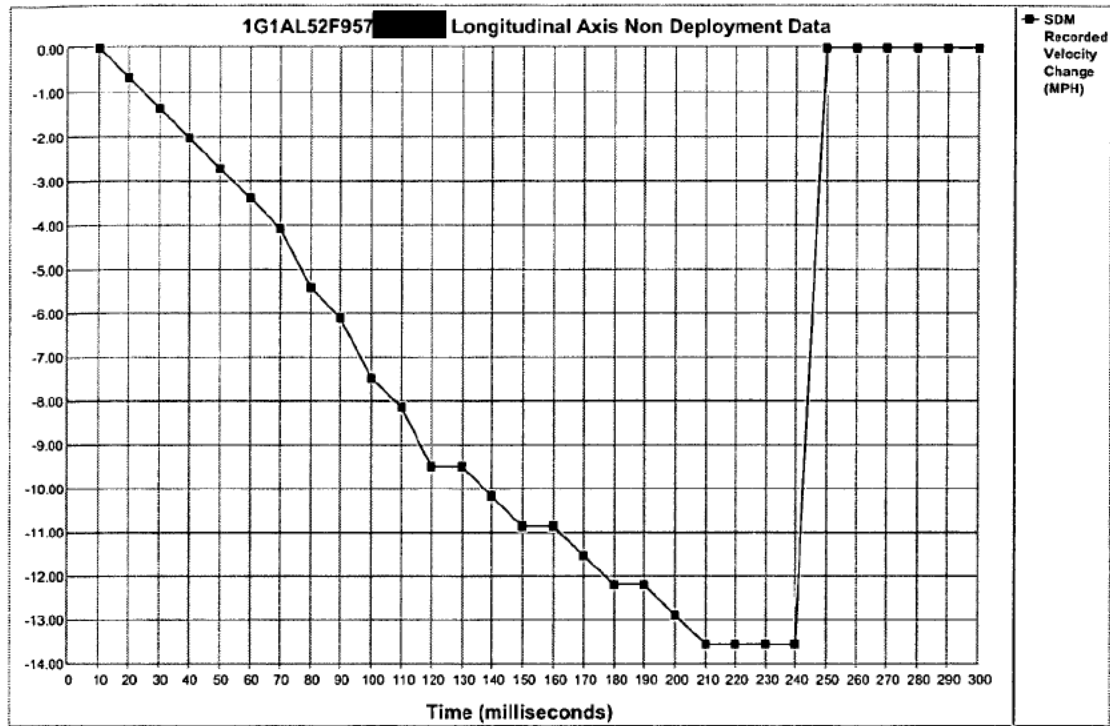
Time (milliseconds)	10	20	30	40	50	60	70	80	90	100	110	120	130	140	150
SDM Longitudinal Axis Recorded Velocity Change (MPH)	0.00	-0.68	-1.36	-2.03	-2.71	-3.39	-4.07	-5.42	-6.10	-7.46	-8.13	-9.49	-9.49	-10.17	-10.85
Time (milliseconds)	160	170	180	190	200	210	220	230	240	250	260	270	280	290	300
SDM Longitudinal Axis Recorded Velocity Change (MPH)	-10.85	-11.52	-12.20	-12.20	-12.88	-13.56	-13.56	-13.56	-13.56	0.00	0.00	0.00	0.00	0.00	0.00

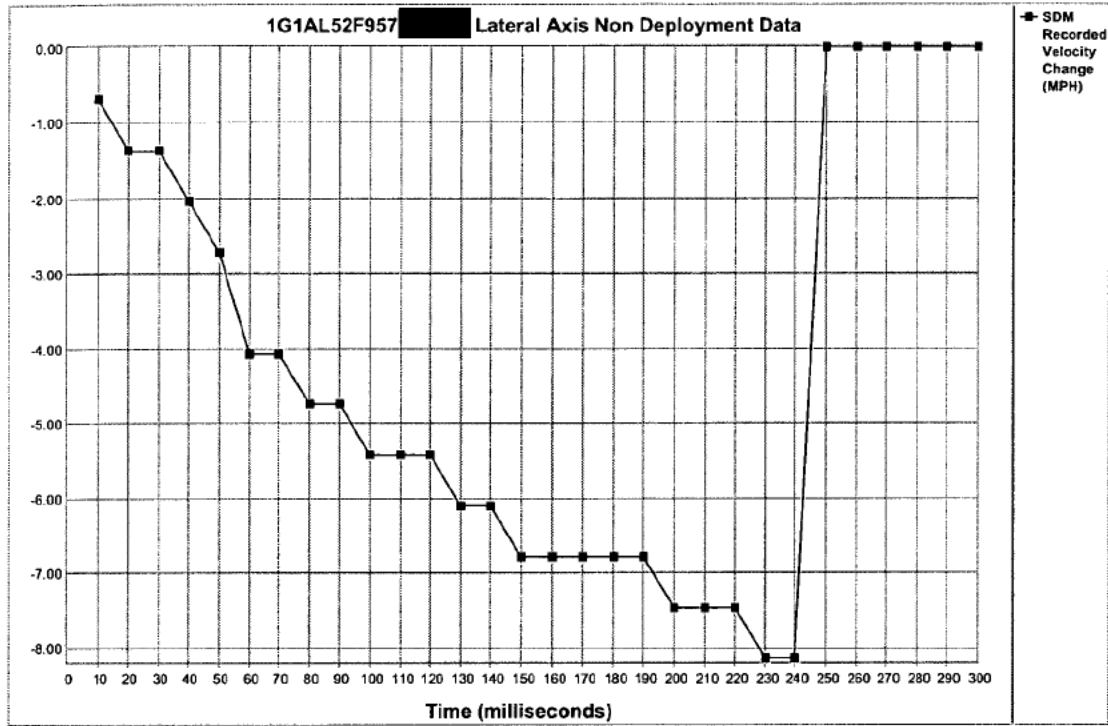
Time (milliseconds)	10	20	30	40	50	60	70	80	90	100	110	120	130	140	150
SDM Lateral Axis Recorded Velocity Change (MPH)	-0.68	-1.36	-1.36	-2.03	-2.71	-4.07	-4.07	-4.74	-4.74	-5.42	-5.42	-5.42	-6.10	-6.10	-6.78
Time (milliseconds)	160	170	180	190	200	210	220	230	240	250	260	270	280	290	300
SDM Lateral Axis Recorded Velocity Change (MPH)	-6.78	-6.78	-6.78	-6.78	-7.46	-7.46	-7.46	-8.13	-8.13	0.00	0.00	0.00	0.00	0.00	0.00
