EWR D&I ANNOTATION

FAN-000001L092001DP92-9094

DI09-096. SEQ ID 92. 2009 Q2. A DRIVER OF A 2007 CHEVY COBALT WAS DRIVING ON A STREET IN TENNESSEE WHEN THE INCIDENT HAPPENED. POLICE REPORT STATES THAT ANOTHER VEHICLE TURNED INTO THE COBALT AND PUSHED IT INTO A BUILDING. PRE-CRASH DATA STATES COBALT WAS DRIVING ABOUT 10 MPH DURING THE INCIDENT. DRIVER ALLEGES THAT AIR BAGS SHOULD HAVE DEPLOYED. VOQ-37. PURSUIT-0 (1 FOR 2006). TSB-0. RECALLS-0. *RM

DI09-096
92 278517479 – 671885
2007 CHEVROLET COBALT

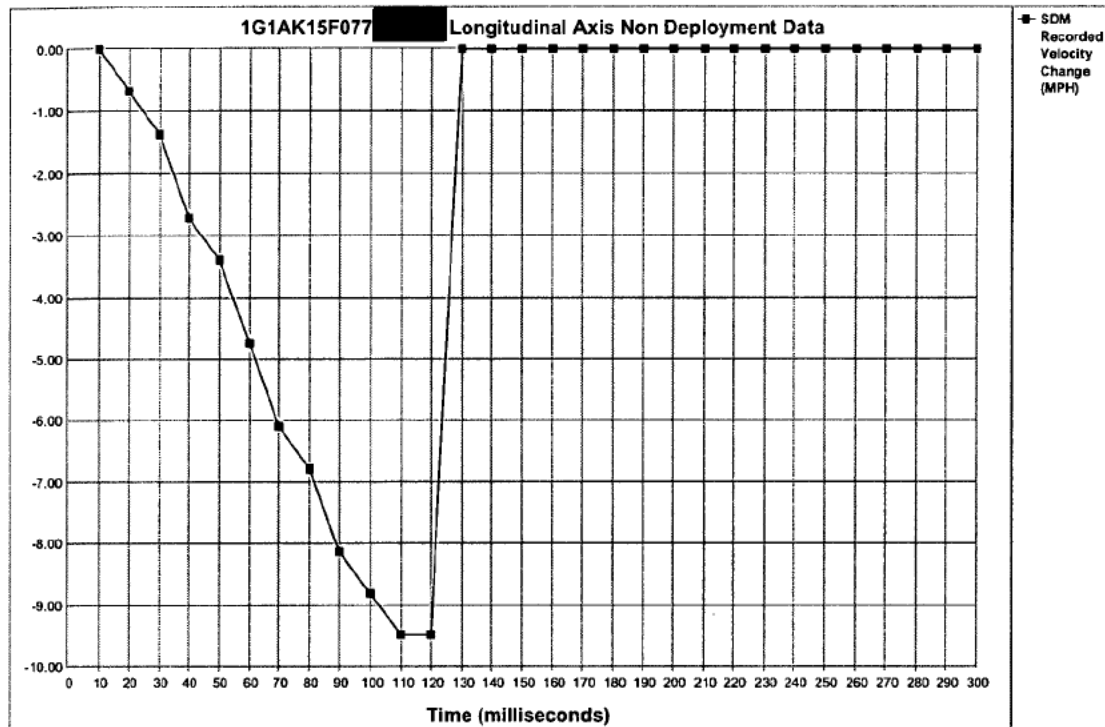
Time (milliseconds)	10	20	30	40	50	60	70	80	90	100	110	120	130	140	150
SDM Longitudinal Axis Recorded Velocity Change (MPH)	0.00	-0.68	-1.36	-2.71	-3.39	-4.74	-6.10	-6.78	-8.13	-8.81	-9.49	-9.49	0.00	0.00	0.00
Time (milliseconds)	160	170	180	190	200	210	220	230	240	250	260	270	280	290	300
SDM Longitudinal Axis Recorded Velocity Change (MPH)	0.00	0.00	0.00	0.00	0.00	0.00	0.00	0.00	0.00	0.00	0.00	0.00	0.00	0.00	0.00

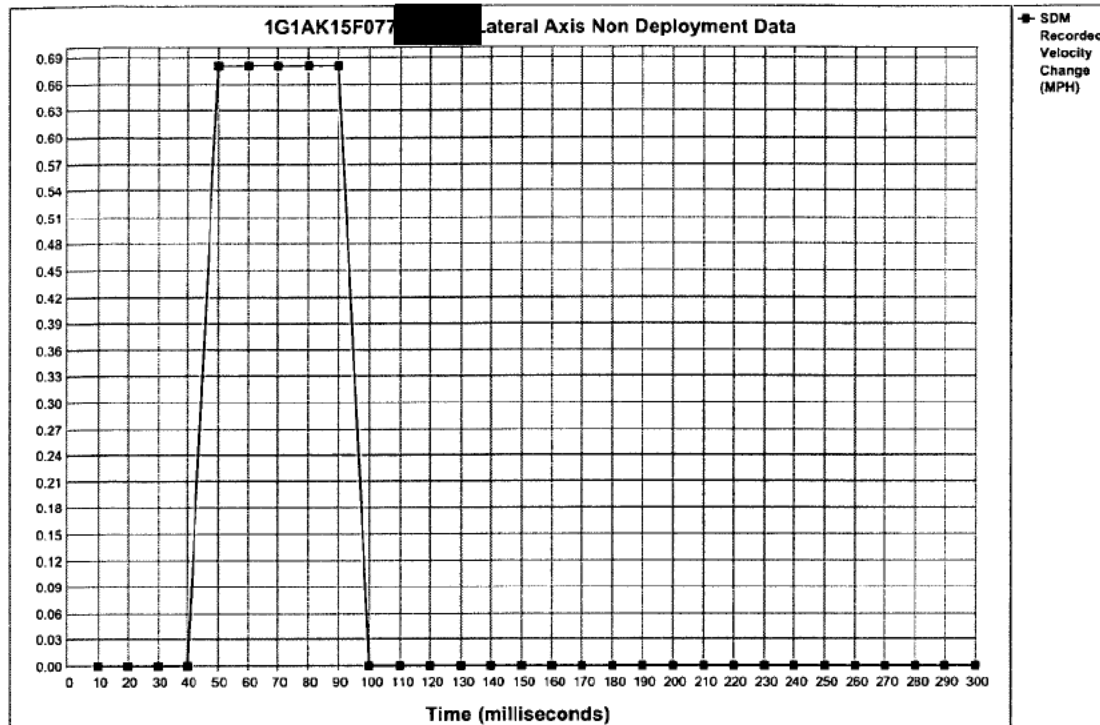
Time (milliseconds)	10	20	30	40	50	60	70	80	90	100	110	120	130	140	150
SDM Lateral Axis Recorded Velocity Change (MPH)	0.00	0.00	0.00	0.00	0.68	0.68	0.68	0.68	0.68	0.00	0.00	0.00	0.00	0.00	0.00
Time (milliseconds)	160	170	180	190	200	210	220	230	240	250	260	270	280	290	300
SDM Lateral Axis Recorded Velocity Change (MPH)	0.00	0.00	0.00	0.00	0.00	0.00	0.00	0.00	0.00	0.00	0.00	0.00	0.00	0.00	0.00
