Description : DI11-072 SEQUENCE ID 12S: A SERVICE REQUEST DETAIL LOG FOR GENERAL MOTORS LLC MAKES THE ALLEGATION THAT A 2007 CHEVROLET COBALT IS POTENTIALLY DANGEROUS DUE TO AN AIR BAG NONDEPLOYMENT. THE LOG STATES THAT THE COBALT WAS INVOLVED IN AN ACCIDENT WHEREBY THE VEHICLE WAS APPROACHING A FLASHING YELLOW LIGHT INTERSECTION AND ANOTHER VEHICLE FAILED TO STOP DESPITE HAVING A FLASHING RED LIGHT. THE DRIVER OF THE COBALT SWERVED TO AVOID HITTING THE OTHER VEHICLE AND RAN INTO A POLE AS A RESULT. NO PICTURES OF THE DAMAGE WERE PROVIDED AND NO DESCRIPTION OF WHERE THE COBALT WAS HIT IS MENTIONED. THE SPEED THE VEHICLE WAS TRAVELING AND/OR SPEED OF IMPACT WAS NOT PROVIDED. NO INJURIES WERE MENTIONED IN THE SEQUENCE DOCUMENTATION. NO POLICE REPORTS WERE INCLUDED WITH THE SEQUENCE DOCUMENTATION. FROM A SEARCH NO RECALLS OR PURSUITS WERE FOUND RELATING THIS VEHICLE TO THE ALLEGED SAFETY DEFECT. FROM A VOQ SEARCH, 11 REPORTS WERE FOUND CLAIMING AIR BAG NON DEPLOYMENT OF VARYING SPEEDS AND INCIDENT SPECIFICS. FROM A SEARCH, 21 FIELD REPORTS WERE FOUND WHICH STATED 'NONDEPLOYMENT' IN THE SUMMARY OF THE REPORT. 7 TSBS WERE FOUND FOR THE AIRBAG COMPONENT WHICH ALL MENTION SIR/PASSENGER PR

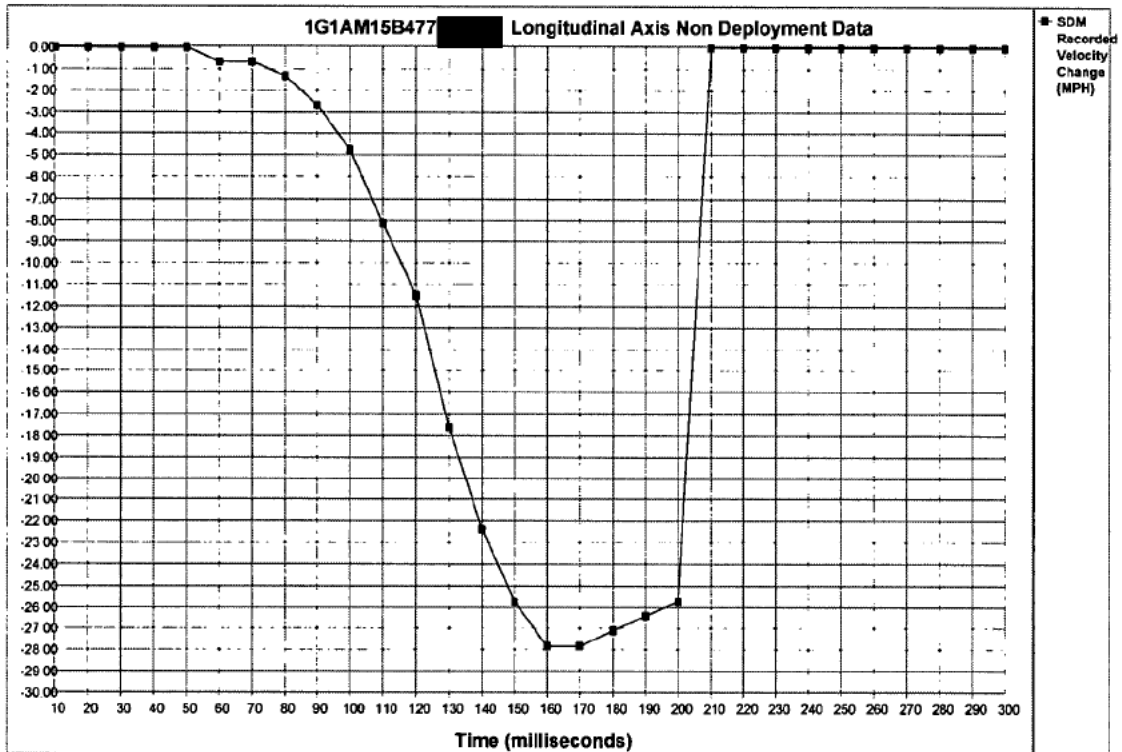
Time (milliseconds)	10	20	30	40	50	60	70	80	90	100	110	120	130	140	150
SDM Longitudinal Axis Recorded Velocity Change (MPH)	0.00	0.00	0.00	0.00	0.00	-0.68	-0.68	-1.36	-2.71	-4.74	-8.13	-11.52	-17.62	-22.36	-25.75
Time (milliseconds)	160	170	180	190	200	210	220	230	240	250	260	270	280	290	300
SDM Longitudinal Axis Recorded Velocity Change (MPH)	-27.79	-27.79	-27.11	-26.43	-25.75	0.00	0.00	0.00	0.00	0.00	0.00	0.00	0.00	0.00	0.00

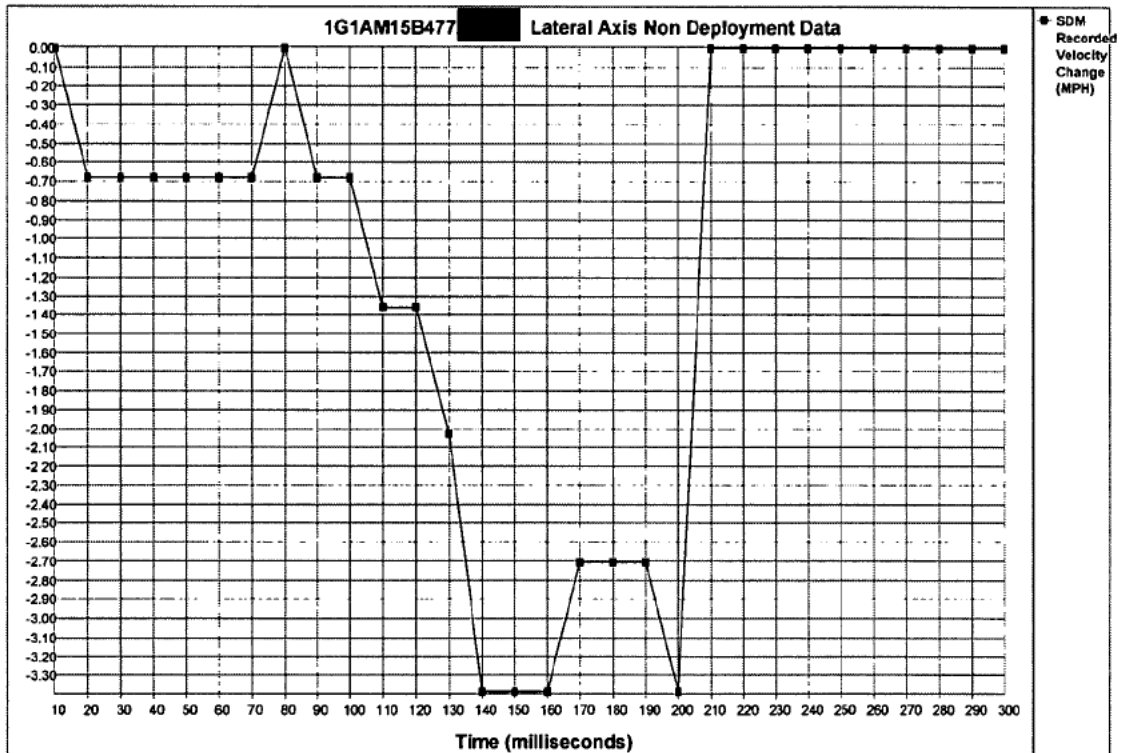
Time (milliseconds)	10	20	30	40	50	60	70	80	90	100	110	120	130	140	150
SDM Lateral Axis Recorded Velocity Change (MPH)	0.00	-0.68	-0.68	-0.68	-0.68	-0.68	-0.68	0.00	-0.68	-0.68	-1.36	-1.36	-2.03	-3.39	-3.39
Time (milliseconds)	160	170	180	190	200	210	220	230	240	250	260	270	280	290	300
SDM Lateral Axis Recorded Velocity Change (MPH)	-3.39	-2.71	-2.71	-2.71	-3.39	0.00	0.00	0.00	0.00	0.00	0.00	0.00	0.00	0.00	0.00
