WAVEGUARD AI

AERO STRUCTURAL HEALTH MONITORING (SHM) PLATFORM

REPORT ID: 1c6b1b8e-aa7
DATE: 2026-11-11 14:39 UTC
STATUS: VERIFIED

1. SPECIMEN & ACOUSTIC ACQUISITION TELEMETRY

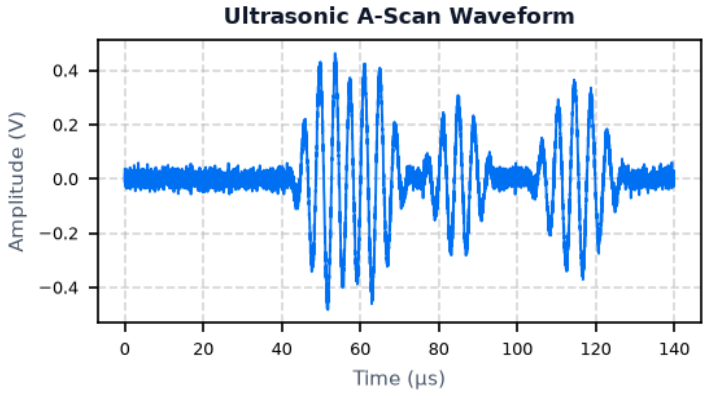
PREDICTED CONDITION: IMPACT DAMAGE

Confidence: 100.0% | **Severity Rating:** Level 4 - Barely Visible Impact Damage (BVID)

Defect Coordinates: X: 259.0 mm, Y: 265.0 mm, Depth: 2.1 mm

Severe structural discontinuity detected. Multiple secondary acoustic scattering echoes and diffuse wave attenuation across all sensor channels confirm localized fiber breakage and core crush.
