GSPCB ENGINEER CONFIRM

June 23, 2014

PCB Engineering Question of P/N: blitz_rev_d

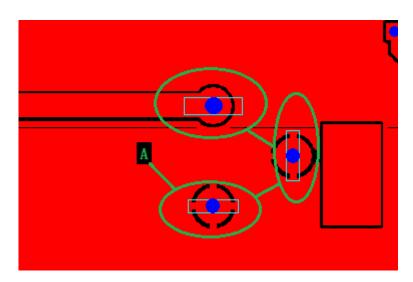
1. Customer supplied a milling layer, see below A point in figure1 shown, but the slots' size is bigger than the PAD size, and we suggest to ignore this three slots and follow the drill holes to built, please confirm.

Remark: the pro. Gerber file has followed the suggestion to do.

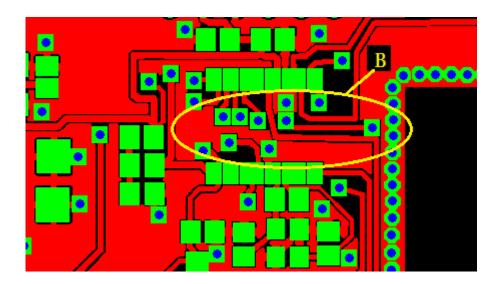
2. See below B point in figure shown, there are solder mask opening for all via holes, we suggest the solder mask follow MASTER GERBER to built, please confirm.

Remark: the pro. Gerber file has followed the suggestion to do.
