Supplementary Material

Salt-Spray Corrosion Failure Analysis and Mechanism-Informed Remaining Useful Life Assessment of Electrical Connectors

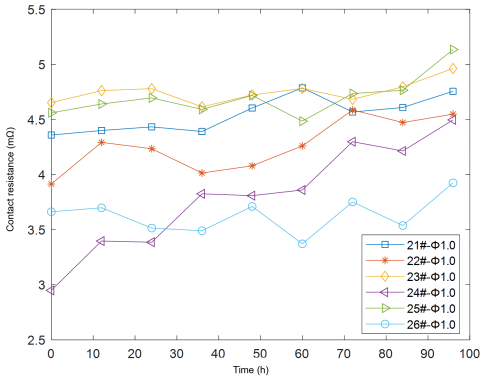
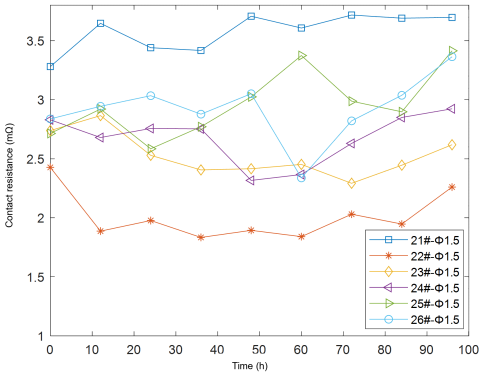
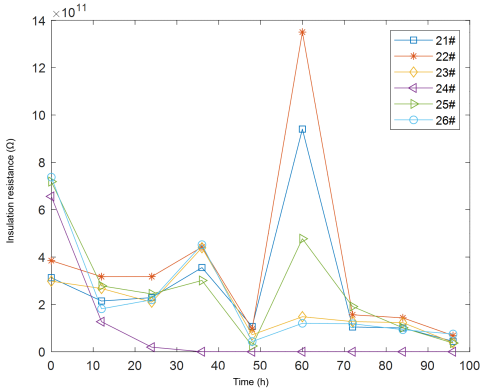
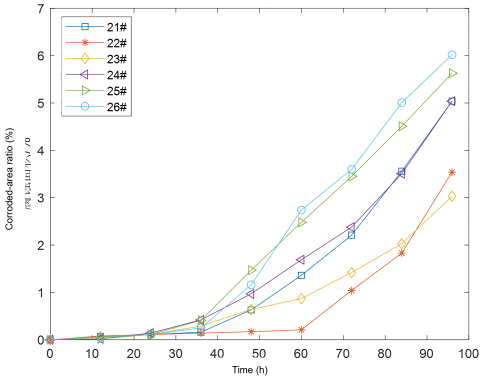
Figure S1: Representative degradation trends of key performance parameters under the 5% salt-spray condition.

Figure S1 gives representative time histories for the XCE33T41 samples under the 5% salt-spray condition. The contact resistance of both contact groups shows an overall upward trend, although the trajectories fluctuate because of specimen-to-specimen differences and localized corrosion. The insulation resistance generally decreases with exposure time, while the shell corrosion-area ratio increases. The simultaneous evolution of these electrical and structural indicators confirms that salt-spray exposure produces coupled contact, insulation, and shell degradation rather than a single isolated failure mode.

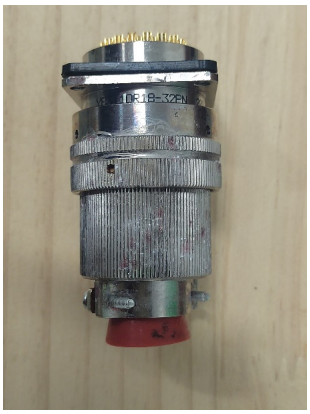
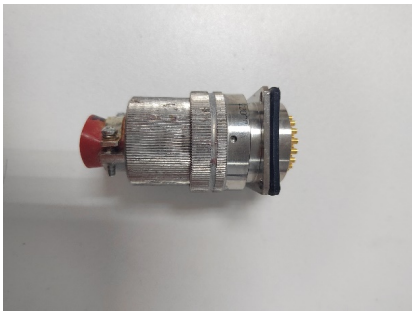
Figure S2: Representative macroscopic appearance of electrical connector samples after salt-spray testing.

The appearance inspection conducted after the salt-spray tests provides macroscopic morphological evidence for the preceding analysis. For the YB3116F18 samples, the photographs illustrate the evolution of corrosion at different salt-spray concentrations; for the XCE33T41 samples, the photographs show representative failure morphologies under the high-concentration condition of 5%. In the YB3116F18 connectors, corrosion is concentrated mainly on the shell and fasteners and is macroscopically manifested as coating discoloration, cracking, and localized peeling. The severity of these features increases progressively with salt-spray concentration. In the XCE33T41 connectors exposed to 5% salt spray, the principal features are discoloration and blistering of the coating in the shell and receptacle regions, accompanied by visible corrosion deposits. The representative macroscopic morphologies are presented in Fig. S2.

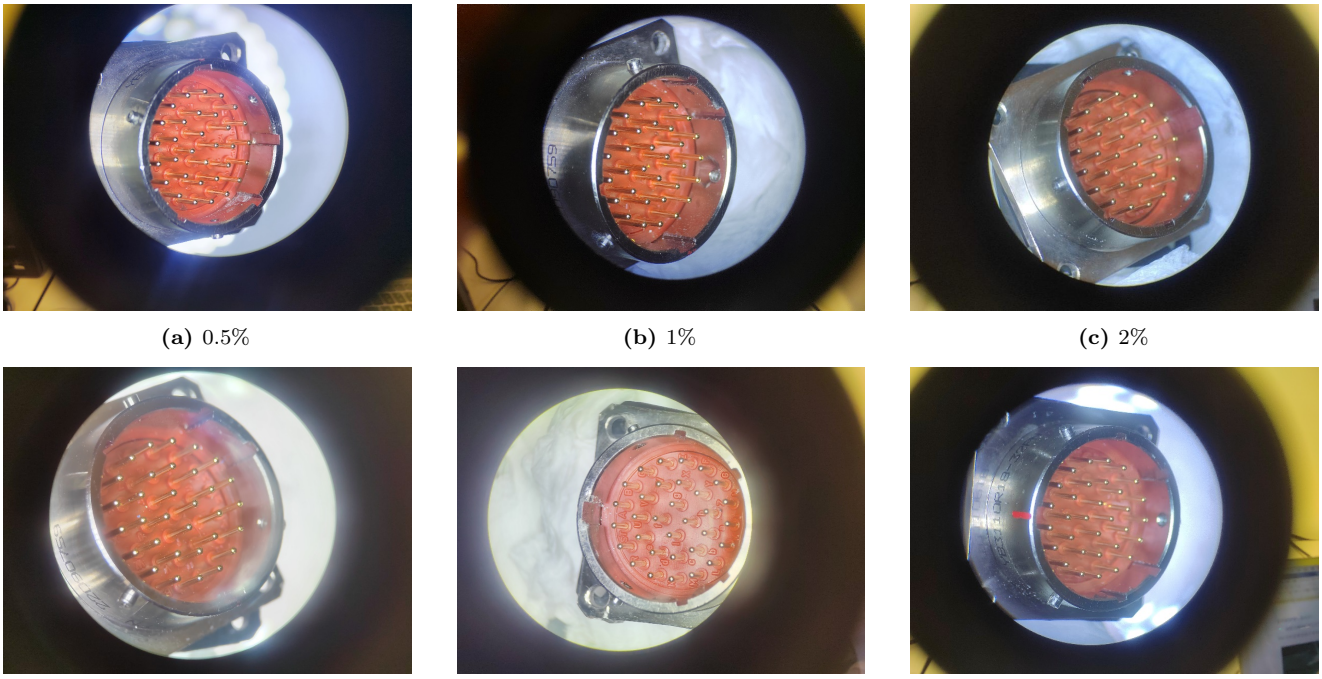
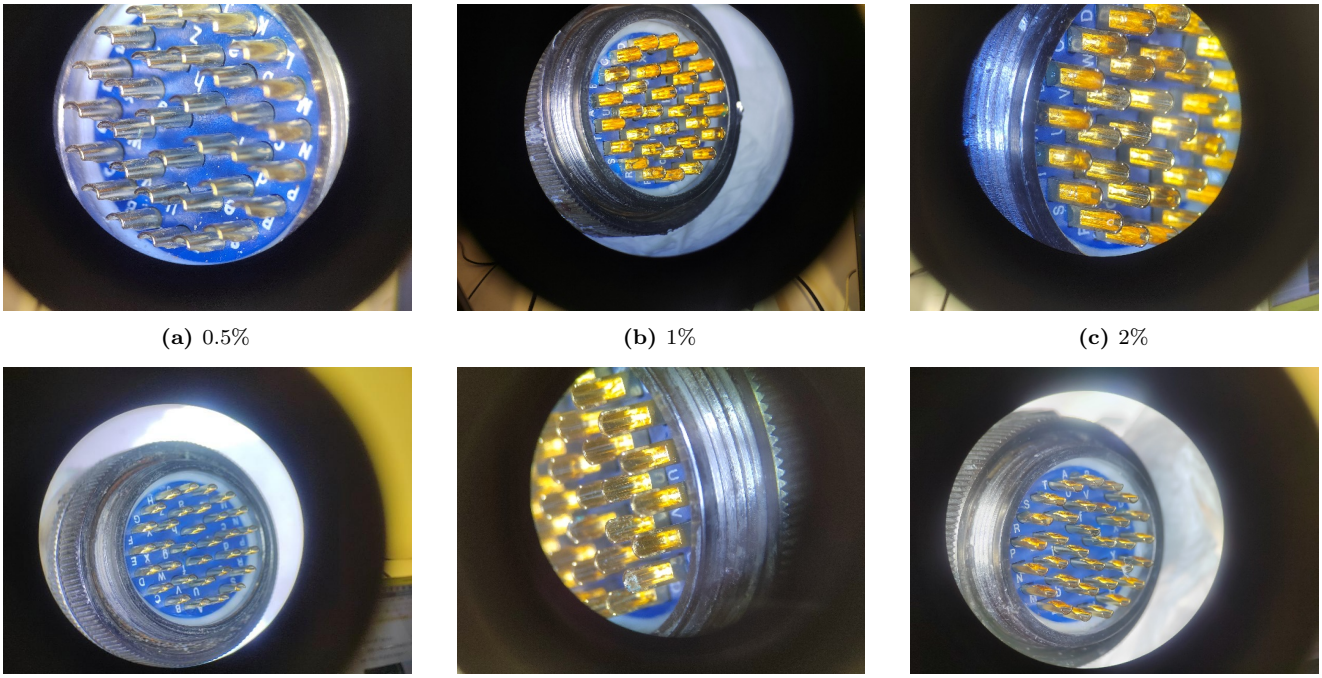
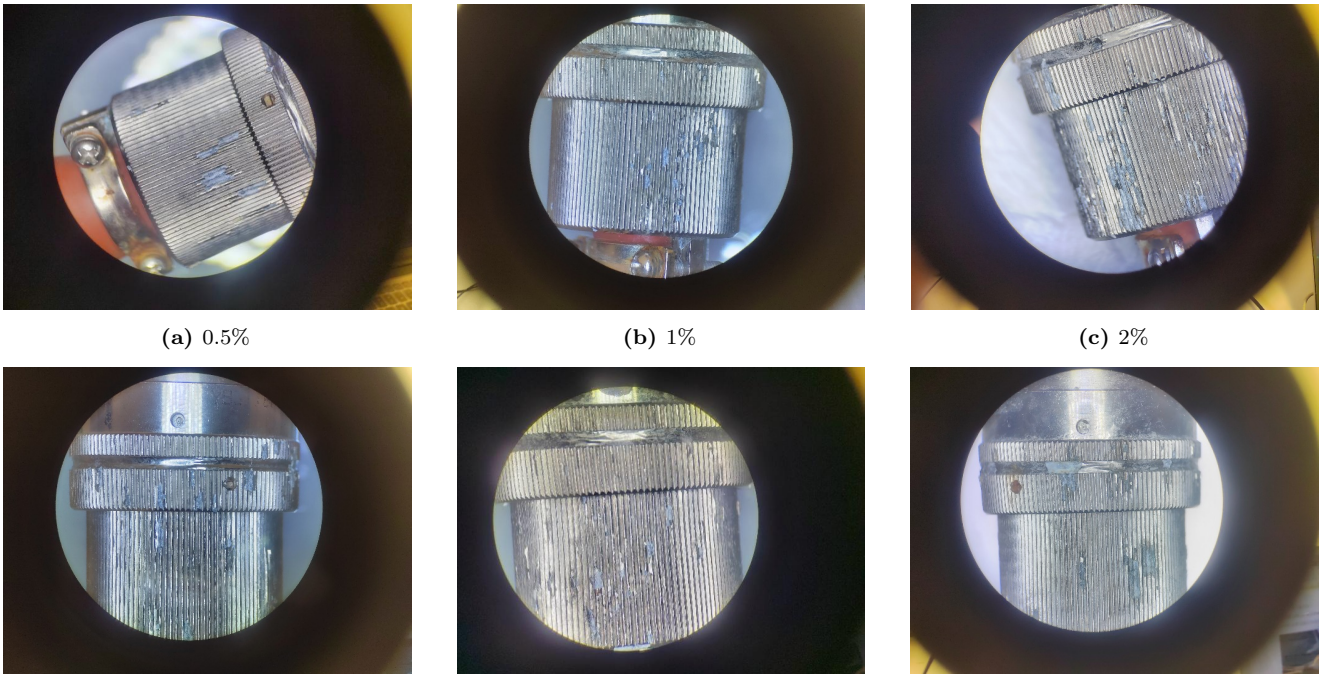
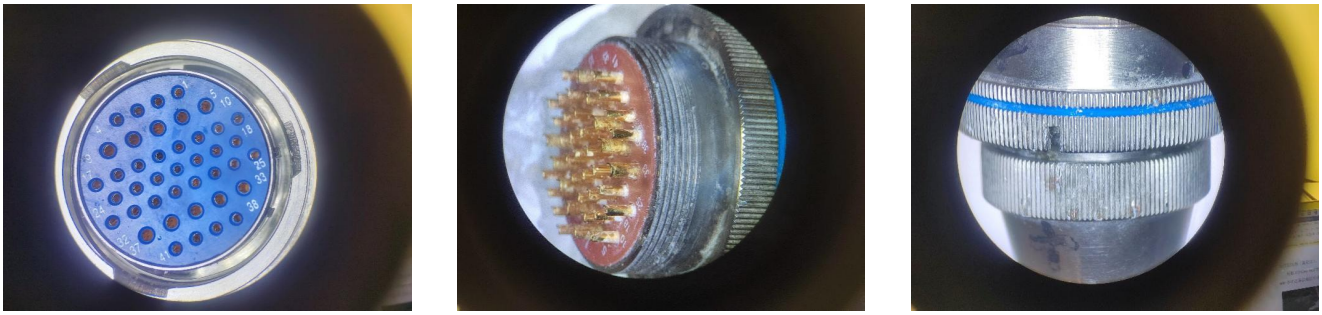
Further stereomicroscope inspection shows gray-white corrosion products, coating blistering, and coating peeling on the YB3116F18 samples exposed to different salt-spray concentrations. Salt precipitates adhere to the contact-pair surfaces, solder-cup contact surfaces, and shell regions, and these corrosion features become progressively more pronounced as the concentration increases. The three regions exhibit different local manifestations: the contact-pair and solder-cup surfaces show localized deposits and changes in metallic appearance, whereas the shell shows broader coating discoloration, blistering, and peeling. Under the 5% salt-spray condition, the XCE33T41 samples likewise exhibit corrosion deposits in the shell and receptacle regions, and local bulging of the material is visible at the bottom of the solder cup. These results show that both connector types follow a degradation sequence from surface deposition and coating damage to the expansion of localized corrosion. The corresponding observations are provided in Figs. S3–S6.

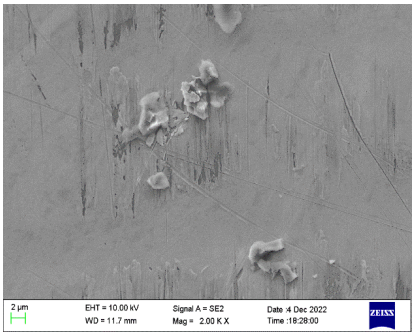
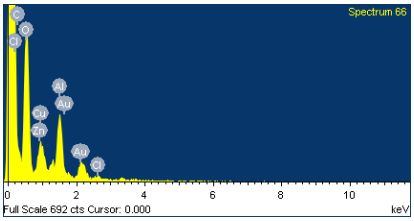
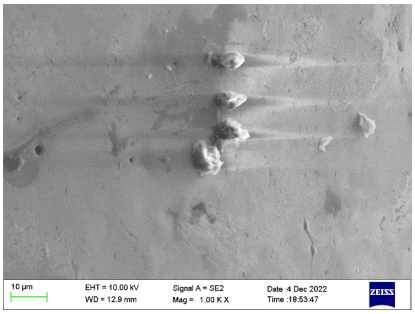
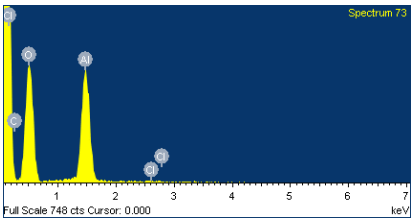
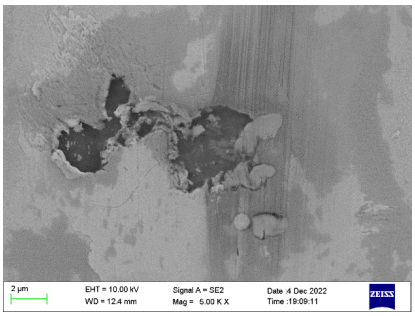
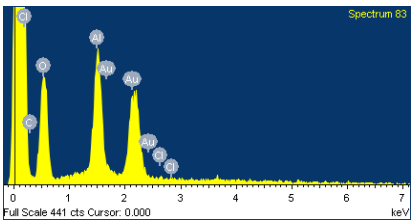
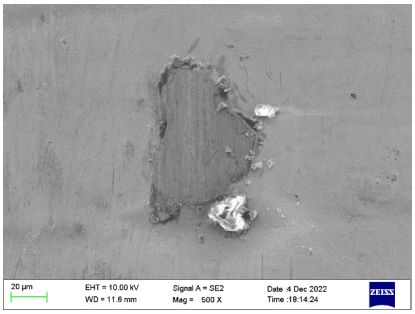
Figure S7: SEM and EDS results for the YB3116F18 contact region at 0.5%–2% salt-spray concentrations.

SEM and EDS analyses were performed to further reveal the microscopic failure mechanism of salt-spray corrosion. To provide representative evidence without excessive duplication, the contact-region morphologies of YB3116F18 samples at several salt-spray concentrations are shown together with complementary high-stress results from XCE33T41 samples exposed to 5% salt spray. The SEM images show that, as the salt-spray concentration increases, corrosion of the contact surface develops from slight localized deposition into more extensive corrosion and surface-layer damage. Corrosion products accumulate more heavily, and some regions show clearer evidence of coating damage and exposure of the underlying material.

The EDS results provide complementary compositional evidence, although the detected elements vary among sampling locations because EDS probes a small local area. The YB3116F18 contact-region spectra repeatedly contain oxygen and material-related elements such as copper or aluminum, and chloride is detected at several representative sites. Their co-occurrence supports the participation of chloride in the continuing corrosion process and the oxidation of copper-bearing or aluminum-bearing materials at damaged or contaminated regions. In mechanistic terms, coating defects and micropores on the contact surface preferentially become initiation sites for localized corrosion. As corrosion products continue to accumulate, the effective conductive area of the interface decreases and the resistance of the interfacial film increases, thereby producing the sustained increase in contact resistance observed during the degradation tests.

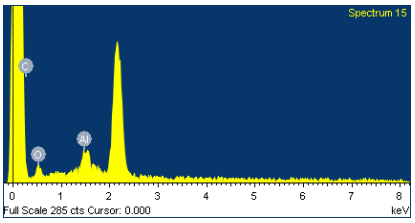
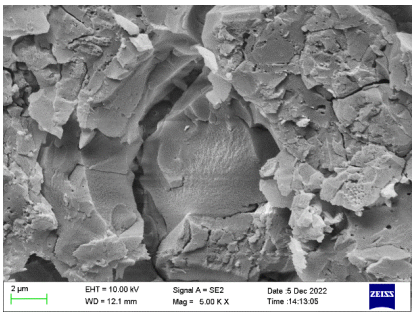
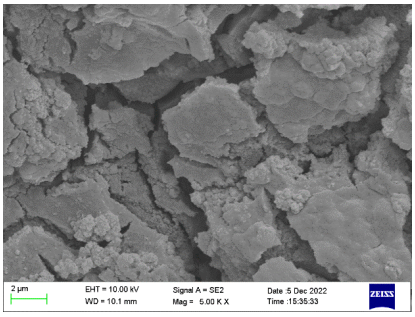
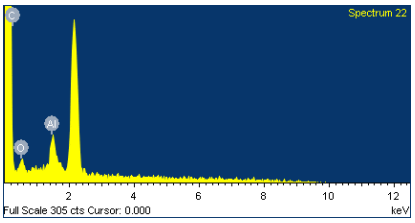
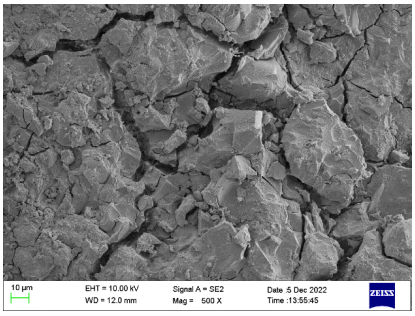
Figure S9: SEM and EDS results for the YB3116F18 shell at 0.5%–2% salt-spray concentrations.

The YB3116F18 shell surfaces show cracked, layered, and locally detached corrosion products, and the surface damage generally becomes more extensive at higher salt-spray concentrations. The shell spectra are dominated by carbon, oxygen, and aluminum, with nickel or sodium detected at some locations. Chloride is not detected uniformly in every shell spectrum because the EDS measurement represents only the selected microscopic area. Nevertheless, the shell morphology together with the oxygen-rich composition is consistent with oxidation of the aluminum-alloy shell, progressive coating degradation, and local exposure of shell-related materials in the salt-spray environment.

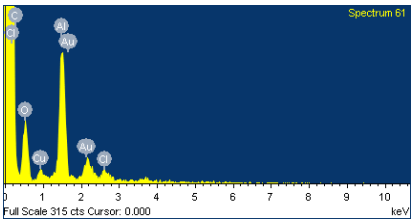
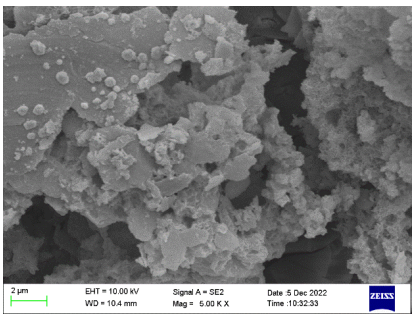
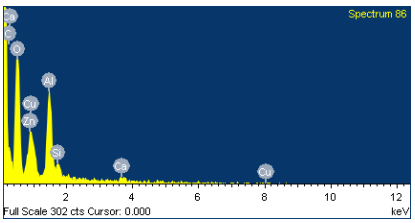
The XCE33T41 results under the 5% condition provide an additional high-stress comparison. In the contact region, the SEM image shows substantial surface deposits and local damage, while the EDS result detects oxygen, aluminum, copper, chloride, and gold among the principal material-related elements at the selected site. This composition is consistent with chloride-assisted electrochemical corrosion involving the contact coating and copper-based substrate. In the shell region, the corrosion products are rich in carbon, oxygen, and aluminum and also contain component- or deposit-related elements at the selected point. Together, the XCE33T41 observations reproduce the same progression from deposition and coating deterioration to localized corrosion that is observed in the YB3116F18 samples.
