Performance Testing of Naiade UV Disinfection System

(Final Report)

January 2005

Delft, The Netherlands

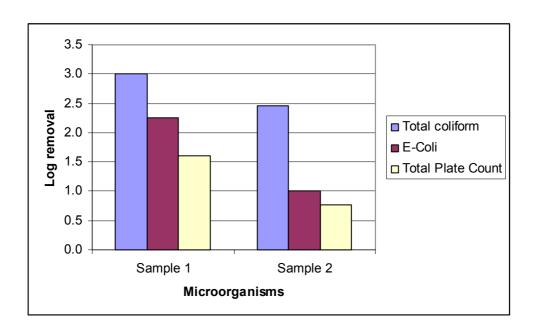
It was found when Delft canal water was used as influent, the number of total coliform and E-coli in the effluent were both <0.01 per mL. This corresponds to at least 2-3 log removals of total coliforms and more than 1 log removal of E-coli.

Fig. 3 Log removal of different organisms from Delft Canal water by Naiade UV disinfection system (without spiking E-coli and kaoline)

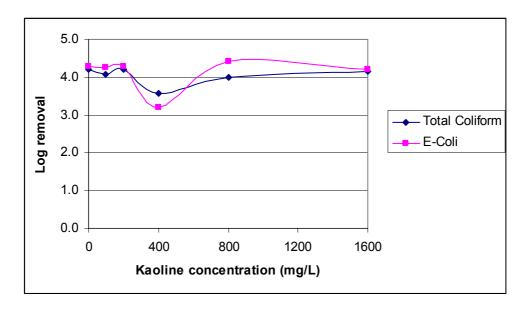
Fig. 4 Effect of kaoline concentration (turbidity) on removal of microorganisms by Naiade UV disinfection system.

It was observed that even when the turbidity of the water was increased from 20 FNU to > 300 FNU (corresponding to kaoline concentration of 0 mg/L to 1600 mg/L) there was more than 3 log removal of E-coli and Total coliform. This suggests that within the range of E-coli and Total coliform level tested (100 - 300 cfu/mL) there was no significant adverse effect of increasing turbidity (corresponding to kaoline concentration of 0 mg/L to 1600 mg/L) on the efficiency of UV disinfection system.

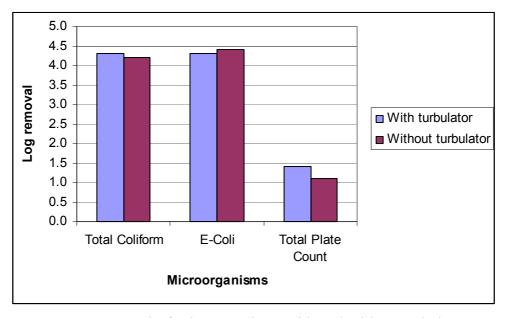
Fig. 5 Log removal of microorganisms with and without turbulator around the UV lamp in Naiade UV disinfection system.

When the UV disinfection system was operated with the turbulator in place, the log removals of Total coliform, E-coli and Total plate count were 4.3, 4.3 and 1.4 respectively. When the turbulator was removed and the samples were taken and analysed the log removals of Total coliform, E-coli and Total plate count were found to be 4.2, 4.4 and 1.1 respectively. These results imply that in general under the conditions tested there was no significant difference in the results with or without turbulator. However, further test should be conducted at higher concentrations of microorganisms and at higher turbidity level to verify the role of the turbulator.
