**Fourth Five-Year Review Report
for the
Tar Creek Superfund Site
Ottawa County, Oklahoma**

**Region 6
United States Environmental Protection Agency
Dallas, Texas**

September 2010

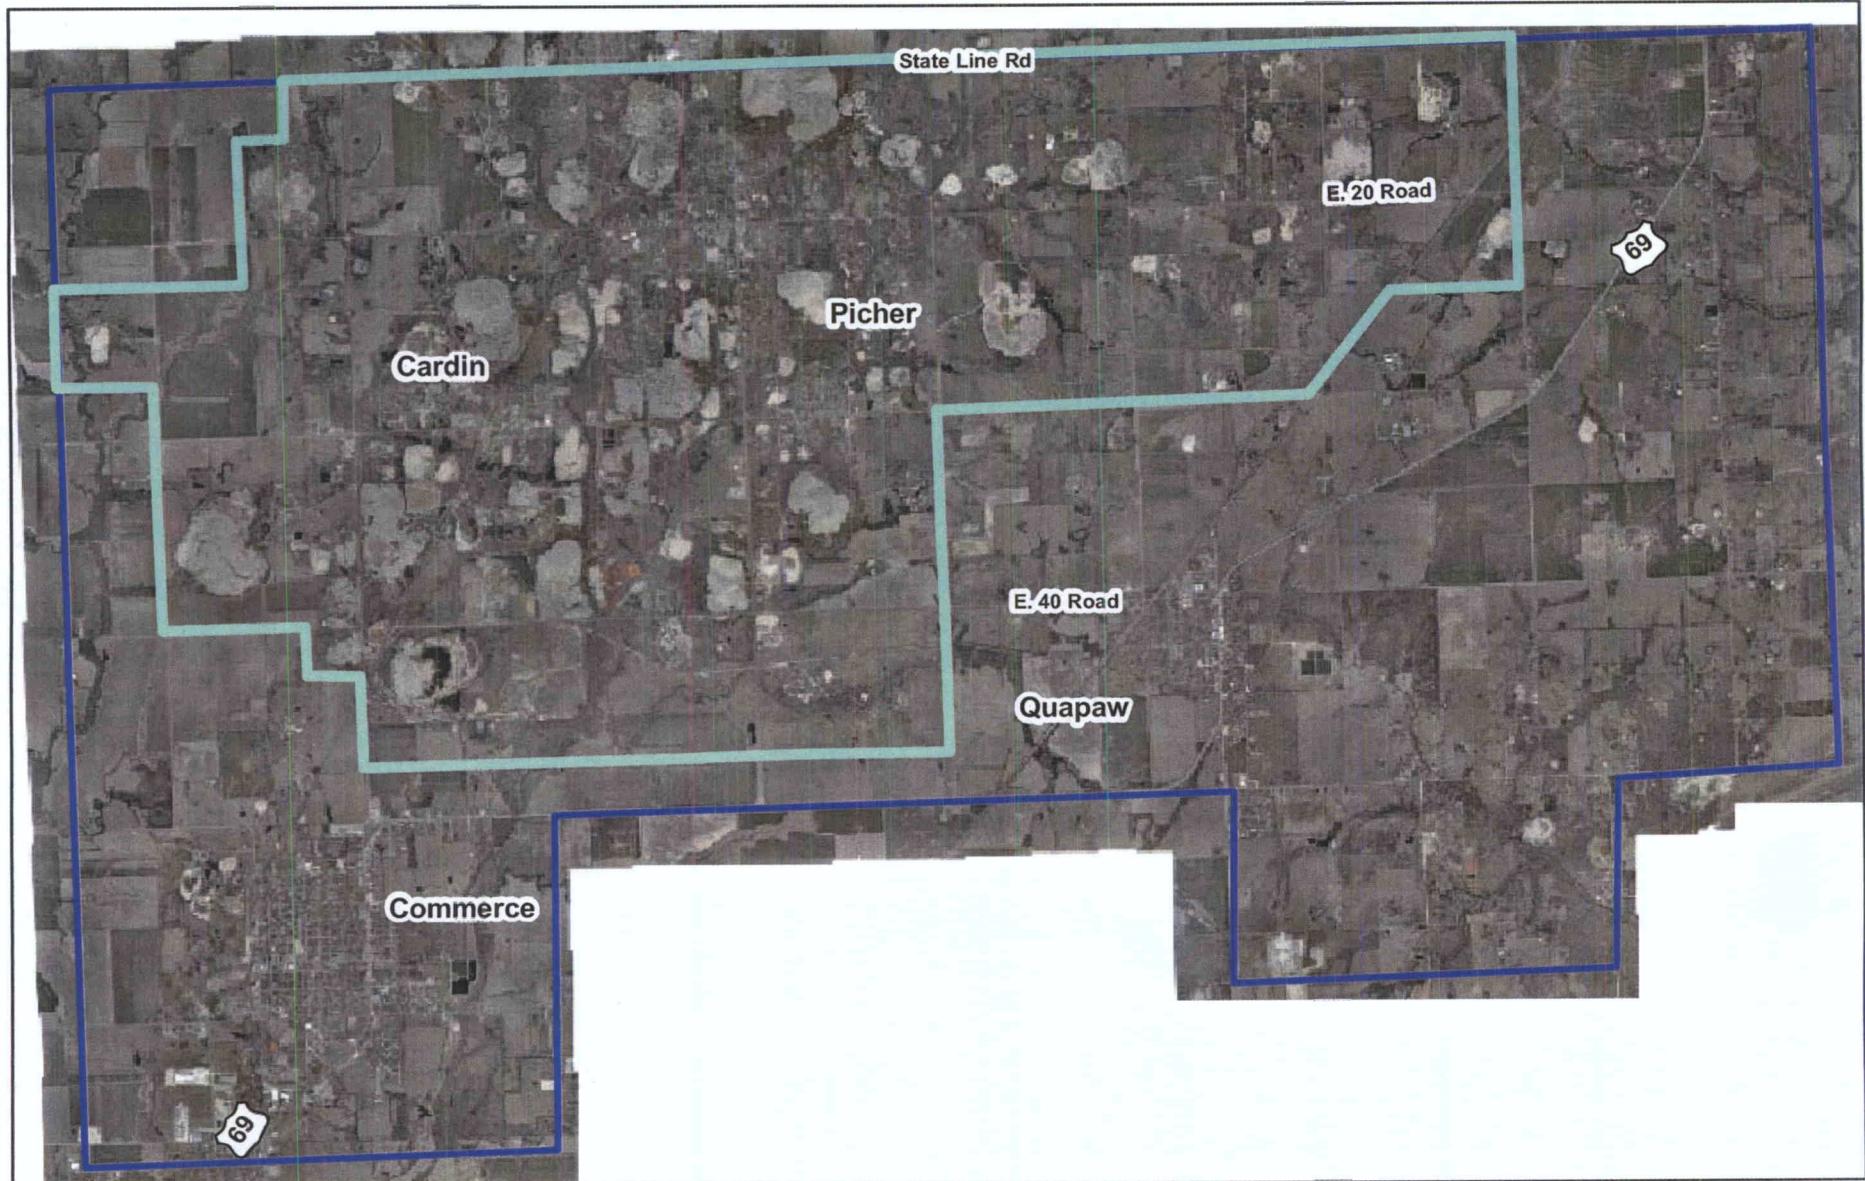
Figure 2

Phase 1 would address voluntary relocation of residents in the area shown in Figure 2, chat sales, and address source materials in a manner that reduces the overall footprint of contamination and reduces the need for land use restrictions, ICs, and O&M.

Voluntary Relocation Boundary Map

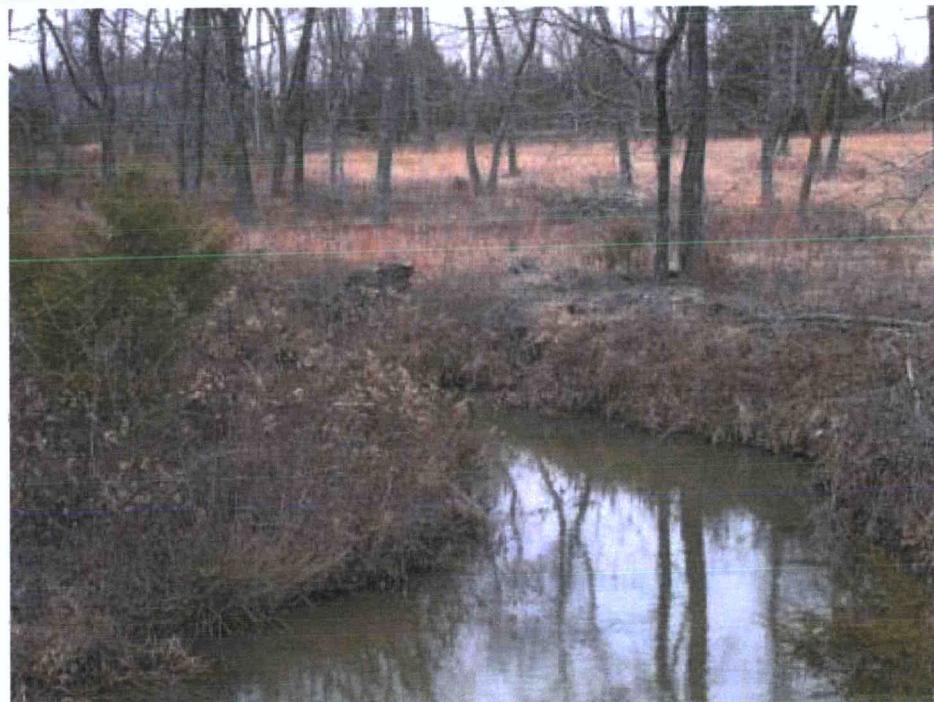
Photo 20: View of tributary channel on north side of bridge. View is facing north.

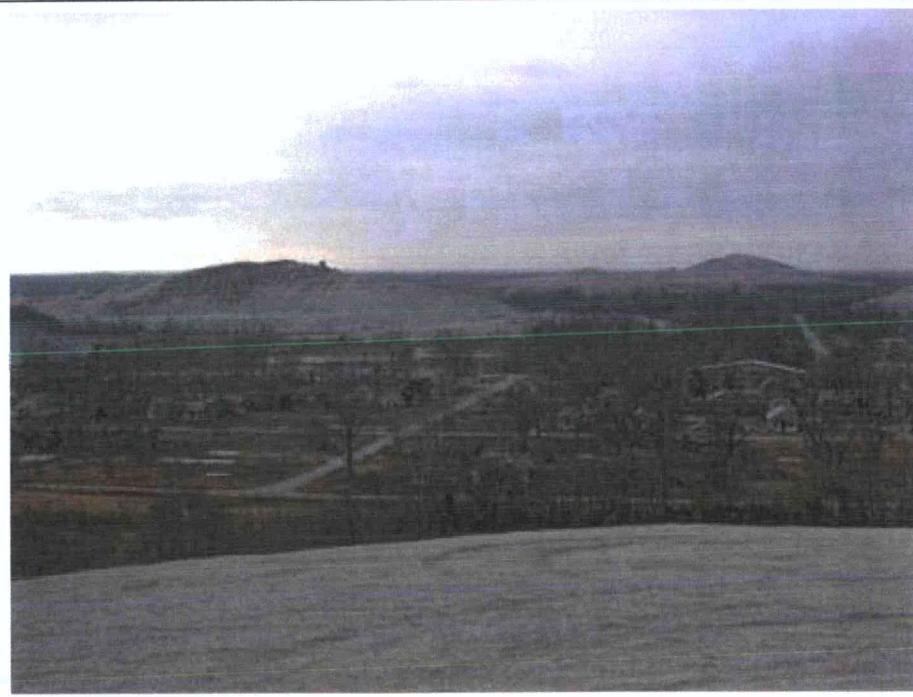
Photo 32: View of Picher from the Fisher Chat Pile. View is to the west.

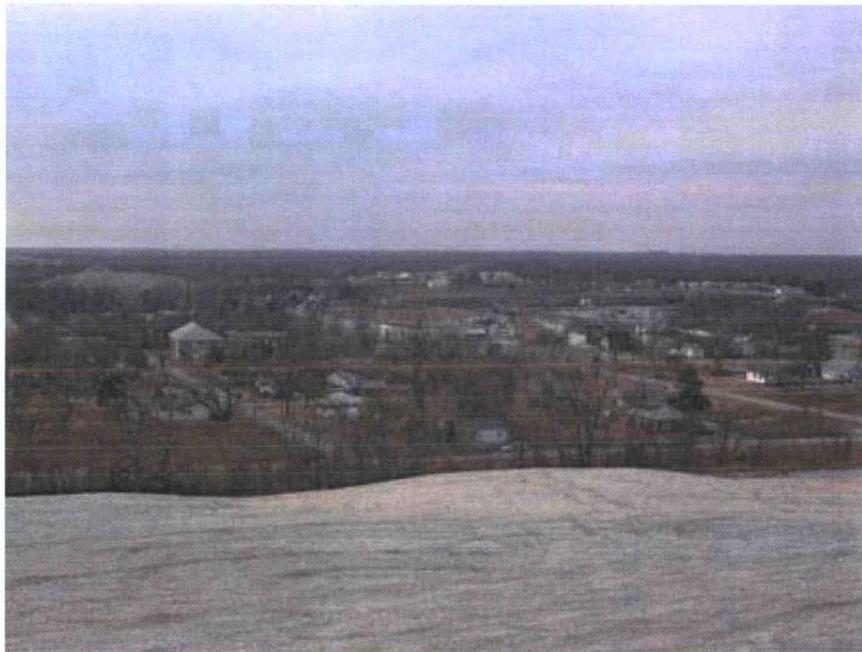
Photo 33: View of Picher from the Fisher Chat Pile. View is to the west.

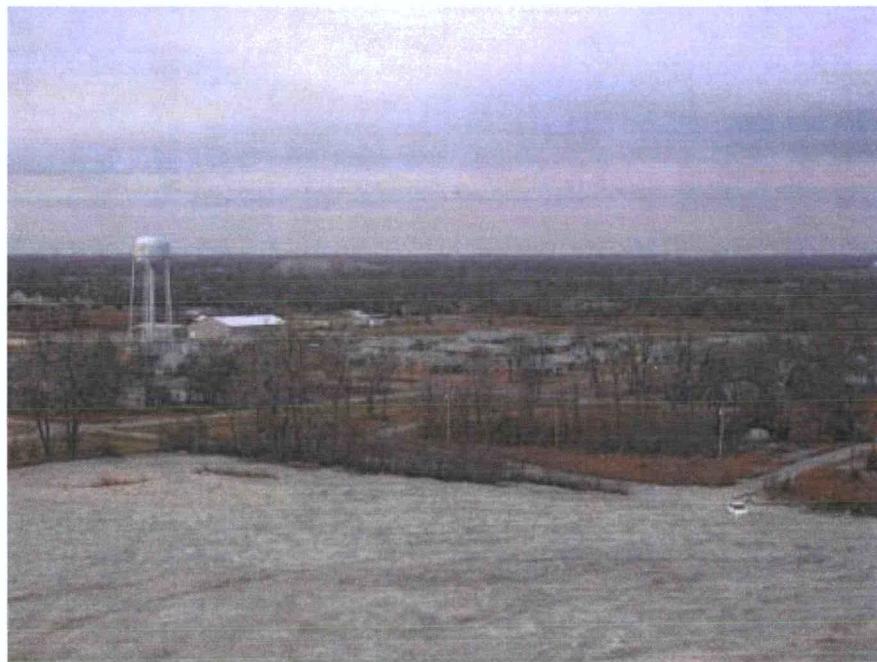
Photo 34: View of Picher from the Fisher Chat Pile. View is to the northwest.

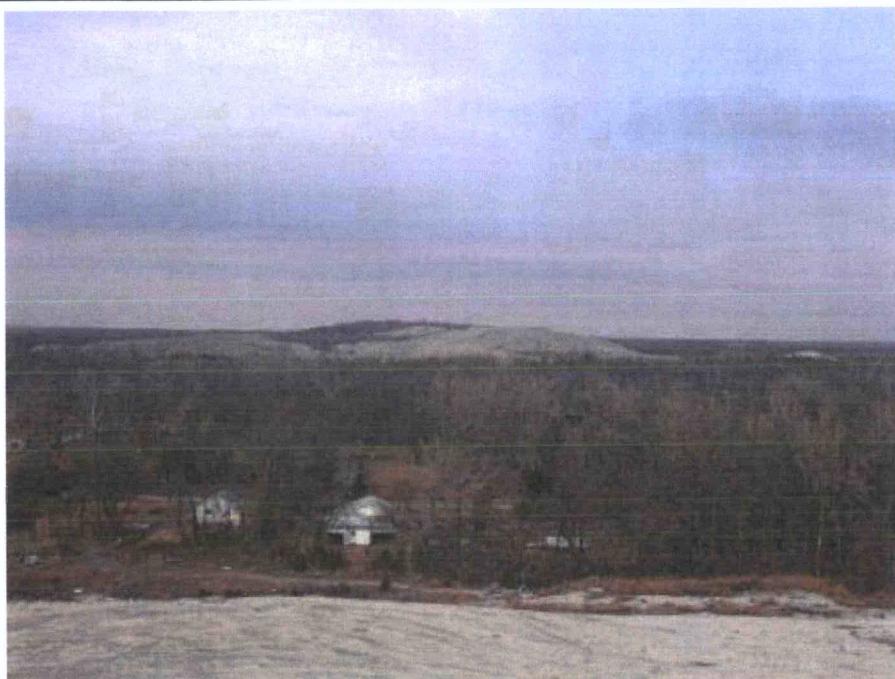
Photo 35: View of Picher from the Fisher Chat Pile. View is to the north.

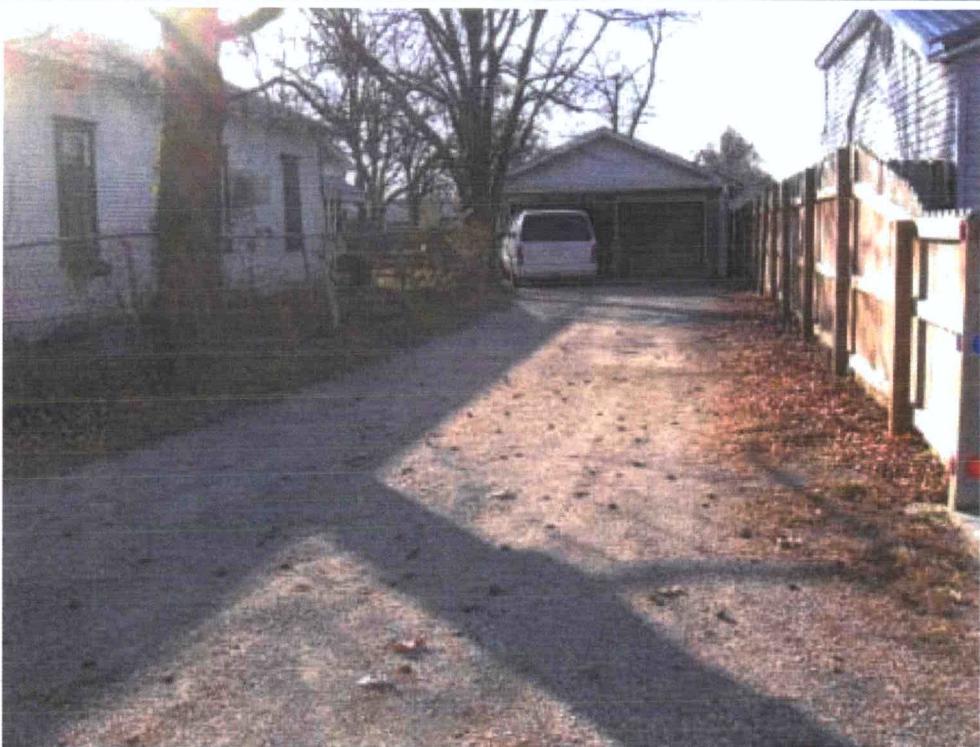
Photo 49: Chat in driveway in Miami.

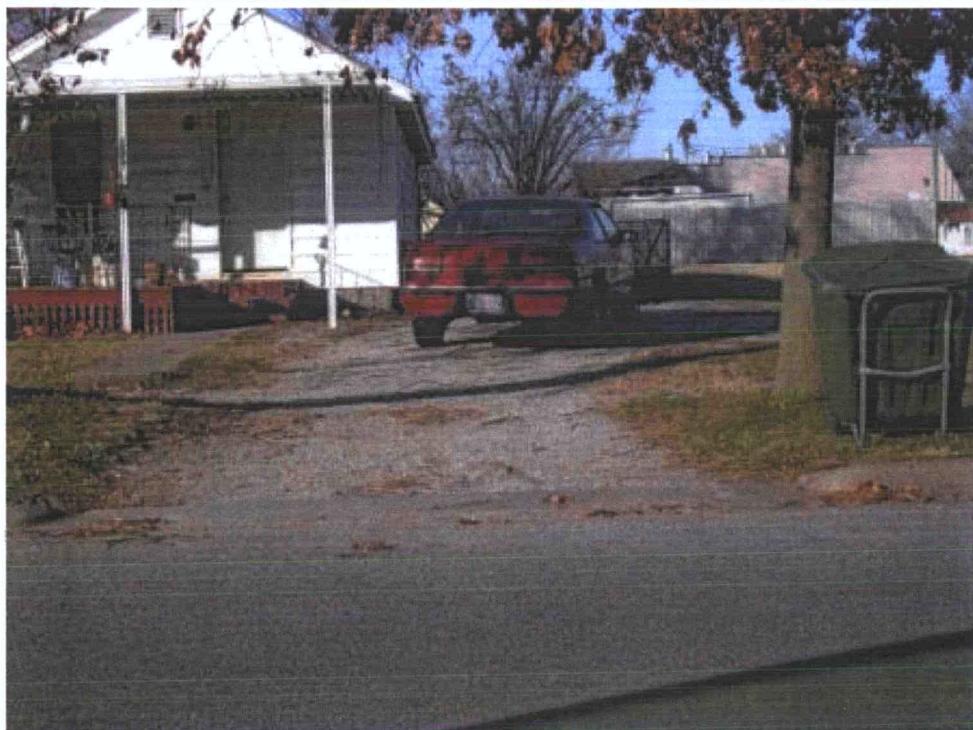
Photo 50: Chat in driveway in Miami.

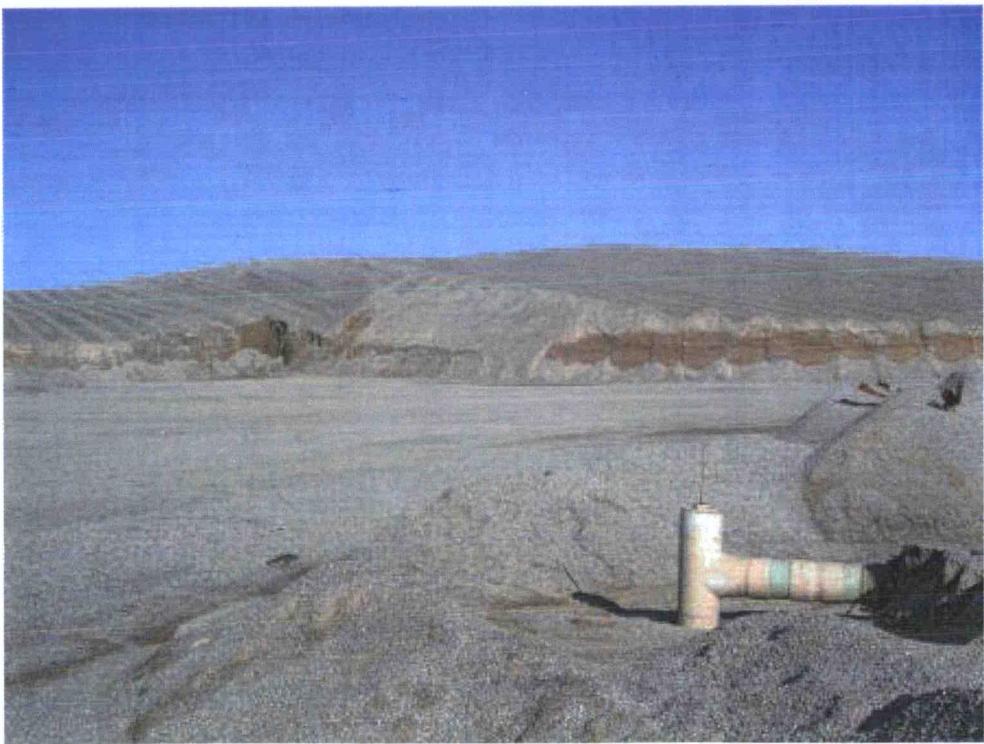
Photo 64: View of injection well and Sooner Chat Pile.

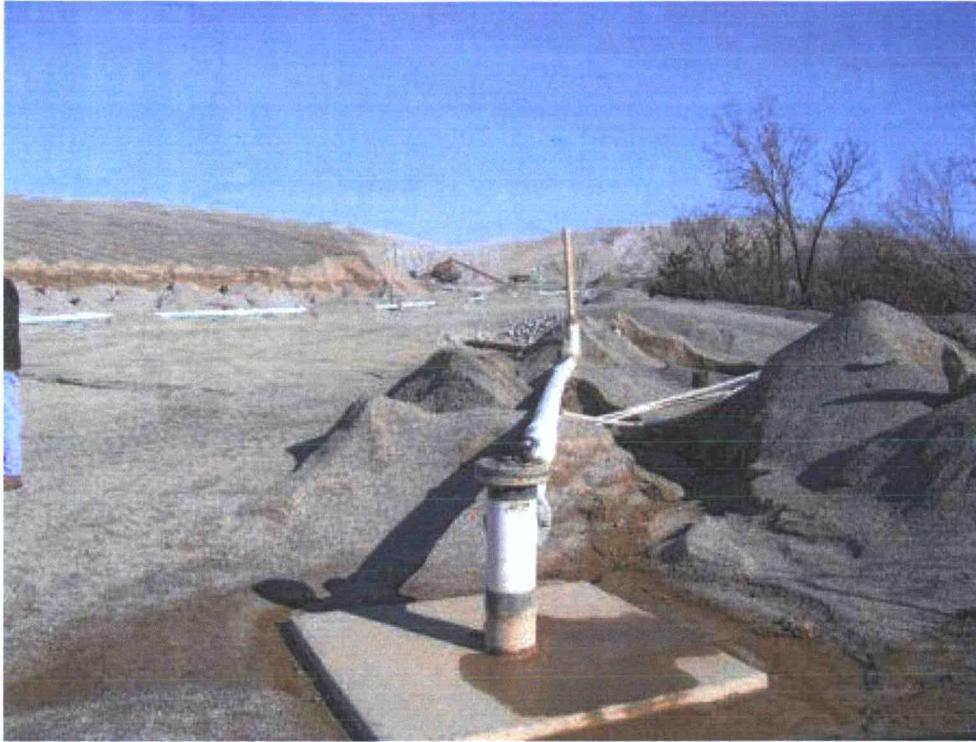
Photo 65: Close-up of injection well and pipeline. Chat washing unit is visible in center background.

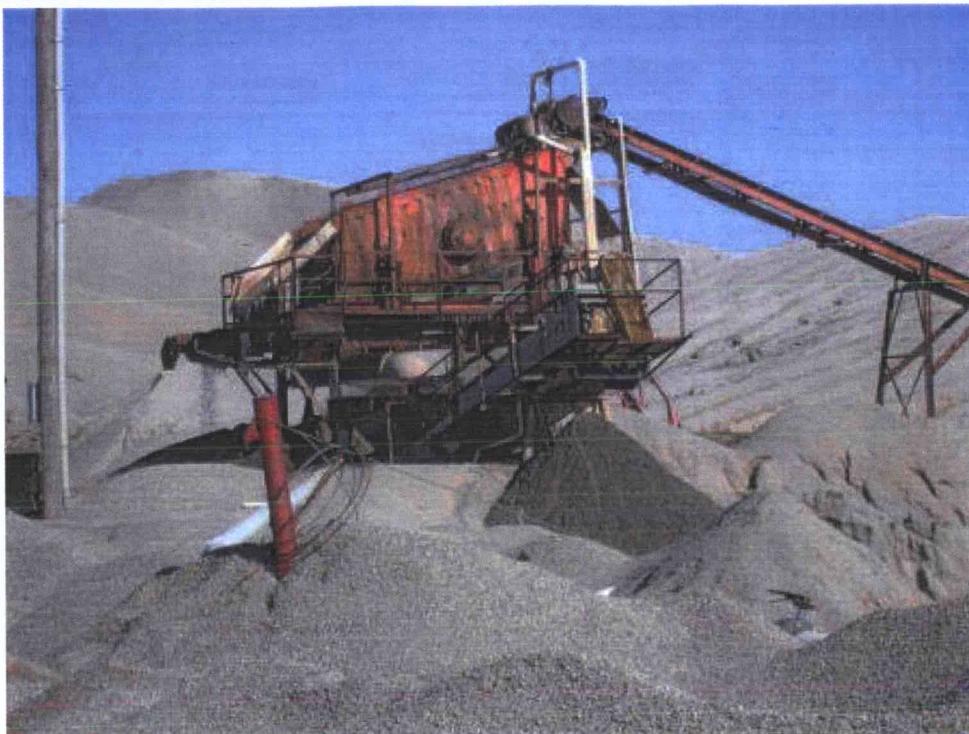
Photo 67: Close-up view of chat washing unit.

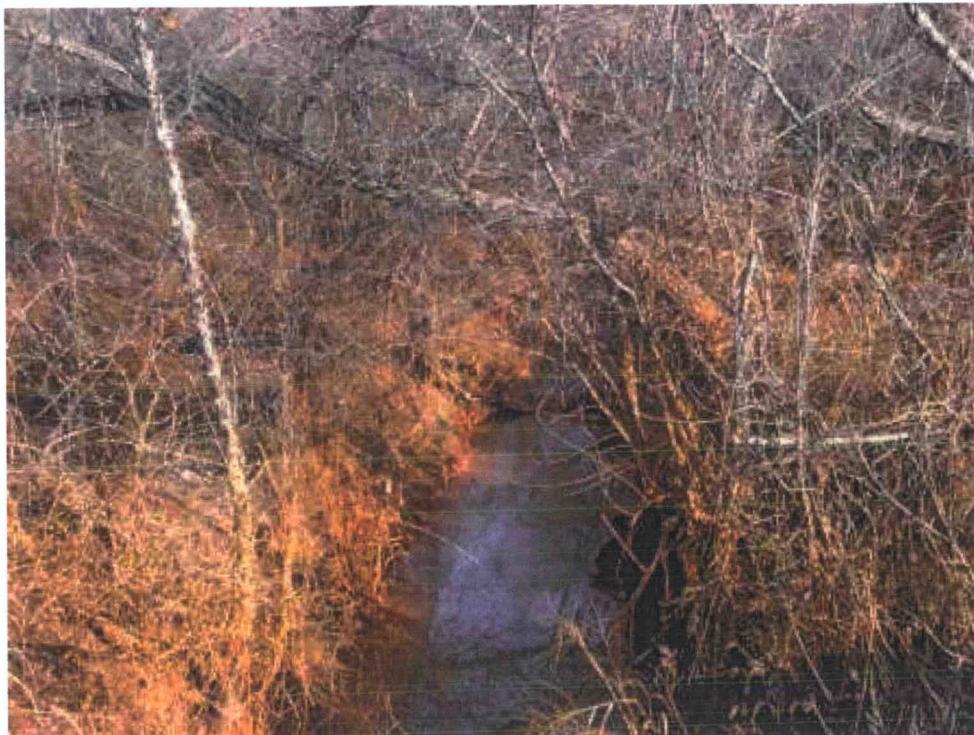
Photo 79: View of old Lytle Creek channel from Douthat Bridge. View is facing northeast.

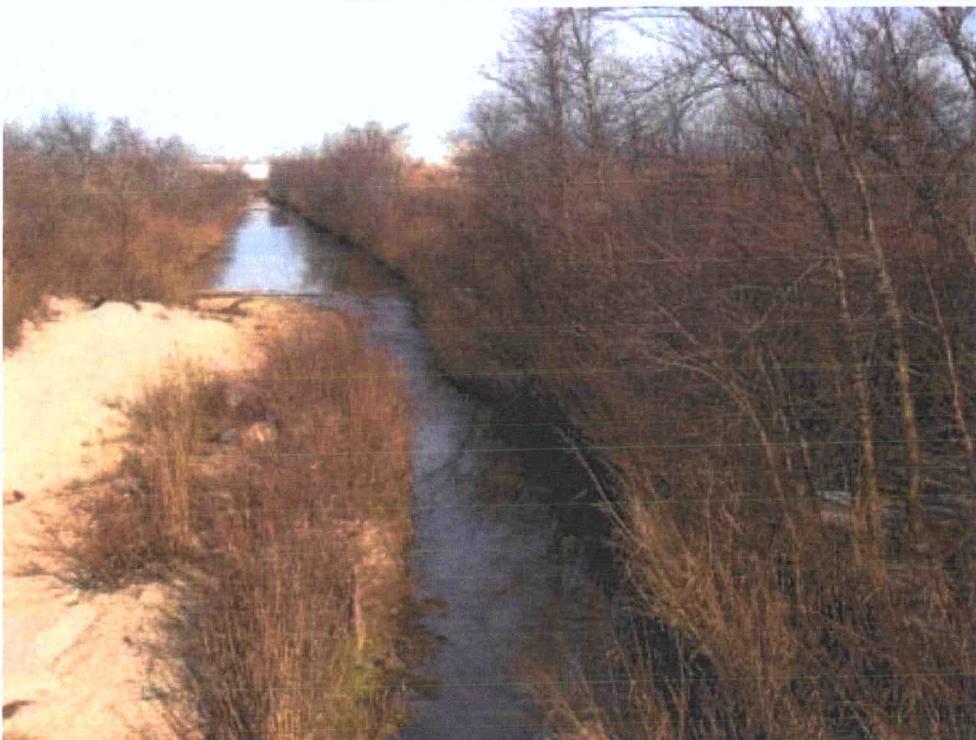
Photo 81: View of Tar Creek upstream (north) of Douthat Bridge.

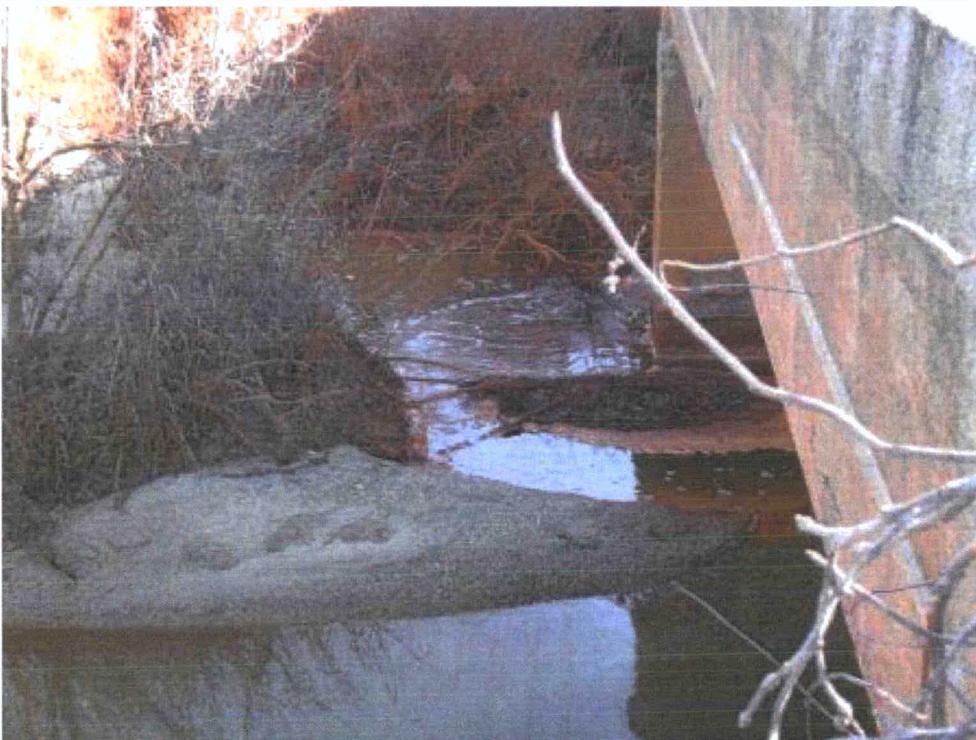
Photo 82: Mine water draining into Tar Creek underneath Douthat Bridge.
