**FIFTH FIVE-YEAR REVIEW REPORT FOR  
THE TAR CREEK SUPERFUND SITE  
OTTAWA COUNTY, OKLAHOMA**

**September 2015**

**Tar Creek Superfund Site**

**EPA ID No. OKD980629844**

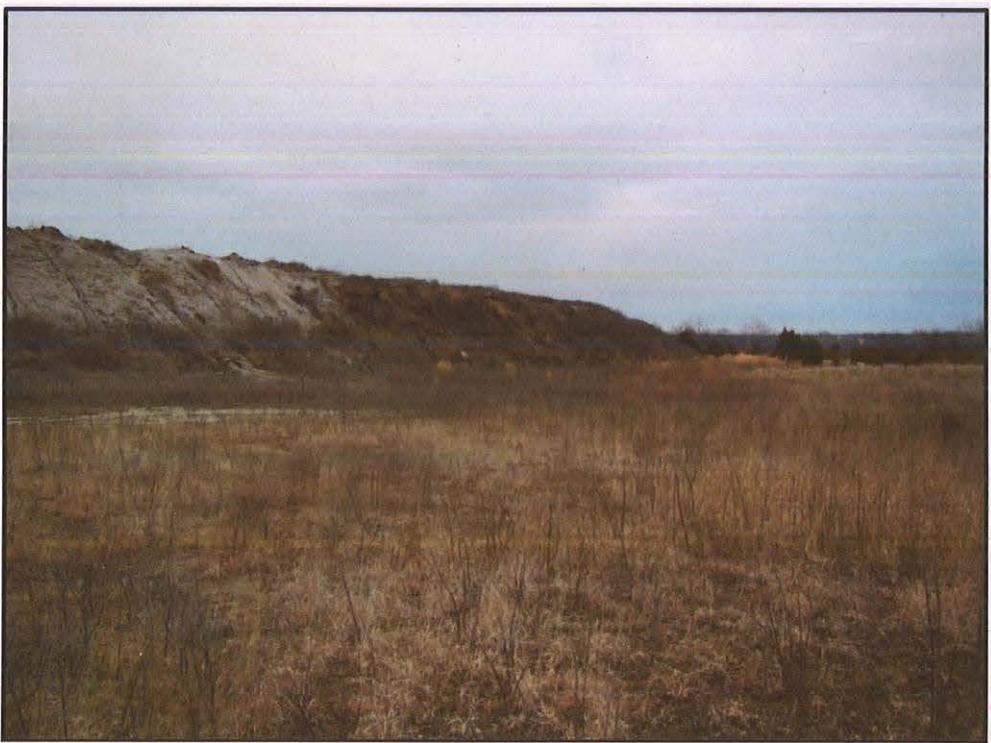
Photo 14: Collapsed Rolled Silt Fence on Northern Side of Central Mill Repository

Photo 15: North Slope of Central Mill Repository (photo taken facing south)

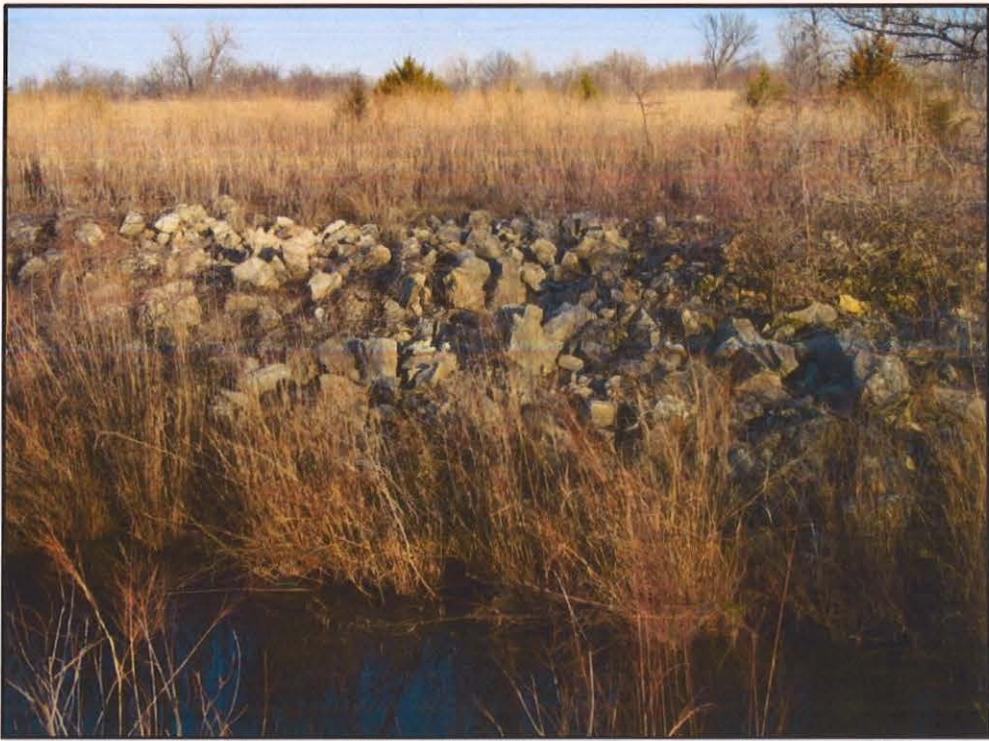
Photo 20: Portion of Diversion and Dike Structures at Admiralty Mine Site

Photo 21: Rip-rap of Diversion Channel at Admiralty Mine Site

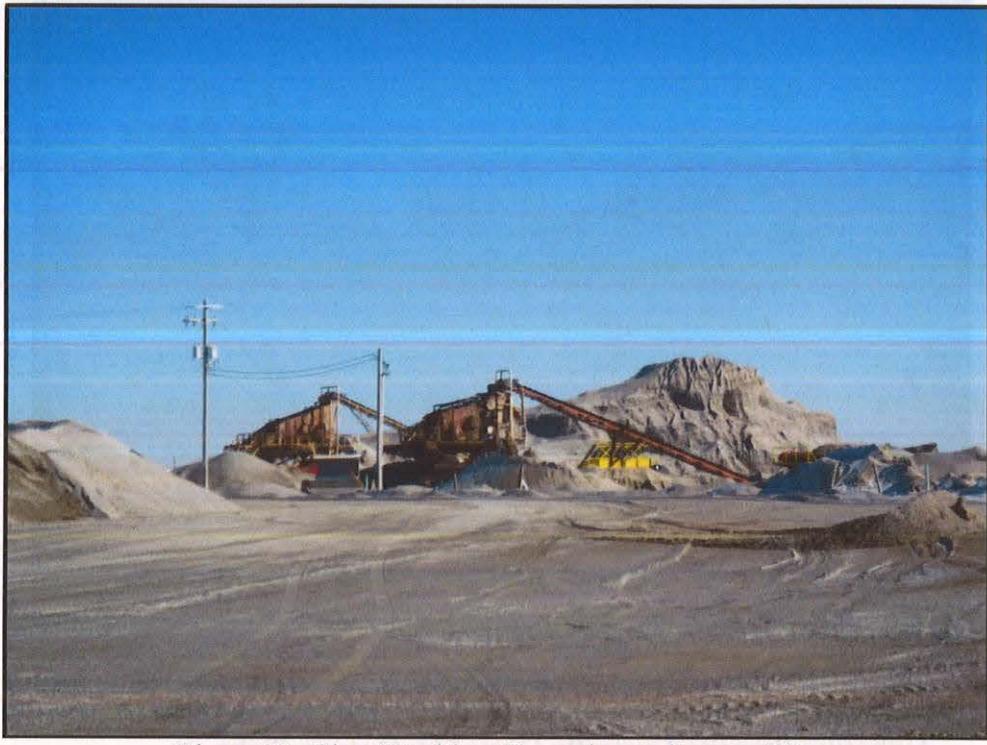
Photo 34: MW-1 at Sooner Pile, Location of Chat Injection Pilot Study

Photo 35: Chat Washing Operation at Sooner Pile
