Map of Debris and Obstructions in Gowanus Canal in 2005  
Upper Canal  
Gowanus Canal  
Brooklyn, New York

Gowanus Canal

Brooklyn, New York

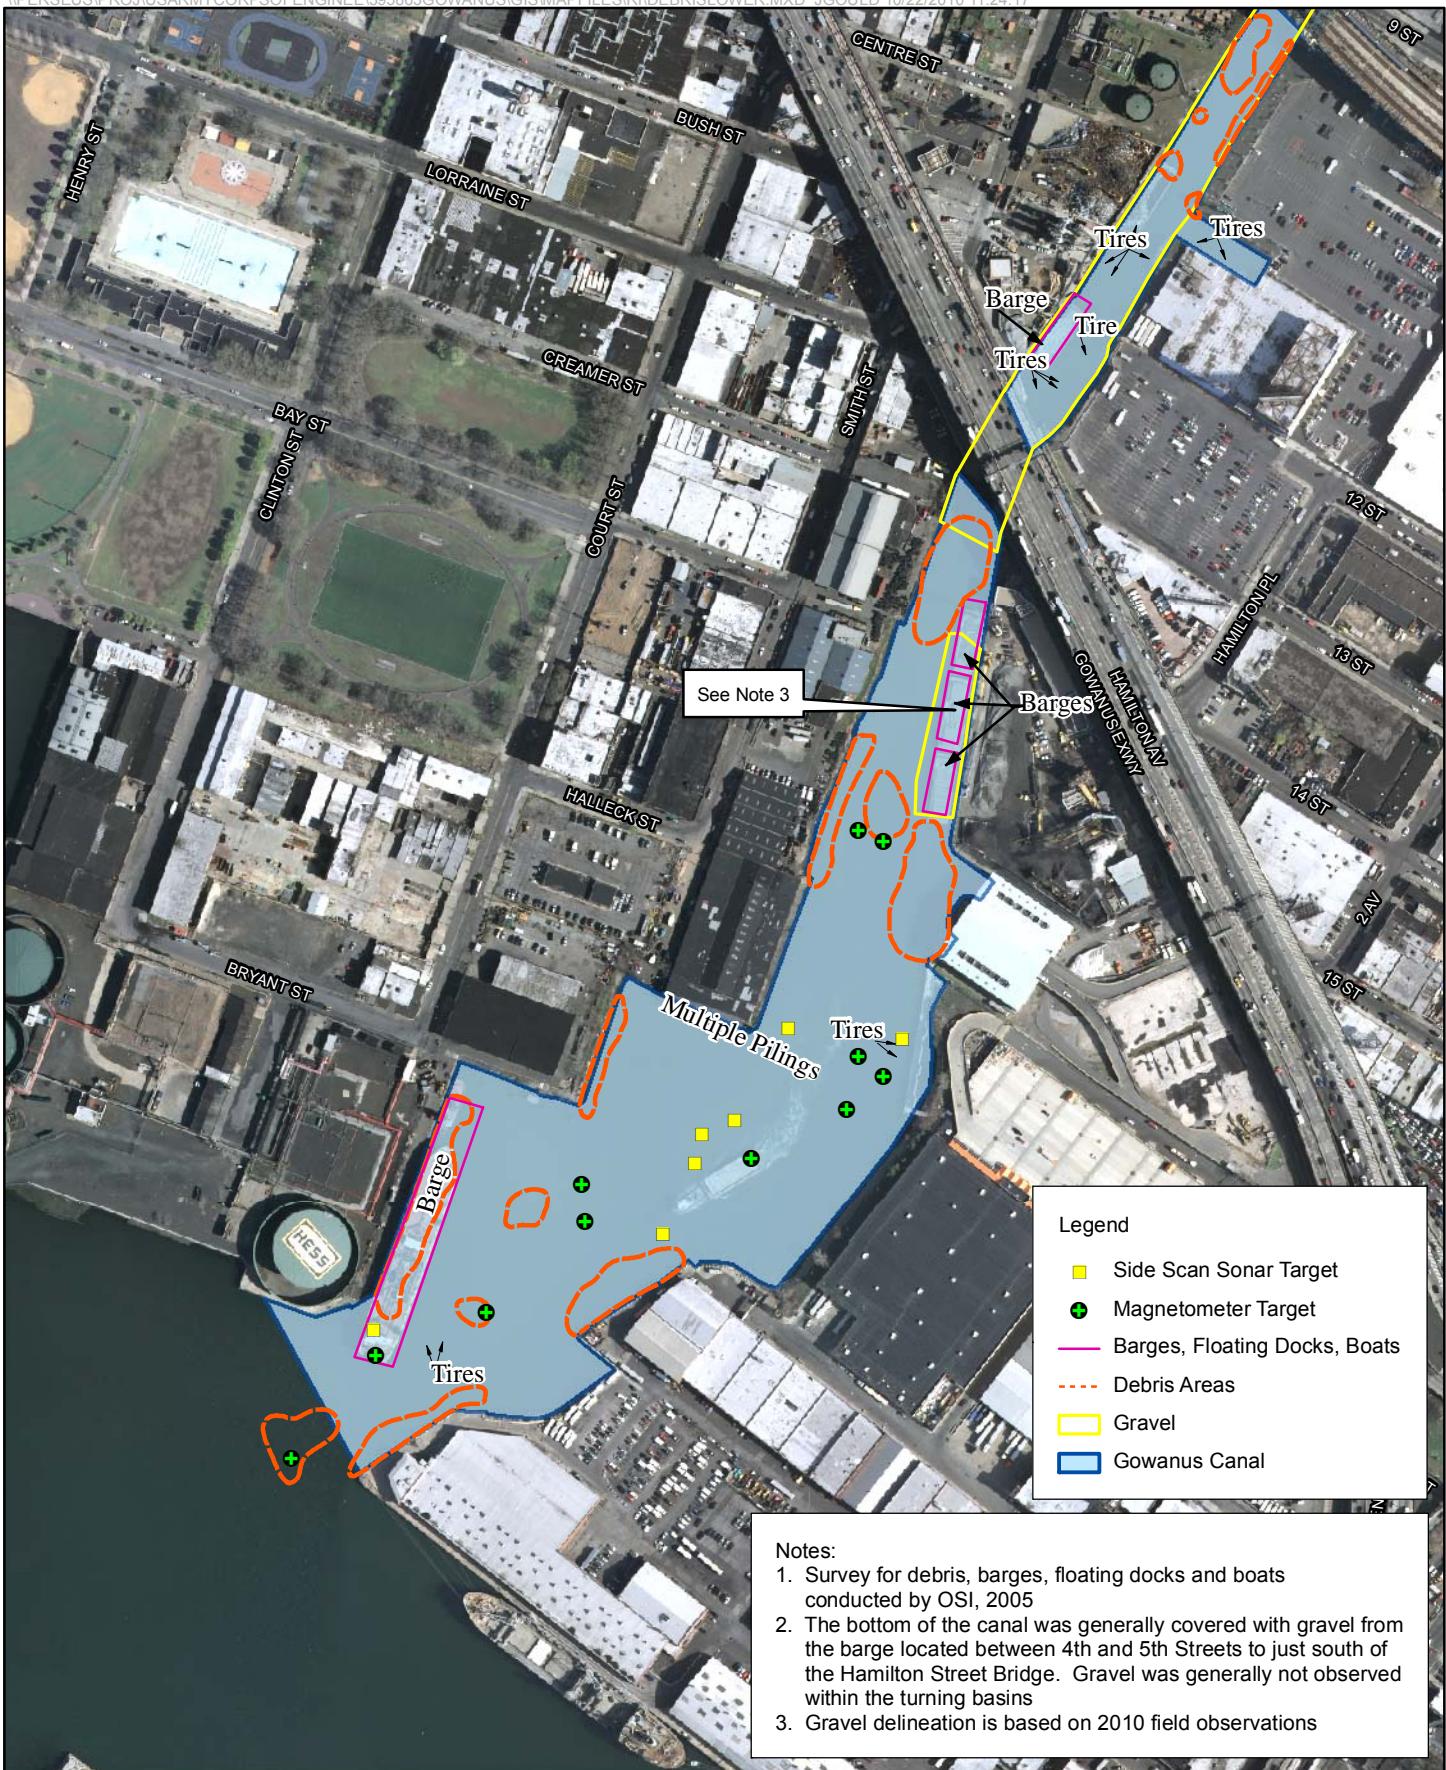
**FIGURE 3-4b**  
Map of Debris and Obstructions in Gowanus Canal in 2005  
Middle Canal  
Gowanus Canal  
Brooklyn, New York

Side Scan Sonar Target No.	Description
11	Pile of large blocks and debris
11a	Pile of debris
11b	Long pile of rip rap
17	Pile of hard, square debris
24	Suspected part of a tree
26	U-shaped object
28	Linear object
31	Small boat wreck
31a	Sunken boat hull
31b	Hard, rectangular feature
31c	Two rectangular features
37	Long section of rubble and rip rap
37a	Sunken barge
37b	Barge hull and small boat wreck
37c	Two hard rectangular features
39	Two rectangular objects
