2023 Türkiye Earthquake Sequence
Initiated 6 February 2023
Released: March 29, 2023
NHERI DesignSafe Project ID: PRJ-3824

JOINT PRELIMINARY VIRTUAL RECONNAISSANCE REPORT (PVRR)

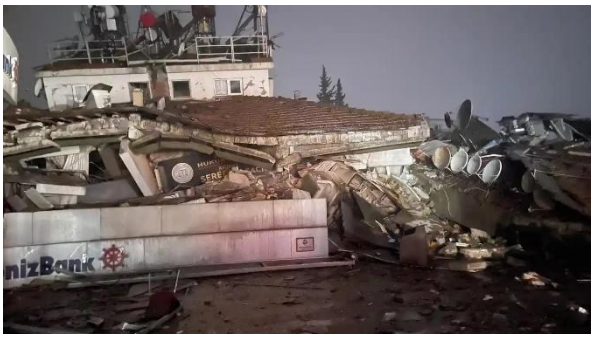
(9) The 7-story building on a 2-story podium in Figure 4.12 is a mixed-use building, where the podium is used as a commercial space and the 7-story building has residential units. The first story of the podium structure has glass façades and is weaker and softer than the second story of the podium. This is a potential reason for the collapse of this building. As observed from the right figure, all stories of the 7-story building collapsed, likely due to the impact of the podium collapse.

Figure 4.12. Collapse of a 7-story mixed-use building in Kahramanmaraş.

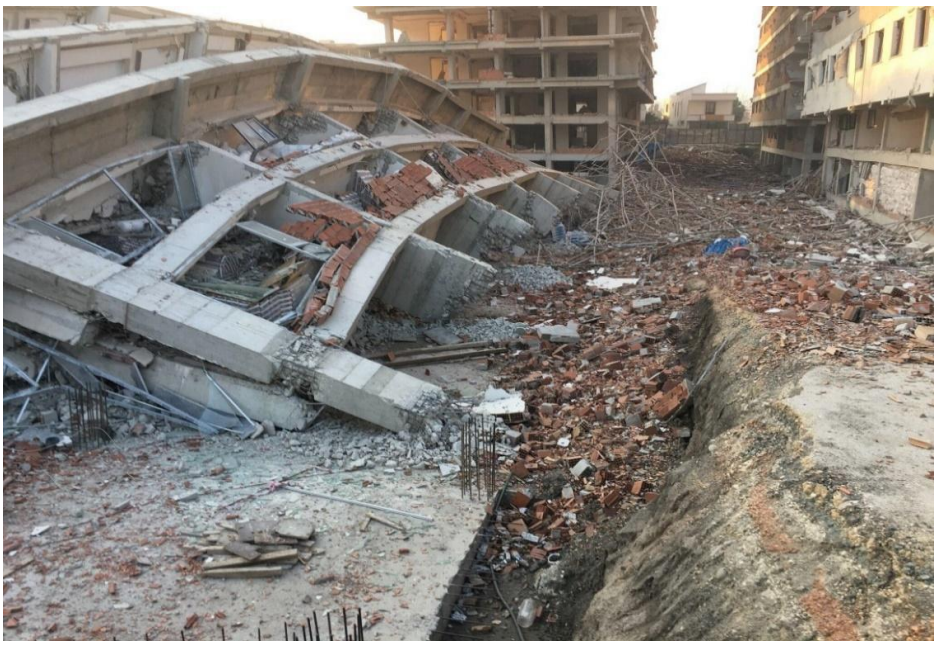
Figure 4.16. Collapse of an RC building under construction (Source: Earthquake Engineering Association Turkey).

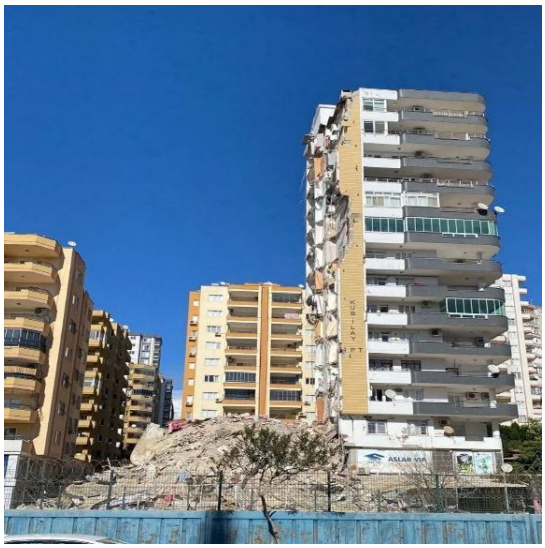
In addition to the numerous failures shown above, Figure 4.19 (b) and (c) show that half of a 15-story mixed-use concrete building collapsed by separation from the other half. This collapse was reported to occur after a Mw 6.1 aftershock. From the top view of the building, an excessive reentrant corner can be seen in the middle. This reentrant corner could have led to excessive stress concentrations at that portion of the building (FEMA-P154, 2012). This may have caused the splitting of one half of the building from the other contributing to the collapse of the split half. It is also noted that the same reentrant corner is present in similar buildings in the neighborhood that are standing, hinting at possible other structural issues of this collapsed building.

Figure 4.19. Partial collapse of a 15-story concrete mixed-use building, Adana (37.049N 35.275E).

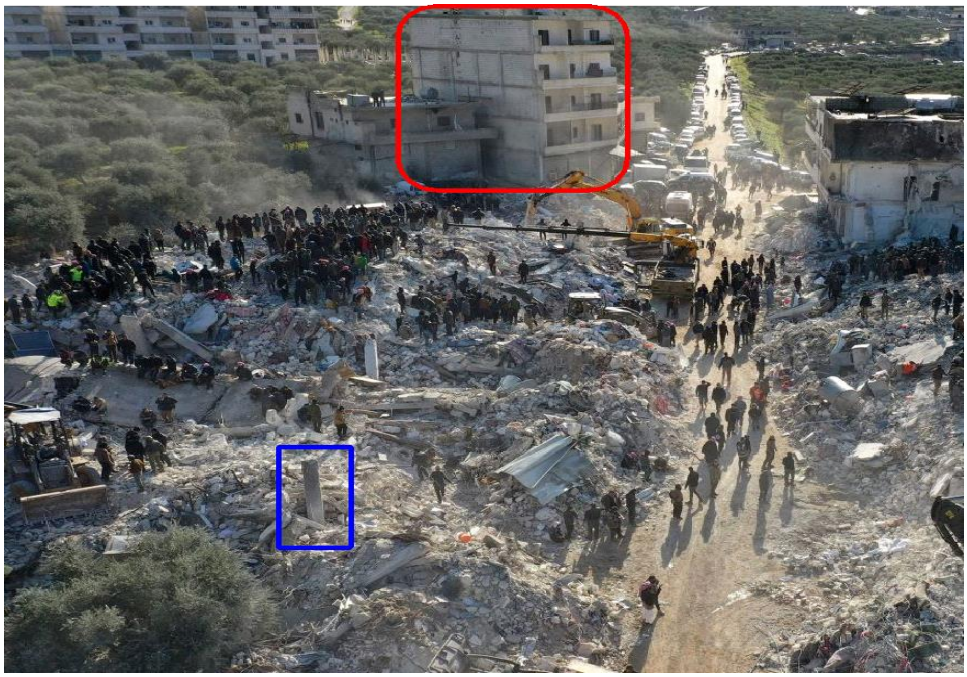
Figure 4.26. Collapsed masonry & RC buildings, Besnaya, Reef Idlib (Source: AFP via npr.org).

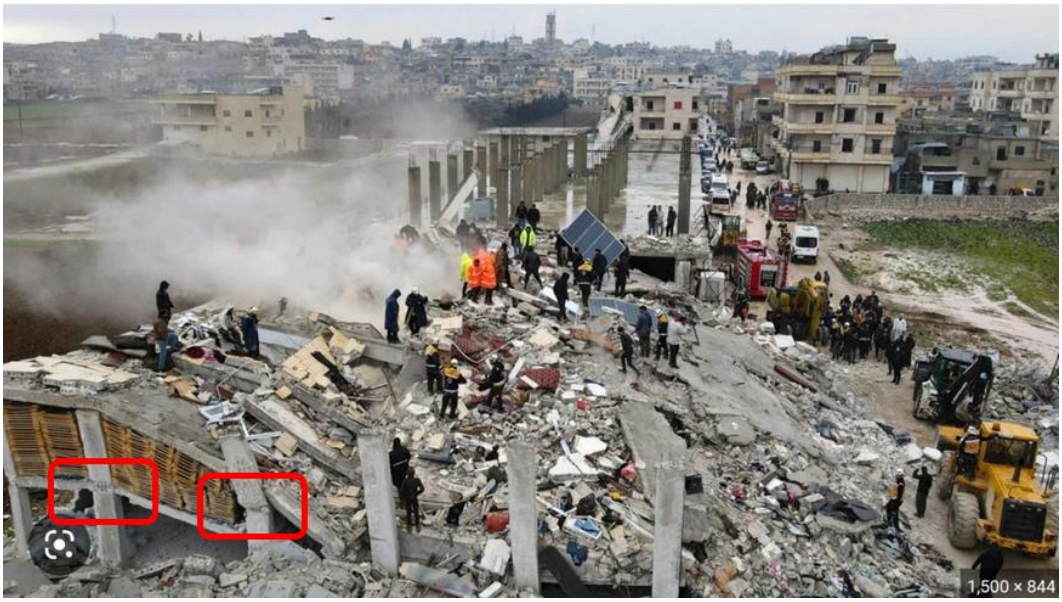
Figure 4.29. A collapsed building in Samada, Northern Syria (Source: Reuters). Notice the light column reinforcement and separation of slab from columns (in red rectangles) in the collapsed building.

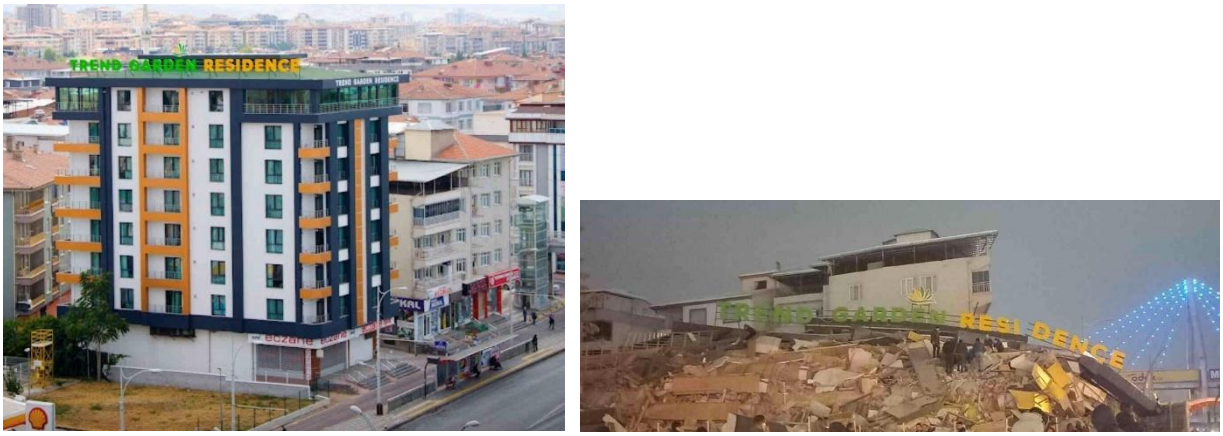
Figure 4.38. Before and after photographs of Trend Garden Residence showing the building collapse in Malatya, the pancake collapse of all stories suggests major structural problems. (38.347N 38.283E) (Source: NY Times).

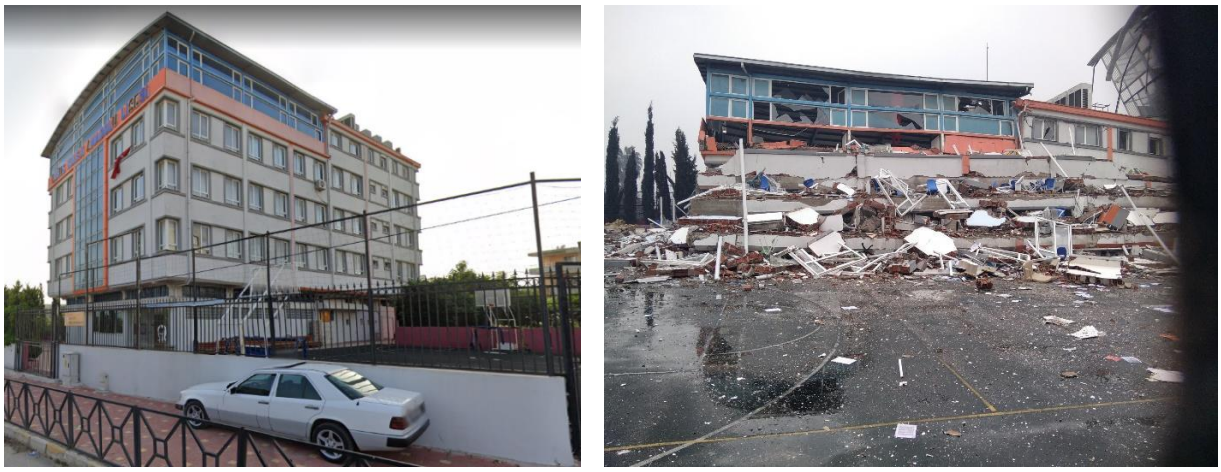
In Antakya, Hatay province, a school building collapsed. Figure 4.44 shows this building with a lateral load resisting system composed of moment resisting frames with unreinforced masonry infill walls. In the pre-earthquake image, the building had a reduced footprint and open two-story frame with possible captive column effects, which may have contributed to the observed collapse.

Figure 4.44. Collapsed building of the "REAL SUCCESS COURSE CENTER" school in Antakya, Hatay province, 36.1853N 36.1210E (Source: (a) Google maps, (b) Twitter).

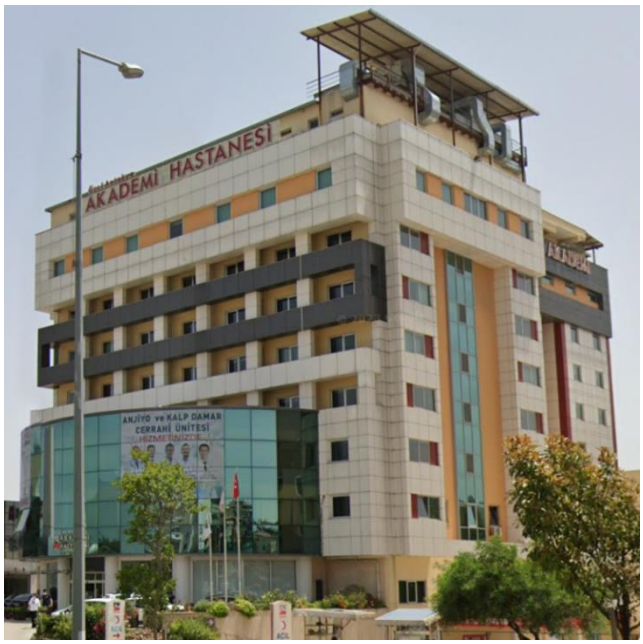
(b) Post-earthquake (3 of 9 stories fully collapsed, with the southern portion more damaged than the northern portion) (Source: Twitter).

Figure 4.53. Structural collapse of the building of Antakya Academy Hospital in Hatay province, 36.2354N 36.1694E.

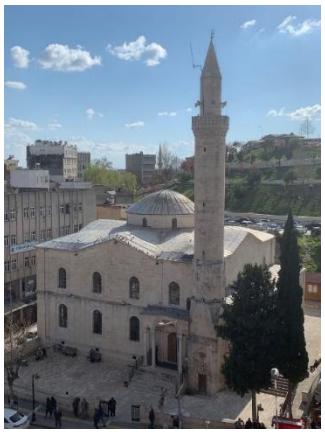
Figure 4.67. Damage to the Adiyaman Ulu Grand Mosque in Adiyaman, Türkiye (Sources: (a) Twitter (b) Middle East Eye 2023).

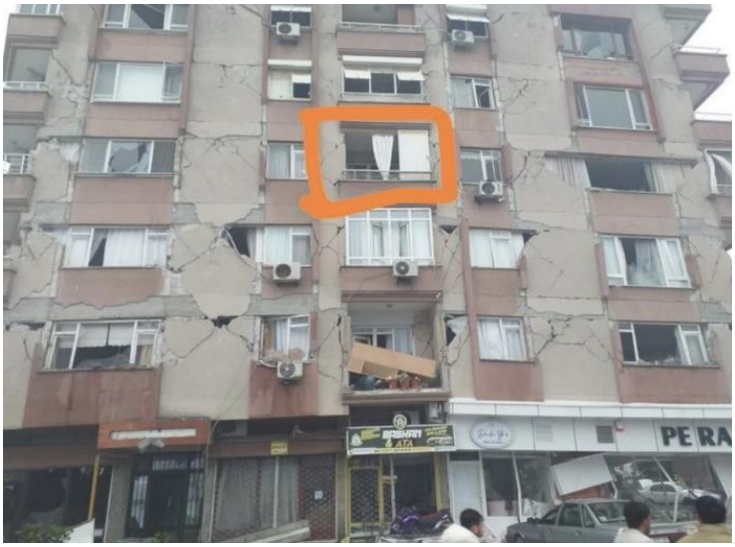
(b) Residents sought help from a rescue team as they were stuck inside the building due to stairwell collapse (Source: Husamettin Dogan via Twitter).

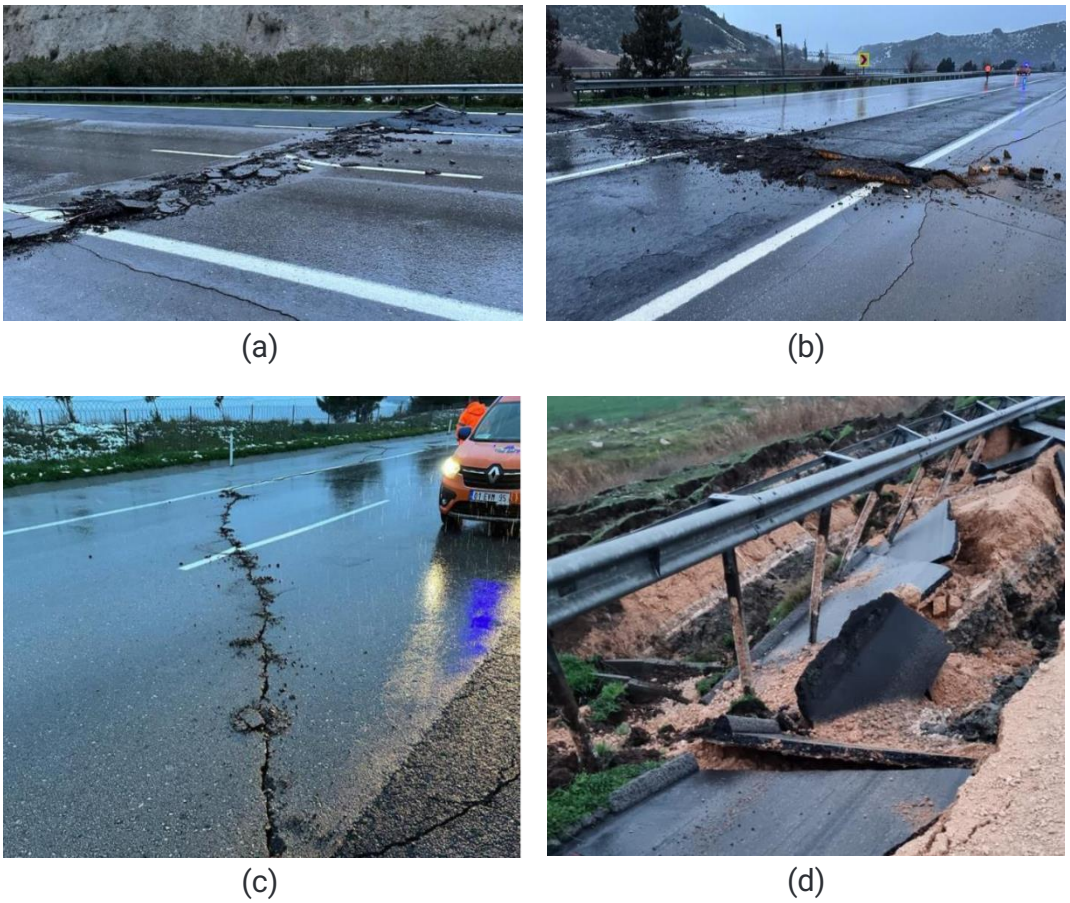
Damage to the Tarsus-Adana–Gaziantep (TAG) Highway occurred due to the Mw 7.8 earthquake. Traffic along the Osmaniye-Gaziantep West Junction portion of the TAGHighway was diverted to the D-400 state road (Demirci 2023). Figure 5.1 shows representative damage of roadways observed after the Mw 7.8 earthquake along the TAG Highway. In several places, cracking of pavement (e.g., Figures 5.1(a-c)) due to seismic compression and vertical settlement induced distortional shearing caused surface failures (Figure 5.2). Vertical settlement of the pavement could be associated with the cyclic softening of materials due to large shear strain imposed by the earthquake sequence. Differential movement of a road near the Tevekkelli village on the Kahramanmaraş-Gaziantep Highway was also observed (Figure 5.3). This movement was measured to be approximately 3 meters.

Figure 5.1. Damage to Tarsus-Adana-Gaziantep (TAG) Highway (Expat Guide Türkiye 2023).

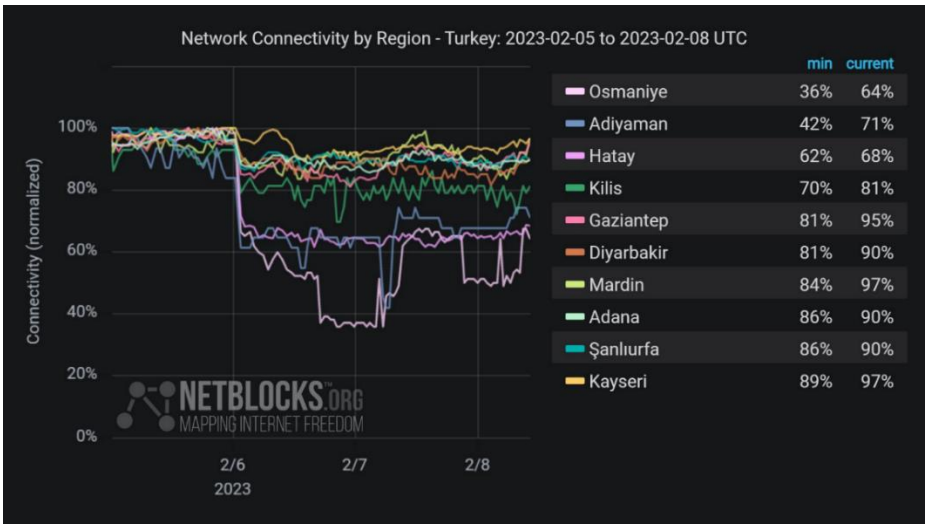
Internet connectivity was lost in all cities impacted by the event in Türkiye. The connectivity was not fully recovered as of February 8, 2023 as shown in Figure 5.14. Over 30 electrical substations were damaged due to the earthquake sequence causing power outages and blackouts reported in Antep, Hatay, and Kilis (The Telegraph, 2023). Generators and mobile power plants were provided to essential power facilities such as hospitals, soup kitchens, and general services for the public. Authorities were fearful of gas leaks and potential fires. Therefore, gas was cut off to the impacted regions to prevent fires.

Figure 5.14. Recovery of data infrastructure in cities of Türkiye impacted by the event (Source: Twitter).

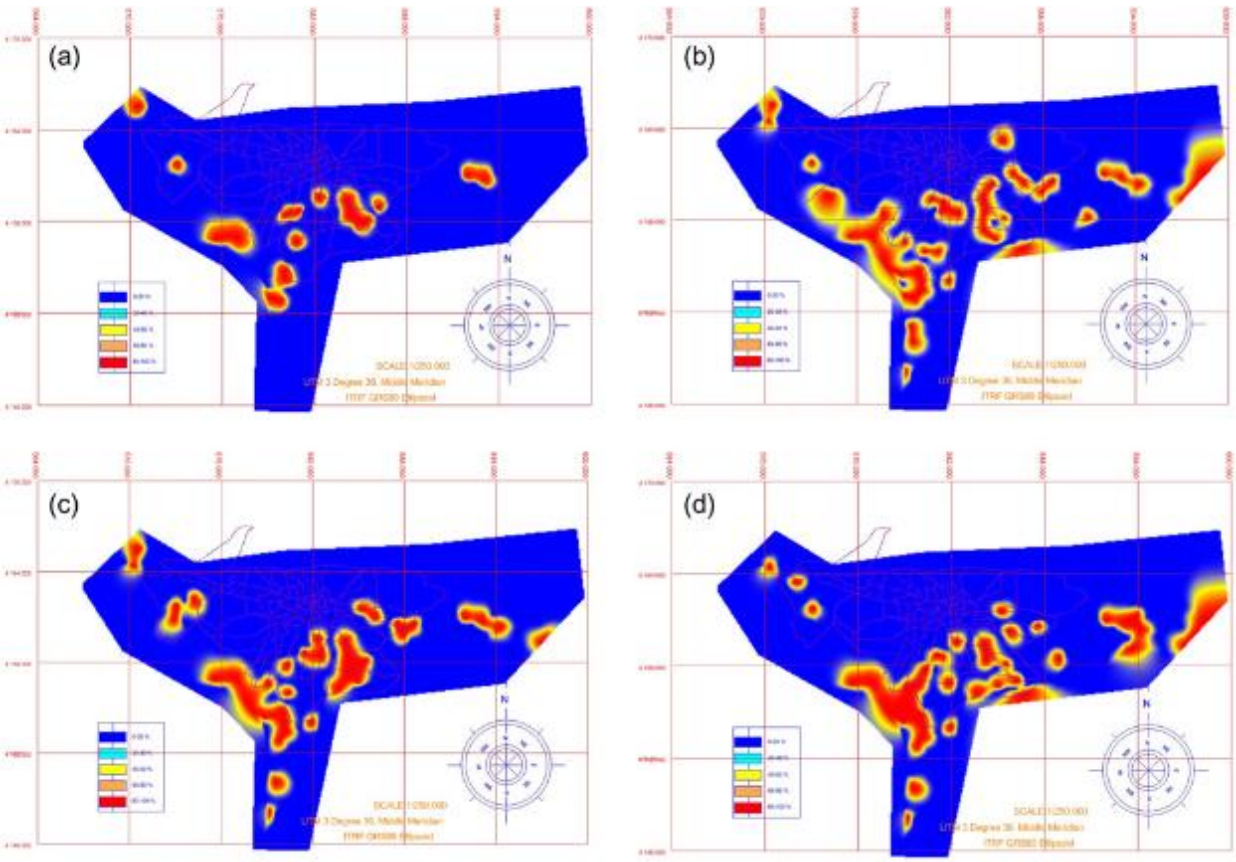
1. Liquefaction potential is not significant for shallow depths (below 3.0 m) in the studied area.
2. The depth of 6.0 m to 7.5 m was identified as the layer with highest liquefaction potential as it contains loose silty-sand in most regions of the studied area.
3. There are certain areas of the city center with the highest potential of liquefaction triggering under the effect of a large magnitude earthquake. Those areas showed high liquefaction potential in almost all depth intervals.

Figure 6.7. The liquefaction map for the Kahramanmaras region at depths: (a) 1.5 m to 3.0 m, (b) 6.0 m to 7.5 m, (c) 9.0 m to 10.5 m, and (d) 13.5 m to 15.0 m (Cabalar et al. 2019). Note that blue and colors indicate the smallest and largest potential for liquefaction.

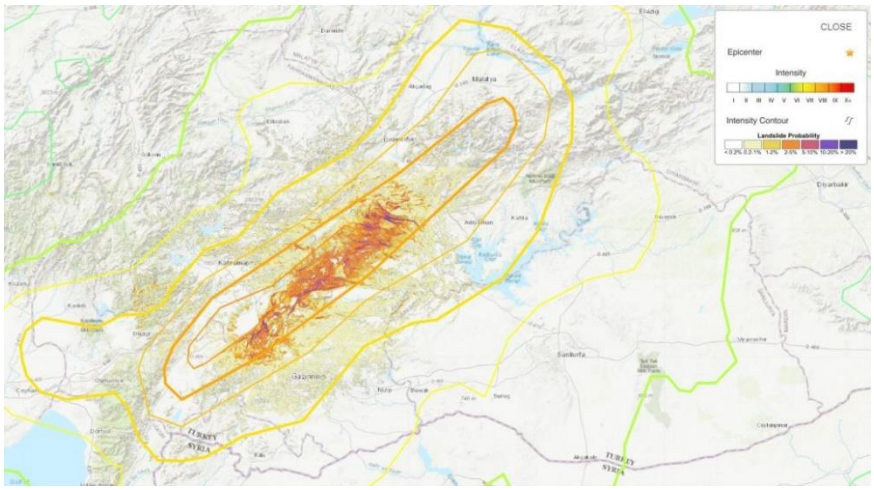
The USGS landslide inventory map shows the probability of landslides in the area (Figure 6.8). Based on this map, it is likely that some landslides will occur during strong ground shaking, and a substantial number of roads could be blocked by slope or embankment failures. This will impede the rescue work, especially in remote areas during the initial, all-important, 24-hour rescue and recovery period. In general, landslides from strike-slip earthquakes cluster close to the surface expression of the fault trace, although some can still occur at considerable distances. A lateral spreading induced landslide was observed on the road between Adana and Gaziantep following the Mw 7.8 and Mw 7.5 earthquakes on February 6 (Figure 6.9). Ground movements caused extensive damage to this roadway.

Figure 6.8. Initial USGS landslide probability map for Feb. 6, 2023 earthquake near Nurdağı in Gaziantep, Türkiye.
