POLYMER SEAL USE IN CENTRIFUGAL COMPRESSORS – TWO USERS' EXPERIENCES OVER 15 YEARS

John K. Whalen, PE

Jim Allen

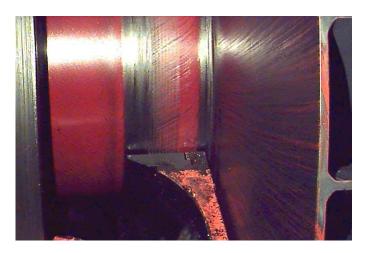
Figure 15. Polymer eye seal in DuPont charge gas compressor after 5 year run.

Seals installed in a charge gas compressor, after a 5 year run, are shown in the photographs in figures 14 and 15. Note that with cleaner sections of this train the seals did not foul, and obviously they did not foul in the clean propylene and ethylene refrigeration compressors.
