District Report

Sindhupalchok

12 April – 9 May 2019

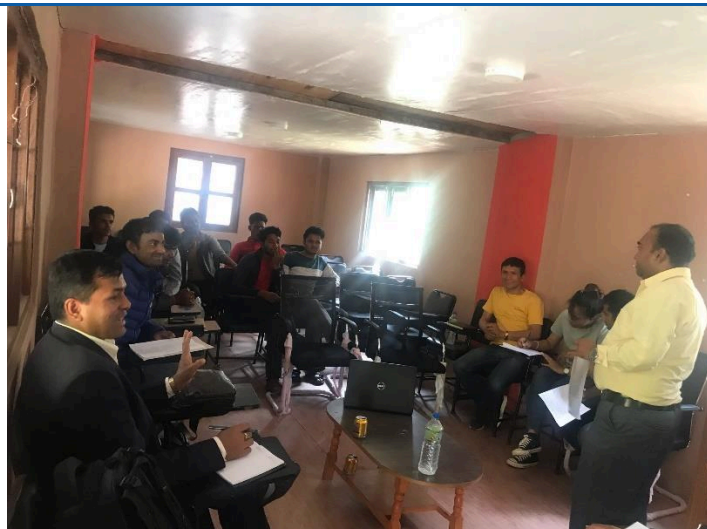
Sindhupalchok General Coordination Meeting taking place under the chairmanship of GMALI chief Mr. Jayaprakash Gupta and the Chief Guest being the DCC Vice-Chief Mrs. Balkumari Sapkota.
