TRANSITIONAL PROJECT IMPLEMENTATION SUPPORT
FOR
EMERGENCY RECONSTRUCTION PROJECTS
IN NEPAL

Public Awareness Campaign and Housing Reconstruction Survey

JICA Technical Assistance Team

January 2017

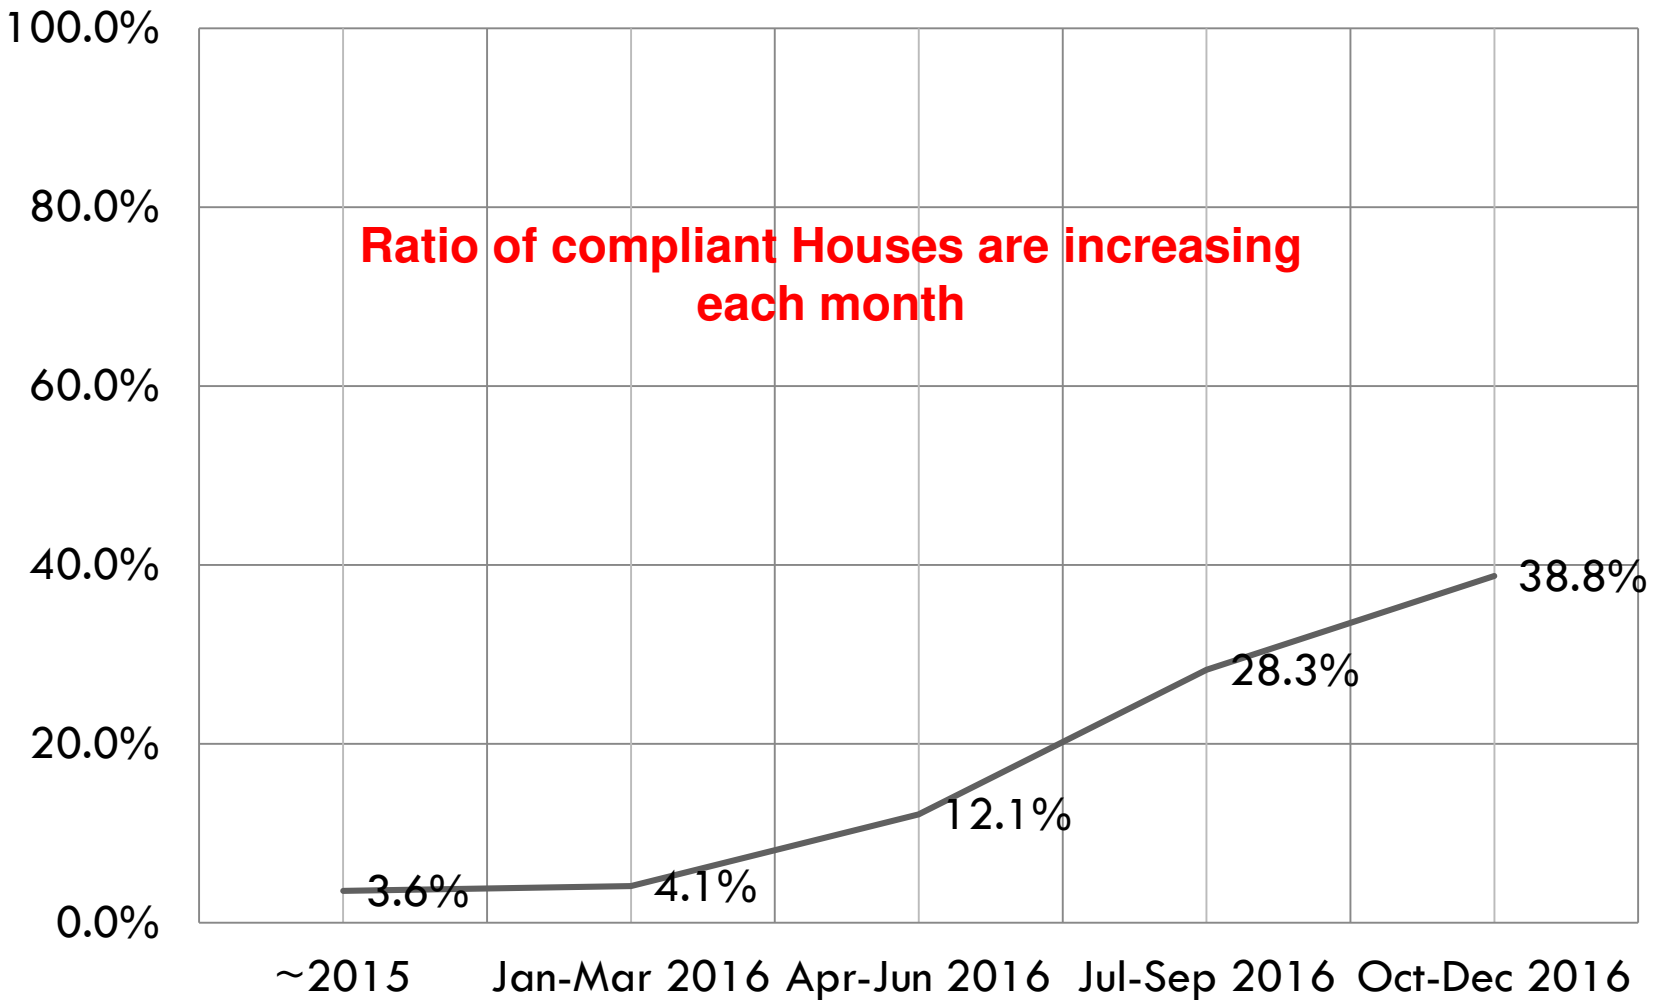
MR Compliant Ratio

VDC	Surveyed Houses			
	Total	House Owner knows MR	Mason knows MR	Compliant with MR
Overall	1346 (100%)	640 (47.5%)	894 (66.4%)	247 (18.4%)
Constructed by Masons trained by TPIS-ERP	358 (100%)	194 (54.2%)	330 (92.2%)	89 (24.9%)

More than 92.2% of Mason knows MR **but just 24.9% is compliant (Overall 18.4%)**

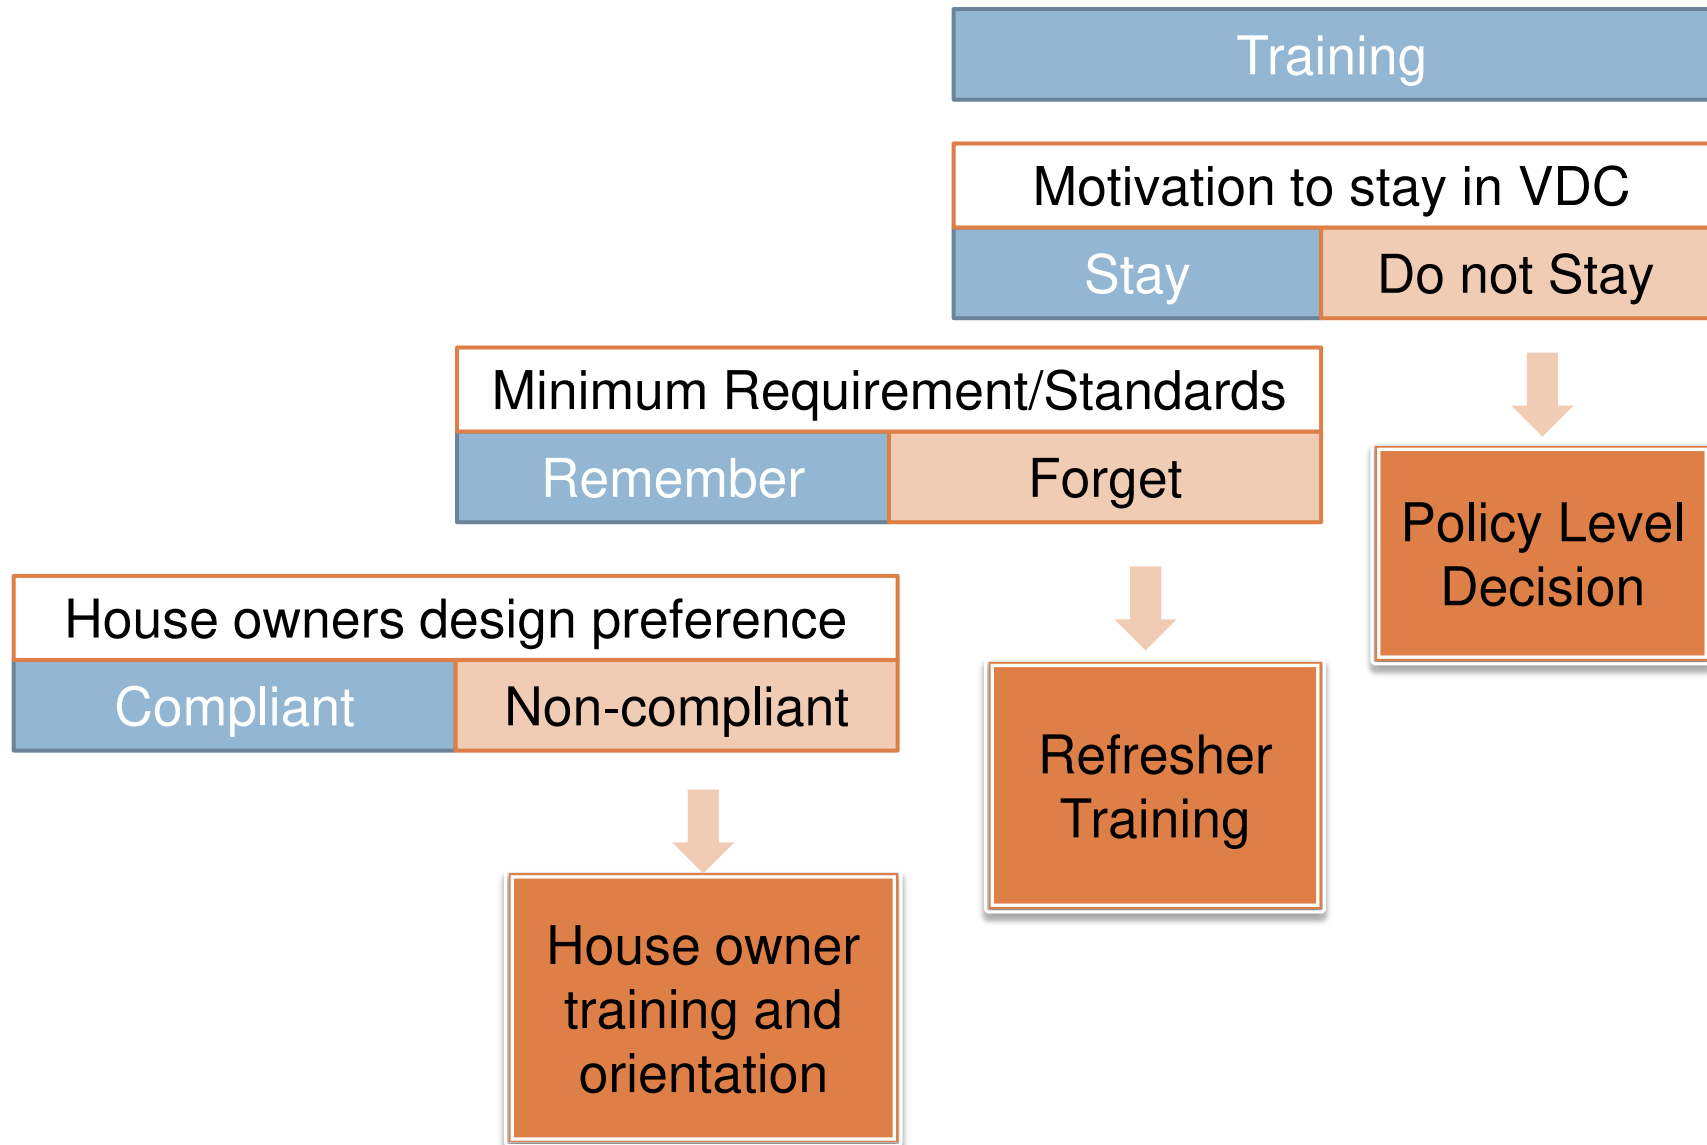
VDC	Overall		~Plinth Band		~Roof Band			Completed	
	Total	Compliant with MR	Total	Compliant with MR	Total	Compliant with MR		Total	Compliant with MR
Total	1346	247 (18.4%)	242	114 (47.1%)	283	78 (27.6%)		821	55 (6.7%)

Till Plinth Band, compliant Houses are 47.1%
But when they complete the construction, it became just 6.7%
