Monthly District Report

Kathmandu

27 September – 21 October 2019

Field Visit Reports (Kathmandu)

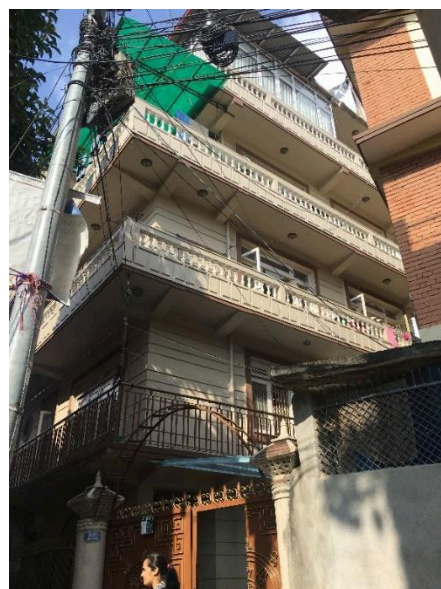
Beneficiary name: Gyanendra Bir Malakar, ward no 29, Pabitra nagar, KMC. 3.5 storey RCC structure. The beneficiary has done jacketing of all the columns and is as per the retrofitting guideline. DSE suggested to submit the documents to change from reconstruction to retrofitting tranche and further result will be given after the structural analysis of the house.
