## Monthly District Report

### Lalitpur, Bhaktapur

9 May - 13 June 2019

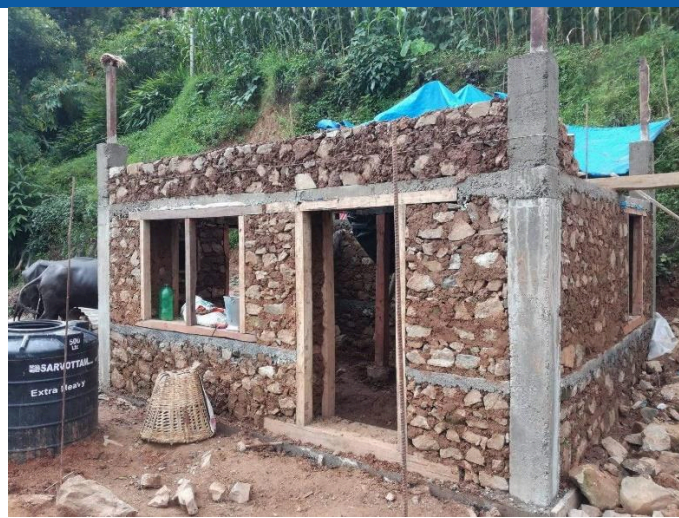
Beneficiary name: Bhimsen Thapa, Ward no. 10 Chitapol, Suryabinayak Municipality, 2 storey, 8 roomed BMC wall system house is under reconstruction with rigid roof works going on. 3<sup>rd</sup> tranche process of the beneficiary is undergoing.
