District Report

Dhading

27 July – 3 August 2017

Field Visit Report

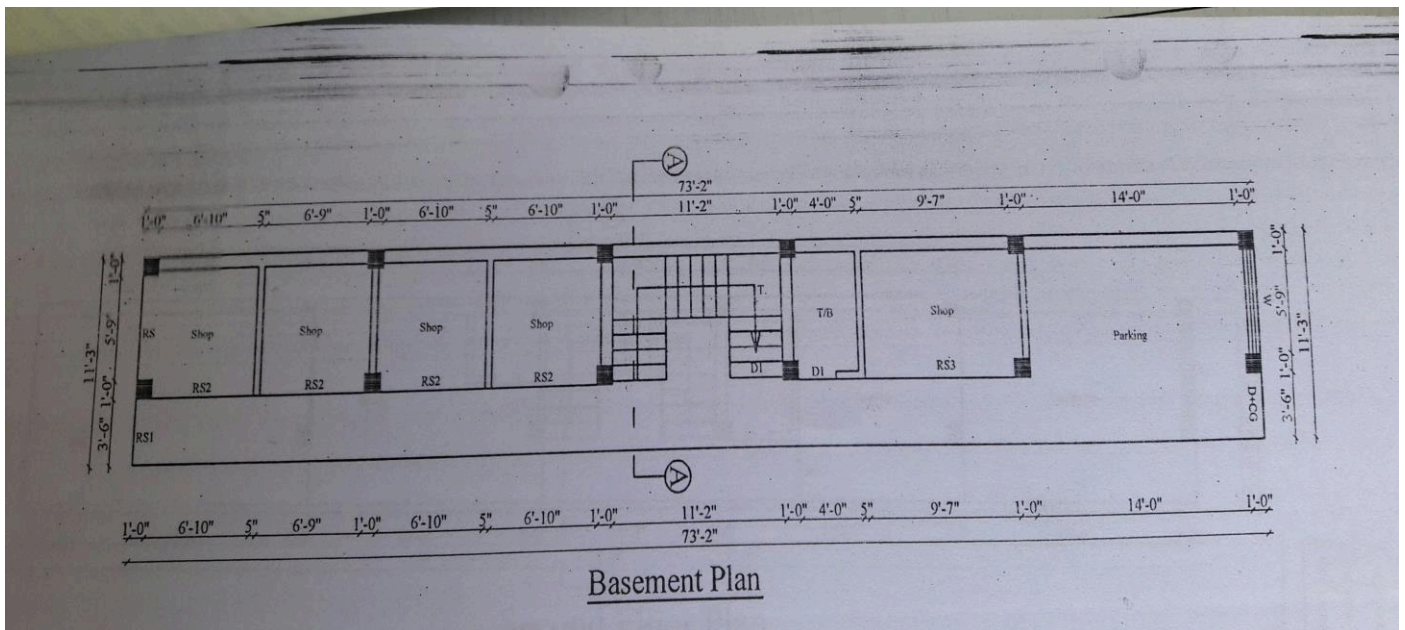
3 Storey RCC building, Column are not in same Grid

1 Bay Building (11'3"x73') Four Storey building
