Confidential	Product Development Design Change Request 产品开发设计变更请求		Version 15 Effective date: 2025-12-01th
	Customer project Name/ 客户项目名称: JIM-4JJ		Design Change Request No. 25_128
Sample status / 样件状态: ☐ A Sample ☐ B Sample ☐ C Sample ☒ D Sample			
Change part&product Name/更改零部件产品的名称(简要描述) DOC DPF :F01ZH003EA-00 SCR: F01ZH003EB-00 DPF BRACKET:F01Z5017P5-05			
Reason of changes/更改理由 (简要描述): DPF 出气法兰, 客户装上双头螺柱后, 有密封垫片, 安装不上, 的风险, 需要增加 对出气法兰螺母的位置检测 SCR 客户要求 在尾管处增加纸质标签 侧支架 客户要求 更改客户料号			
Change from/变更来源:			
Customer request / 客户要求 ☒		Supplier request / 供应商请求 ☐	Design optimization / 设计优化 ☐
Correction / 更正(错误) ☐		Other / 其他 ☐ ()	
Change inform to/变更通知人: Zhang Shengchang,Zhang Hanquan,Shen Weibo, Li Yicen, Fang Jiayan, Yin Kangzhuang Yang Guangtuo,Jia Kebin, Luo jing, Lu Qingsong,Xie Youfu			
Whether this change impact others component or product 此变更是否影响到其他部件和产品: ☐ yes/是 ☒ no/否			
If impact others product, Whether others projects&product change or not? 如果影响, 别的部件和产品是否也需要同时变更?

PDEC R25-128 (4JJ1-D 样件)

Test Report

Vehicle endurance test parts investigation

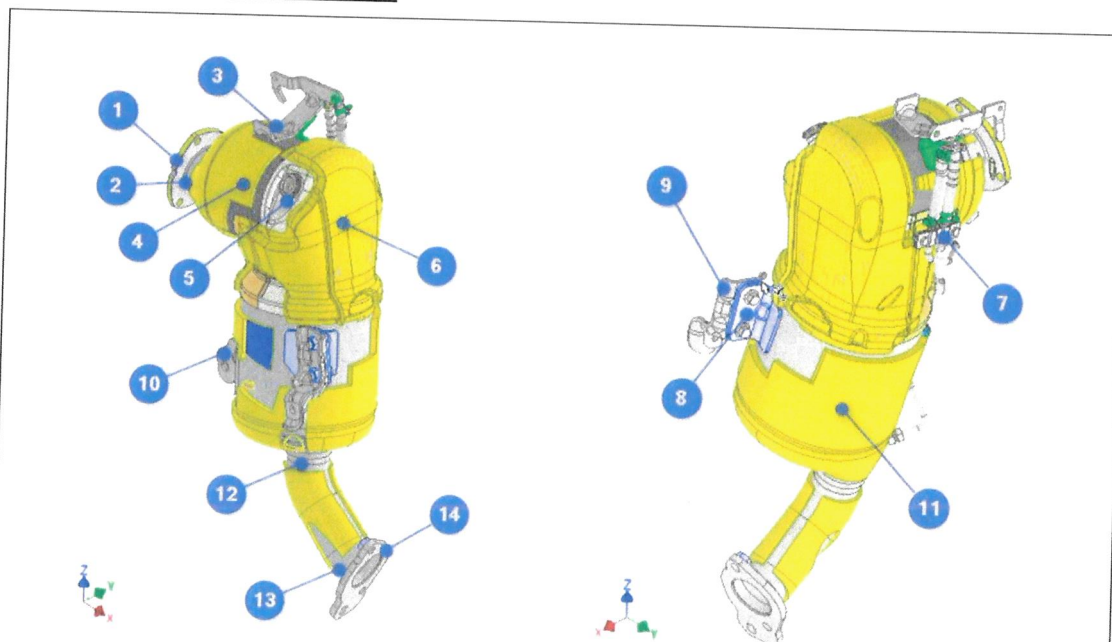
Table 1 Leakage test result for DOC+DPF

- After the endurance test, the leakage test was performed to the DOC+DPF and SCR units. From the leakage test results (table 1-2), the leakage rate of the ATS after test can fulfill the design requirement.

Leakage rate result before and after test @30kPa filling pressure		
	After testing	Test requiremnt
Leakge rate (L/min)	0.157	<0.5
