AI & COMPUTER-VISION BASED SURFACE & PRODUCT DEFECT INSPECTION

Automated Quality Inspection Report

Inspection ID:	DEF-2026-0318	**Date & Time:**	2026-11-02 13:50:24
Product / Part:	Unnamed Product	**Batch / Lot:**	-
Product Line:	GENERAL MANUFACTURED	**Station:**	Line 1 · Final QC
Inspector:	Line Supervisor	**Outcome:**	**REVIEW**

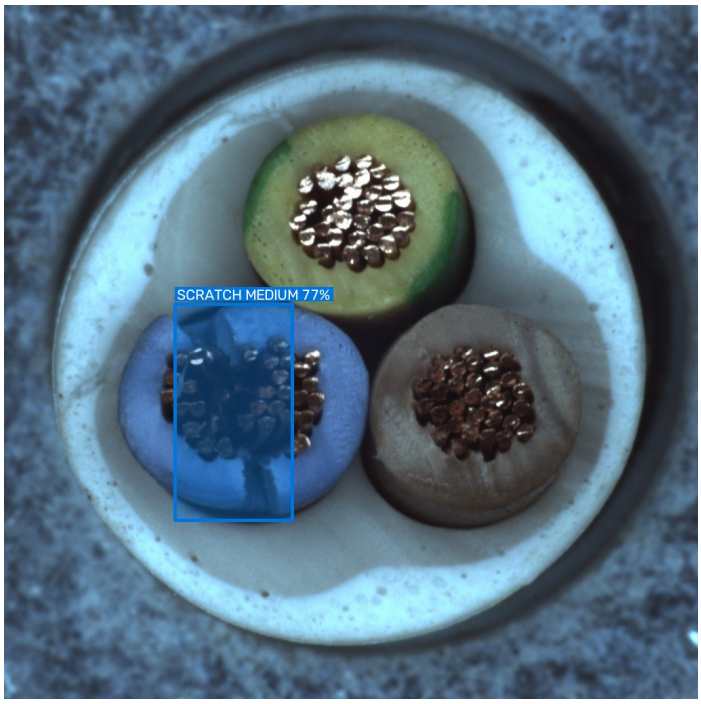
Defect Type	Count	Critical	High	Medium	Low
Scratch	1	0	0	1	0

#	Type	Severity	Confidence	Location (px)	Detector	Review
1	Scratch	**MEDIUM**	77%	252,441 - 424,759	YOLO_SEG +ANOMALY	CONFIRMED

Scratch (1)
• Abrasive contact during conveyor transfer or manual handling
• Burrs or debris on guide rails, fixtures, or tooling
• Insufficient protective film / interleaving between stacked parts
→ Inspect and deburr guide rails, grippers, and transfer chutes
→ Add protective film or separators at stacking and packing stations
