AI & COMPUTER-VISION BASED SURFACE & PRODUCT DEFECT INSPECTION

Automated Quality Inspection Report

Inspection ID:	DEF-2026-0319	**Date & Time:**	2026-11-02 14:06:30
Product / Part:	Unnamed Product	**Batch / Lot:**	-
Product Line:	METAL SHEET	**Station:**	Line 1 · Final QC
Inspector:	Line Supervisor	**Outcome:**	**REVIEW**

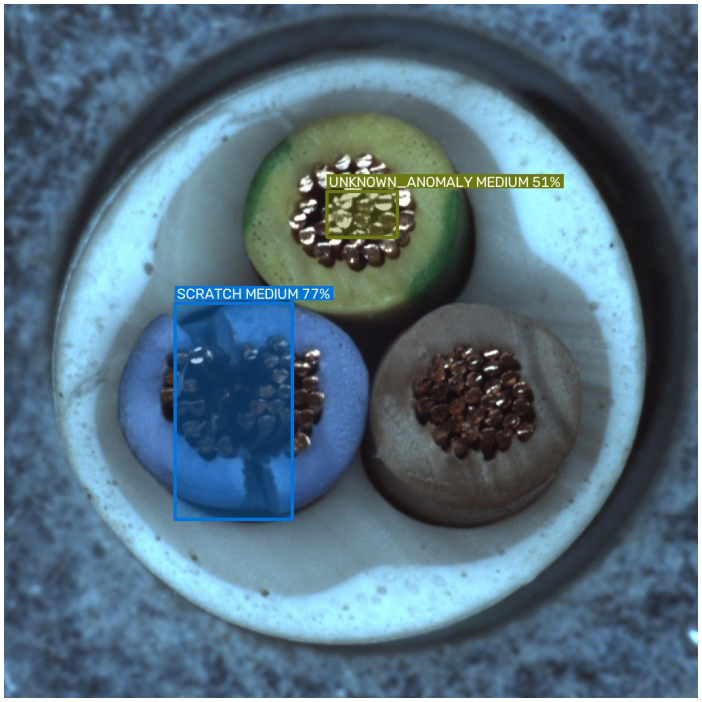
#	Type	Severity	Confidence	Location (px)	Detector	Review
1	Scratch	**MEDIUM**	77%	252,441 - 424,759	YOLO_SEG +ANOMALY	CONFIRMED
2	Unknown Anomaly	**MEDIUM**	51%	476,276 - 580,344	ANOMALY	PENDING

Scratch (1)
- Abrasive contact during conveyor transfer or manual handling
- Burrs or debris on guide rails, fixtures, or tooling

Unknown Anomaly (1)
• Process variation not covered by the built-in knowledge base
→ Collect confirmed samples and perform a 5-Why / fishbone analysis with the line team

• Insufficient protective film / interleaving between stacked parts
→ Inspect and deburr guide rails, grippers, and transfer chutes
→ Add protective film or separators at stacking and packing stations
