AI & COMPUTER-VISION BASED SURFACE & PRODUCT DEFECT INSPECTION

Automated Quality Inspection Report

Inspection ID:	DEF-2026-0320	**Date & Time:**	2026-11-01 20:42:15
Product / Part:	metal_nut	**Batch / Lot:**	-
Product Line:	GENERAL MANUFACTURED	**Station:**	-
Inspector:	Line Supervisor	**Outcome:**	**DEFECTIVE**

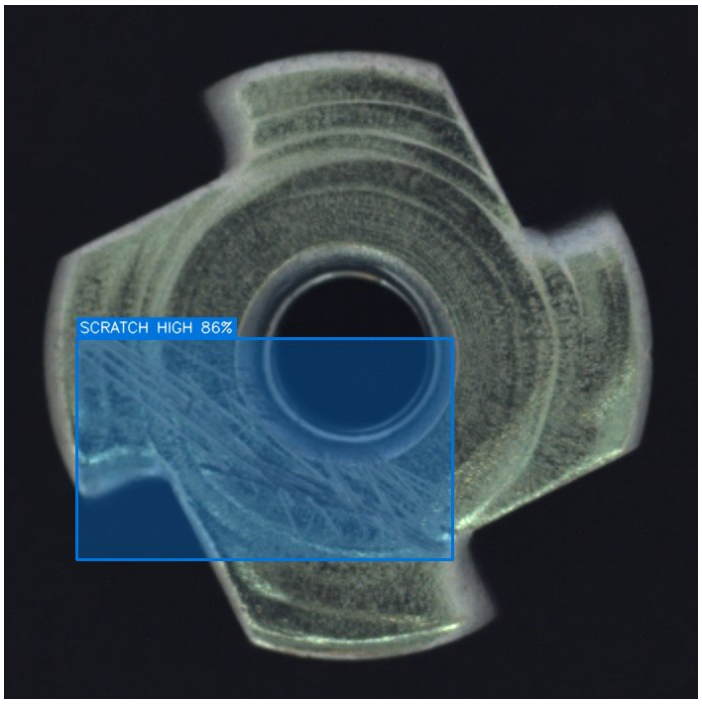
Defect Type	Count	Critical	High	Medium	Low
Scratch	1	0	1	0	0

#	Type	Severity	Confidence	Location (px)	Detector	Review
1	Scratch	HIGH	86%	73,335 - 452,559	YOLO_SEG	PENDING

• Abrasive contact during conveyor transfer or manual handling
• Burrs or debris on guide rails, fixtures, or tooling
• Insufficient protective film / interleaving between stacked parts
→ Inspect and deburr guide rails, grippers, and transfer chutes
→ Add protective film or separators at stacking and packing stations
