AI & COMPUTER-VISION BASED SURFACE & PRODUCT DEFECT INSPECTION

Automated Quality Inspection Report

Inspection ID:	DEF-2026-0354	**Date & Time:**	2026-11-01 20:48:36
Product / Part:	metal_nut	**Batch / Lot:**	-
Product Line:	GENERAL MANUFACTURED	**Station:**	-
Inspector:	Line Supervisor	**Outcome:**	**DEFECTIVE**

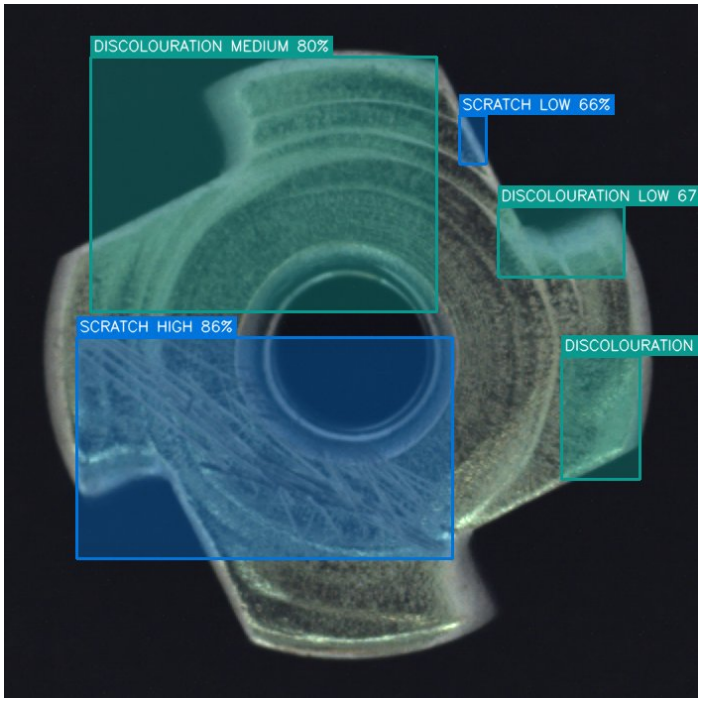
Defect Type	Count	Critical	High	Medium	Low
Discolouration	3	0	0	1	2
Scratch	2	0	1	0	1

#	Type	Severity	Confidence	Location (px)	Detector	Review
1	Scratch	**HIGH**	86%	73,335 - 452,559	YOLO_SEG	PENDING
2	Discolouration	**MEDIUM**	80%	87,53 - 436,310	OPENCV	PENDING
3	Discolouration	**LOW**	69%	562,355 - 641,479	OPENCV	PENDING
4	Discolouration	**LOW**	67%	498,204 - 625,275	OPENCV	PENDING
5	Scratch	**LOW**	66%	459,112 - 486,161	OPENCV	PENDING

Discolouration (3)
• Inconsistent curing, heat treatment, or coating thickness
• Oxidation / corrosion from moisture exposure or contamination
• Raw-material or paint batch variation
→ Check oven / curing temperature uniformity and dwell time
→ Review storage humidity and batch traceability of coating material

Scratch (2)
• Abrasive contact during conveyor transfer or manual handling
• Burrs or debris on guide rails, fixtures, or tooling
• Insufficient protective film / interleaving between stacked parts
→ Inspect and deburr guide rails, grippers, and transfer chutes
→ Add protective film or separators at stacking and packing stations
