AI & COMPUTER-VISION BASED SURFACE & PRODUCT DEFECT INSPECTION

Automated Quality Inspection Report

Inspection ID:	DEF-2026-0365	**Date & Time:**	2026-11-01 21:00:46
Product / Part:	metal_nut	**Batch / Lot:**	-
Product Line:	GENERAL MANUFACTURED	**Station:**	-
Inspector:	Line Supervisor	**Outcome:**	**DEFECTIVE**

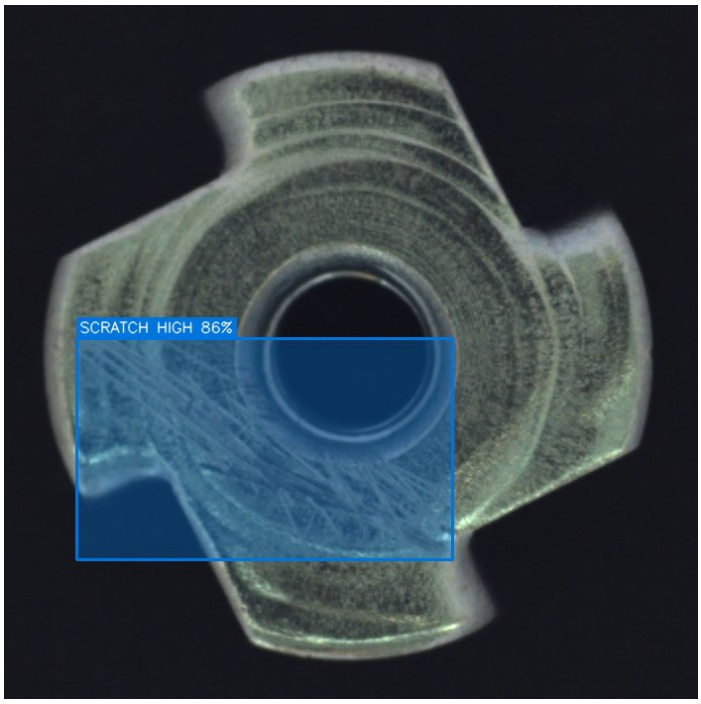
Defect Type	Count	Critical	High	Medium	Low
Scratch	1	0	1	0	0

#	Type	Severity	Confidence	Location (px)	Detector	Review
1	Scratch	HIGH	86%	73,335 - 452,559	YOLO_SEG	PENDING

Scratch (1)

• Abrasive contact during conveyor transfer or manual handling
• Burrs or debris on guide rails, fixtures, or tooling
• Insufficient protective film / interleaving between stacked parts
→ Inspect and deburr guide rails, grippers, and transfer chutes
→ Add protective film or separators at stacking and packing stations
