ADA Compliance Program

Clark County Facilities Transition Plan
Clark County Center for Community Health – 3rd and 4th Floors

Date of Survey: May 8, 2006
Conducted by:

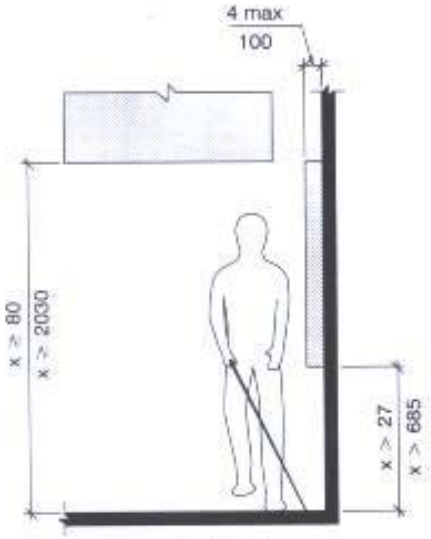
Item: Drinking Fountain – 3rd Floor Lobby

Typical installation of all drinking fountains on 3rd floor and throughout the building.

ANSI 307.2 Protrusion Limits.

Objects with leading edges more than 27 inches and not more than 80 inches above the floor shall protrude 4 inches maximum horizontally into the circulation path.
The drinking fountain shown protrudes 11 inches and the height shown is 32 3/8 inches.

- Fountains should be recessed into an alcove.
- Barrier's constructed around fountains
