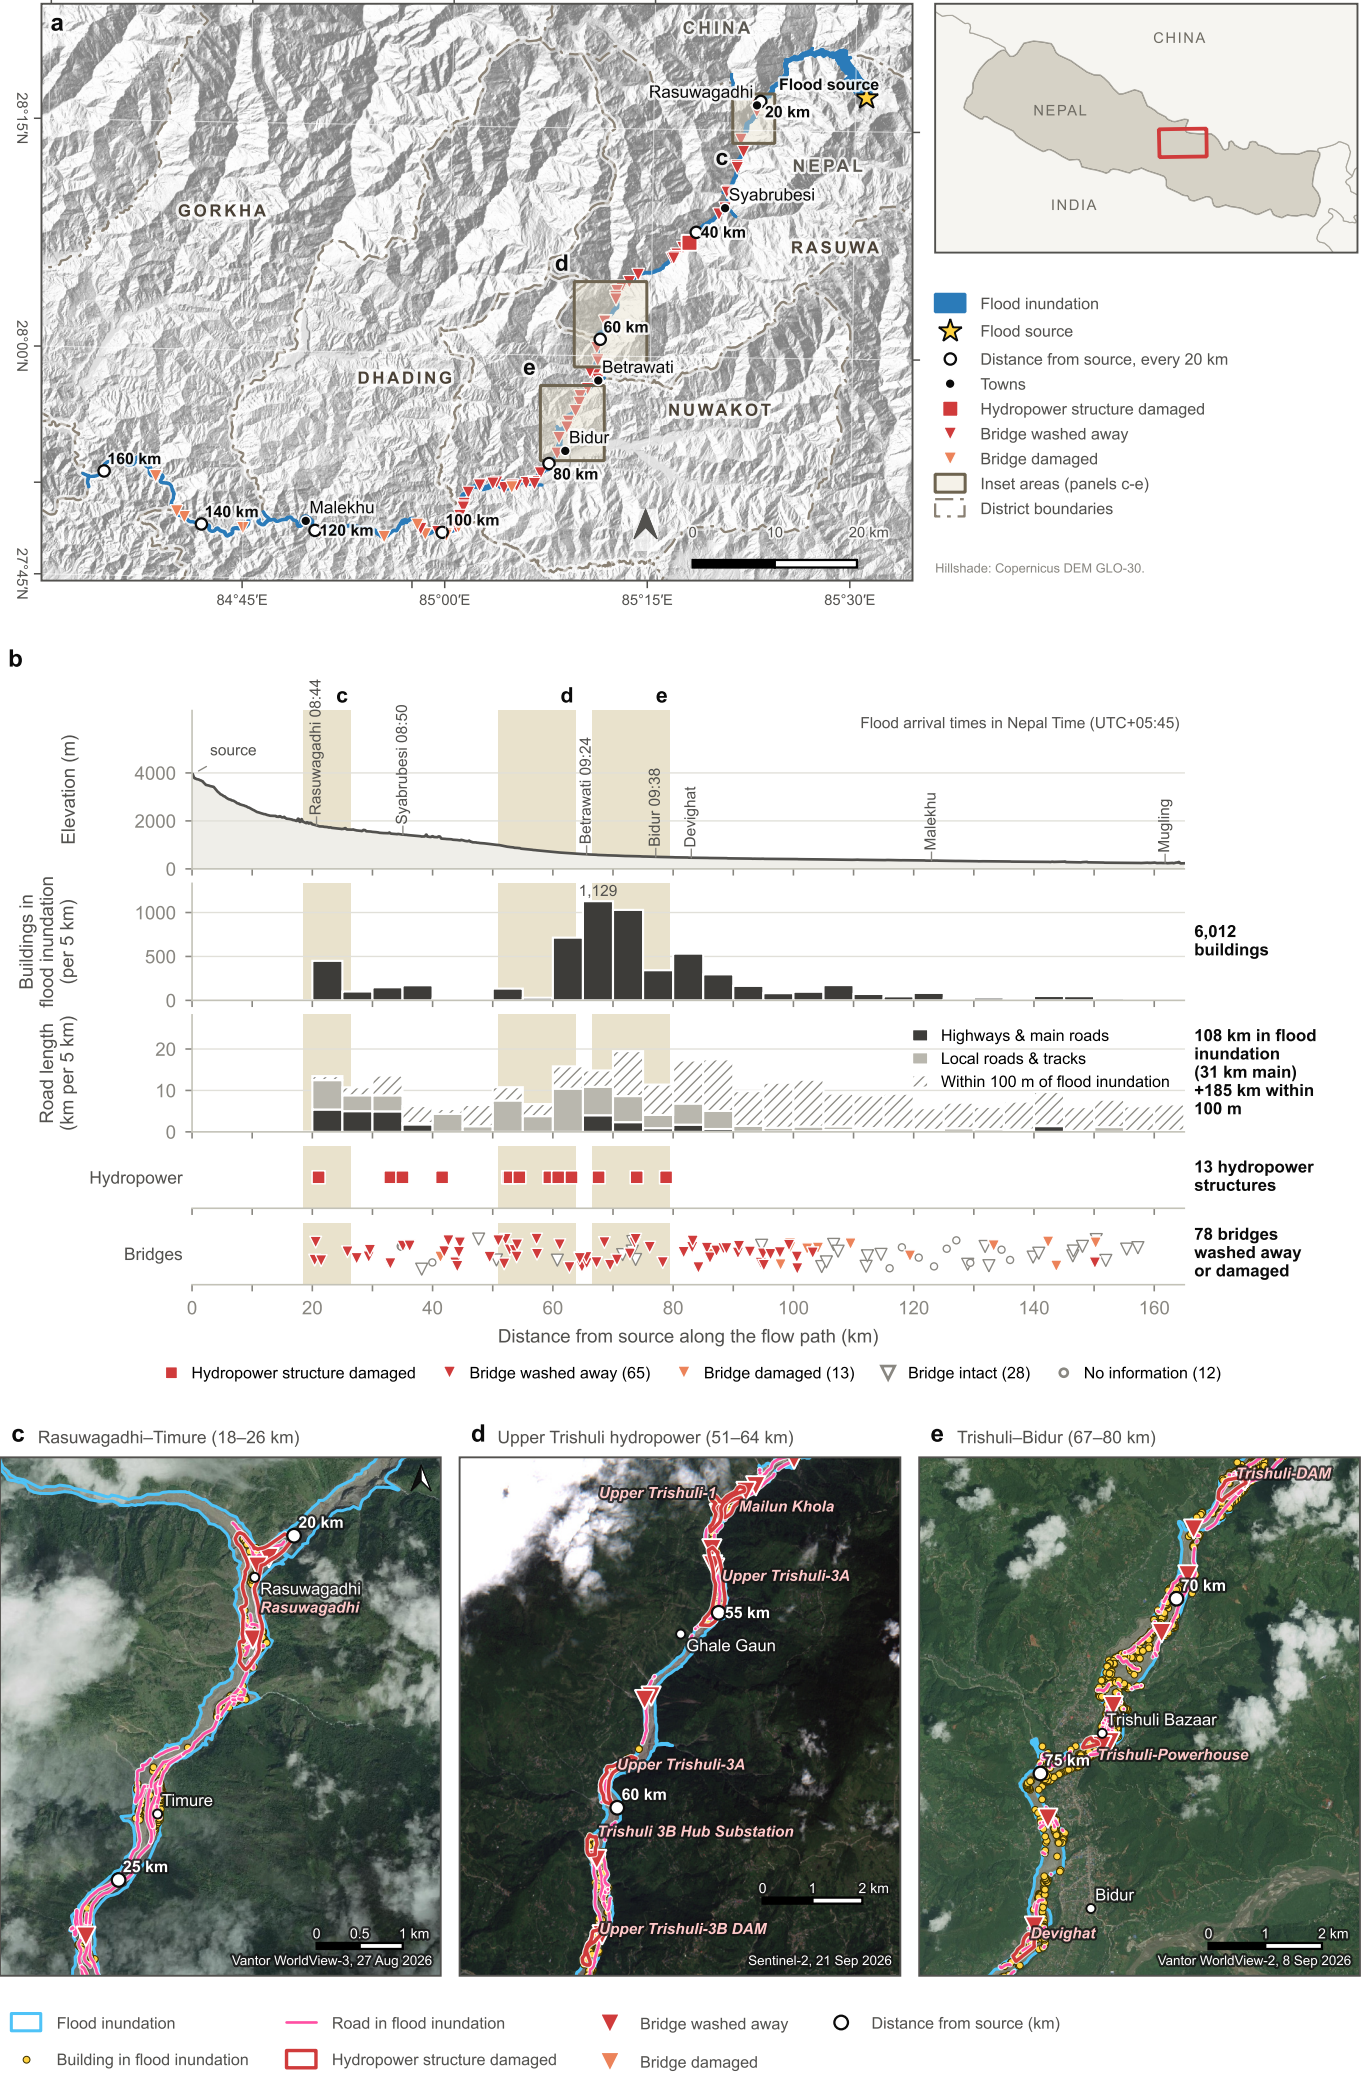
a
CHINA
NEPAL
INDIA
Rasuwagadhi
Flood source
20 km
c
Syabrubesi
40 km
GORKHA
RASUWA
d
60 km
Betrawati
e
DHADING
NUWAKOT
Bidur
80 km
160 km
140 km
Malekhu
120 km
100 km
0
10
20 km
28°15'N
28°00'N
27°45'N
84°45'E
85°00'E
85°15'E
85°30'E
Flood inundation
Flood source
Distance from source, every 20 km
Towns
Hydropower structure damaged
Bridge washed away
Bridge damaged
Inset areas (panels c-e)
District boundaries
Hillshade: Copernicus DEM GLO-30.
b
Flood arrival times in Nepal Time (UTC+05:45)
source
Rasuwagadhi 08:44
Syabrubesi 08:50
Betrawati 09:24
Bidur 09:38
Devighat
Malekhu
Mugling
Elevation (m)
4000
2000
0
Buildings in flood inundation (per 5 km)
1,129
1000
500
0
6,012 buildings
Road length (km per 5 km)
20
10
0
Highways & main roads
Local roads & tracks
Within 100 m of flood inundation
108 km in flood inundation (31 km main) +185 km within 100 m
Hydropower
13 hydropower structures
Bridges
78 bridges washed away or damaged
0
20
40
60
80
100
120
140
160
Distance from source along the flow path (km)

Hydropower structure damaged
Bridge washed away (65)
Bridge damaged (13)
Bridge intact (28)
No information (12)
c Rasuwagadhi–Timure (18–26 km)
20 km
Rasuwagadhi
Rasuwagadhi
Timure
25 km
0

0.5
1 km
Vantor WorldView-3, 27 Aug 2026
d Upper Trishuli hydropower (51–64 km)
Upper Trishuli-1
Mailun Khola
Upper Trishuli-3A
55 km
Ghale Gaun
Upper Trishuli-3A
60 km
Trishuli 3B Hub Substation
0
1
2 km
Upper Trishuli-3B DAM
Sentinel-2, 21 Sep 2026
e Trishuli–Bidur (67–80 km)
Trishuli-DAM
70 km
Trishuli Bazaar
75 km
Trishuli-Powerhouse
Bidur
Devighat
0
1
2 km
Vantor WorldView-2, 8 Sep 2026
Flood inundation
Road in flood inundation
Bridge washed away
Distance from source (km)
Building in flood inundation
Hydropower structure damaged
Bridge damaged
