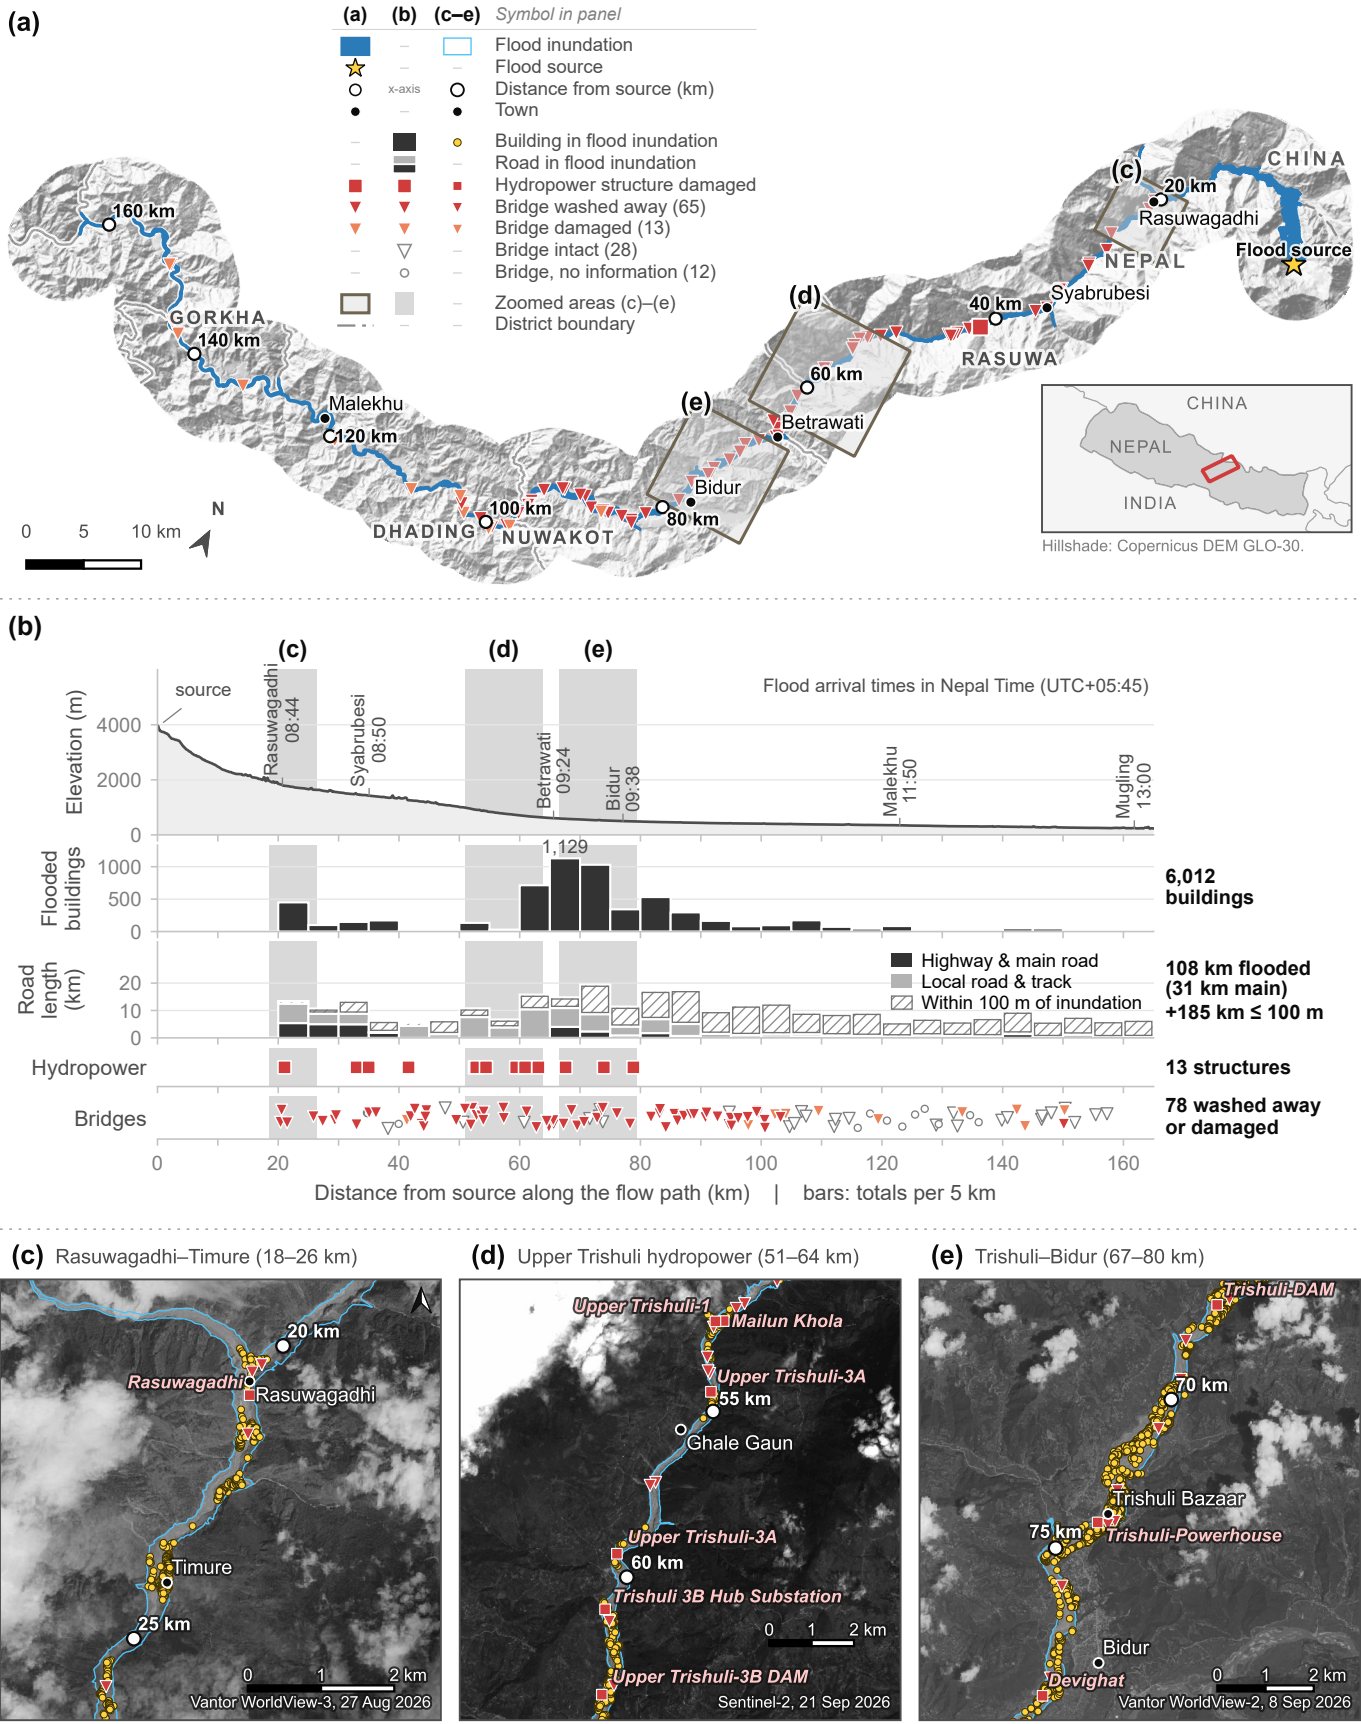
(a)
(a) (b) (c–e) Symbol in panel
Flood inundation
Flood source
x-axis
Distance from source (km)
Town
Building in flood inundation
Road in flood inundation
Hydropower structure damaged
Bridge washed away (65)
Bridge damaged (13)
Bridge intact (28)
Bridge, no information (12)
Zoomed areas (c)–(e)
District boundary
160 km
GORKHA
140 km
Malekhu
120 km
DHADING
100 km
NUWAKOT
80 km
Bidur
(e)
60 km
Betrawati
(d)
40 km
Syabrubesi
RASUWA
(c)
20 km
Rasuwagadhi
NEPAL
CHINA
Flood source
0 5 10 km
N
CHINA
NEPAL
INDIA
Hillshade: Copernicus DEM GLO-30.
(b)
(c)
(d)
(e)
Flood arrival times in Nepal Time (UTC+05:45)
source
Rasuwagadhi 08:44
Syabrubesi 08:50
Betrawati 09:24
Bidur 09:38
Malekhu 11:50
Mugling 13:00
Elevation (m)
4000
2000
0
Flooded buildings
1,129
1000
500
0
6,012 buildings
Road length (km)
20
10
0
Highway & main road
Local road & track
Within 100 m of inundation
108 km flooded (31 km main)
+185 km ≤ 100 m
Hydropower
13 structures
Bridges
78 washed away or damaged
0 20 40 60 80 100 120 140 160

Distance from source along the flow path (km) | bars: totals per 5 km
(c) Rasuwagadhi–Timure (18–26 km)
20 km
Rasuwagadhi
Rasuwagadhi
Timure
25 km
0 1 2 km
Vantor WorldView-3, 27 Aug 2026

(d) Upper Trishuli hydropower (51–64 km)
Upper Trishuli-1
Mailun Khola
Upper Trishuli-3A
55 km
Ghale Gaun
Upper Trishuli-3A
60 km
Trishuli 3B Hub Substation
0 1 2 km
Upper Trishuli-3B DAM
Sentinel-2, 21 Sep 2026

(e) Trishuli–Bidur (67–80 km)
Trishuli-DAM
70 km
Trishuli Bazaar
75 km
Trishuli-Powerhouse
Bidur
Devighat
0 1 2 km
Vantor WorldView-2, 8 Sep 2026
