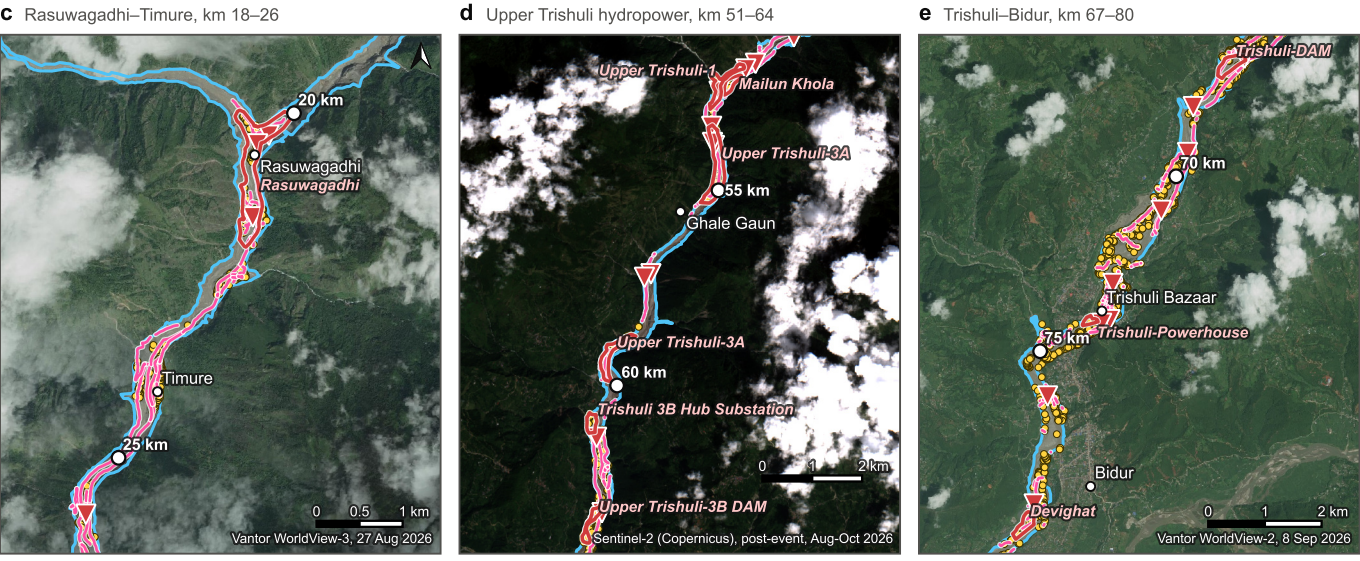
c Rasuwagadhi–Timure, km 18–26
20 km
Rasuwagadhi
Rasuwagadhi
Timure
25 km
0 0.5 1 km
Vantor WorldView-3, 27 Aug 2026
d Upper Trishuli hydropower, km 51–64
Upper Trishuli-1
Mailun Khola
Upper Trishuli-3A
55 km
Ghale Gaun
Upper Trishuli-3A
60 km
Trishuli 3B Hub Substation
Upper Trishuli-3B DAM
0 1 2 km
Sentinel-2 (Copernicus), post-event, Aug-Oct 2026
e Trishuli–Bidur, km 67–80
Trishuli-DAM
70 km
Trishuli Bazaar
Trishuli-Powerhouse
75 km
Bidur
Devighat
0 1 2 km
Vantor WorldView-2, 8 Sep 2026
Flood inundation
Road in flood inundation
Bridge destroyed, washed away
Distance from source (km)
Building in flood inundation
Hydropower structure, fully damaged
Bridge damaged, needs repair
