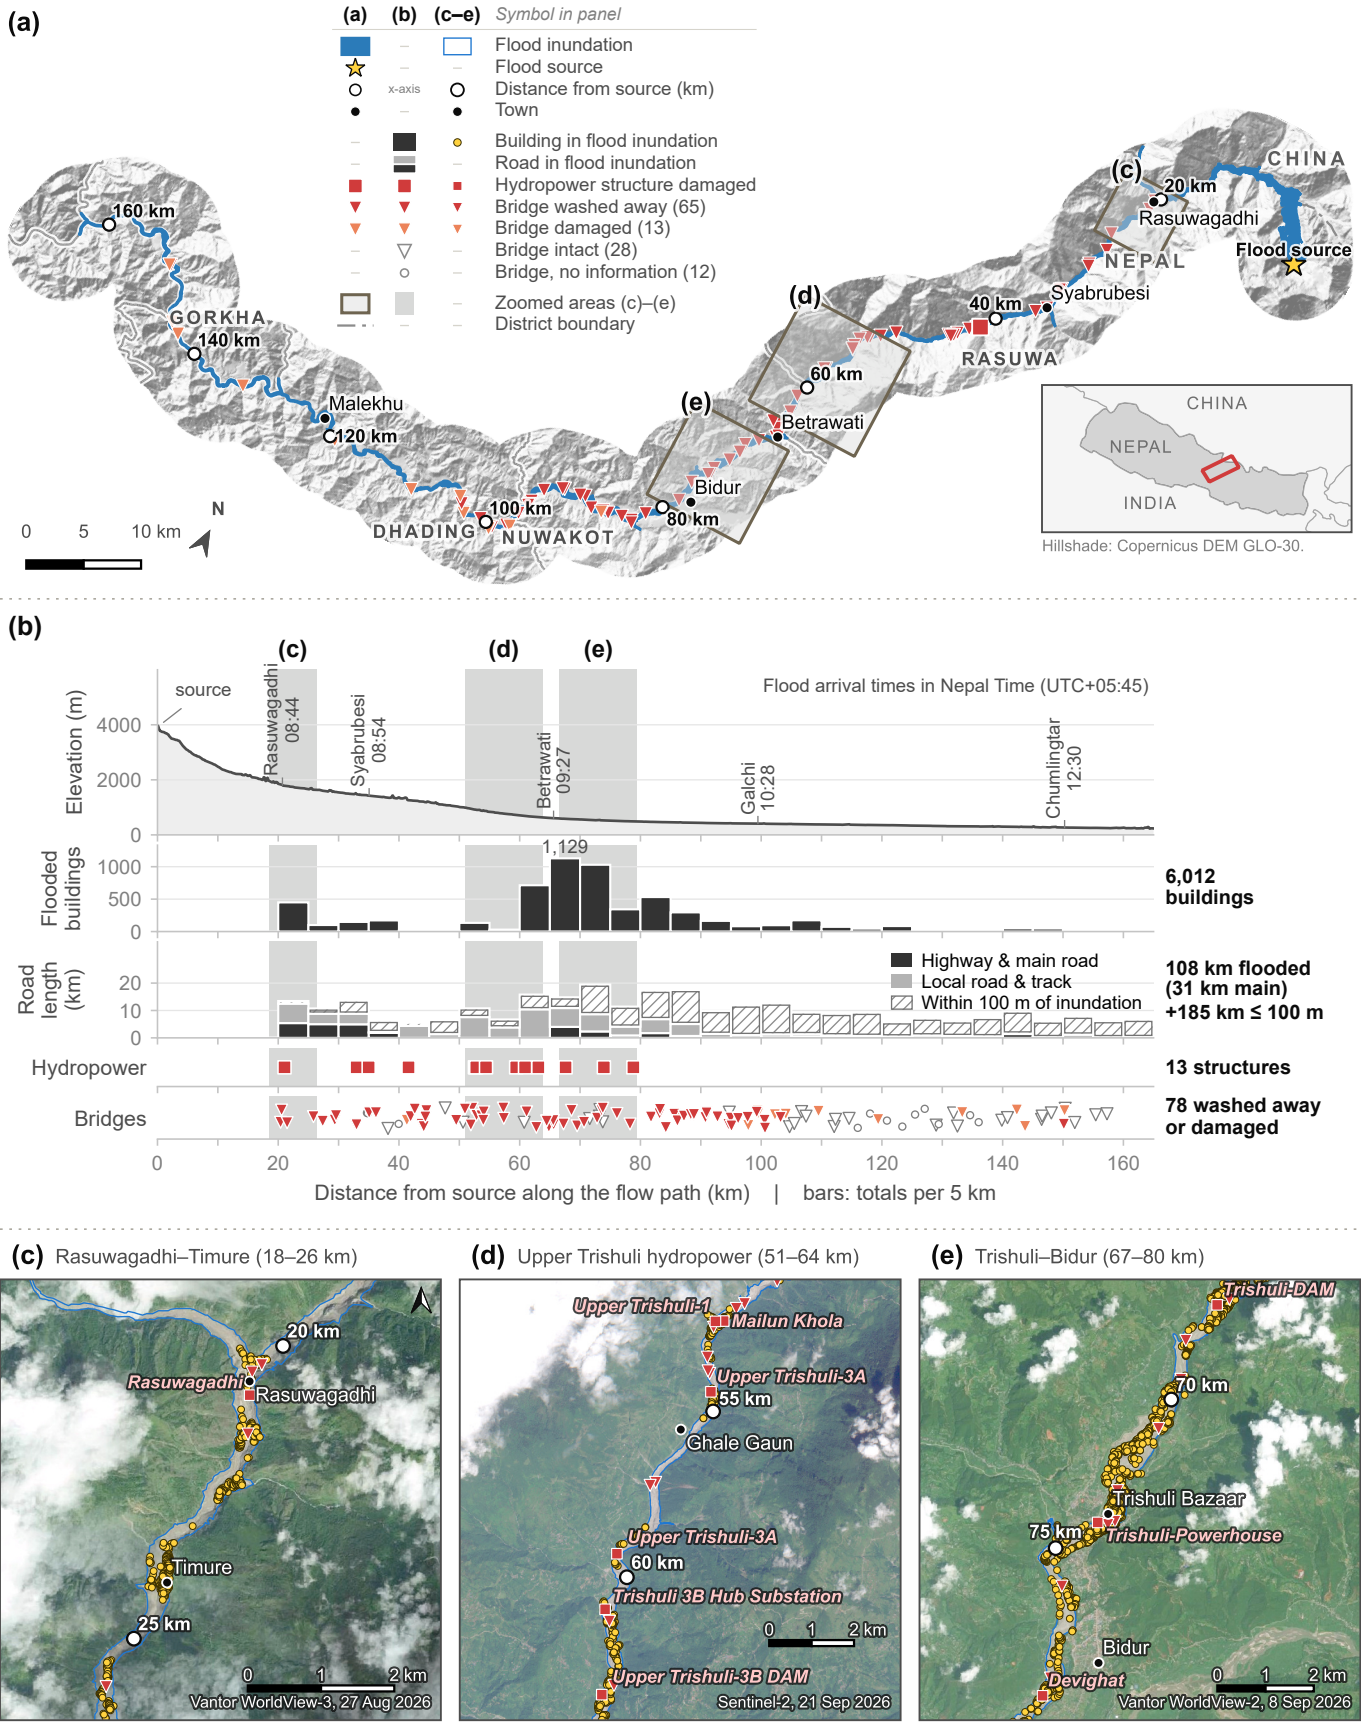
(a)
(a) (b) (c–e) Symbol in panel
Flood inundation
Flood source
x-axis
Distance from source (km)
Town
Building in flood inundation
Road in flood inundation
Hydropower structure damaged
Bridge washed away (65)
Bridge damaged (13)
Bridge intact (28)
Bridge, no information (12)
Zoomed areas (c)–(e)
District boundary
160 km
GORKHA
140 km
Malekhu
120 km
DHADING
100 km
NUWAKOT
80 km
Bidur
(e)
60 km
Betrawati
(d)
40 km
Syabrubesi
RASUWA
(c)
20 km
Rasuwagadhi
NEPAL
CHINA
Flood source
0 5 10 km
N
CHINA
NEPAL
INDIA
Hillshade: Copernicus DEM GLO-30.
(b)
(c)
(d)
(e)
source
Rasuwagadhi 08:44
Syabrubesi 08:54
Betrawati 09:27
Galchi 10:28
Chumlingtar 12:30
Flood arrival times in Nepal Time (UTC+05:45)
Elevation (m)
4000
2000
0
Flooded buildings
1,129
1000
500
0
6,012 buildings
Road length (km)
20
10
0
Highway & main road
Local road & track
Within 100 m of inundation
108 km flooded (31 km main)
+185 km ≤ 100 m
Hydropower
13 structures
Bridges
78 washed away or damaged
0 20 40 60 80 100 120 140 160

Distance from source along the flow path (km) | bars: totals per 5 km
(c) Rasuwagadhi–Timure (18–26 km)
20 km
Rasuwagadhi
Rasuwagadhi
Timure
25 km
0 1 2 km
Vantor WorldView-3, 27 Aug 2026

(d) Upper Trishuli hydropower (51–64 km)
Upper Trishuli-1
Mailun Khola
Upper Trishuli-3A
55 km
Ghale Gaun
Upper Trishuli-3A
60 km
Trishuli 3B Hub Substation
0 1 2 km
Upper Trishuli-3B DAM
Sentinel-2, 21 Sep 2026

(e) Trishuli–Bidur (67–80 km)
Trishuli-DAM
70 km
Trishuli Bazaar
75 km
Trishuli-Powerhouse
Bidur
Devighat
0 1 2 km
Vantor WorldView-2, 8 Sep 2026
