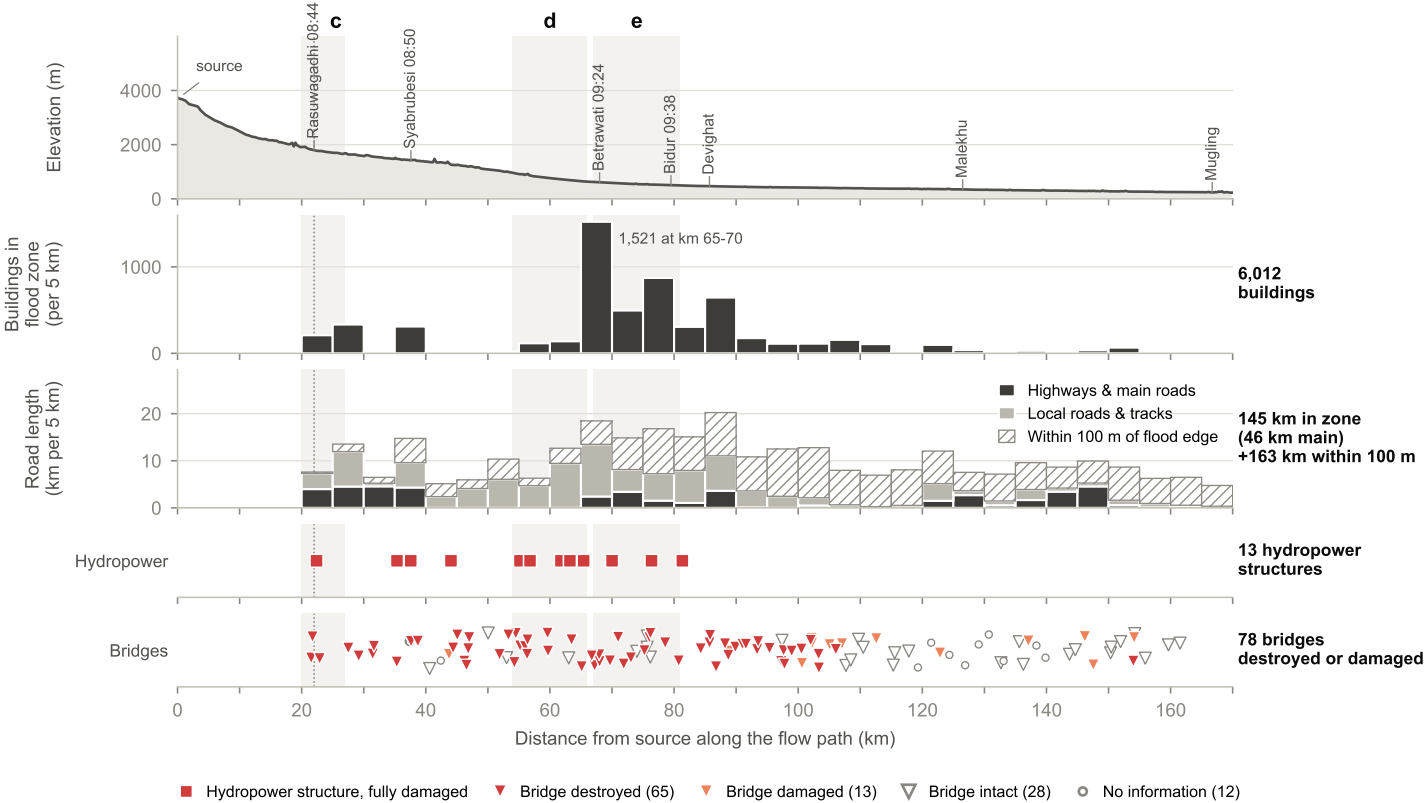
c
d
e
source
Rasuwagadhi 08:44
Syabrubesi 08:50
Betrawati 09:24
Bidur 09:38
Devighat
Malekhu
Mugling
Elevation (m)
4000
2000
0
Buildings in flood zone (per 5 km)
1,521 at km 65-70
1000
0
6,012 buildings
Road length (km per 5 km)
Highways & main roads
Local roads & tracks
Within 100 m of flood edge
20
10
0
145 km in zone (46 km main) +163 km within 100 m
Hydropower
13 hydropower structures
Bridges
78 bridges destroyed or damaged
0
20
40
60
80
100
120
140
160
Distance from source along the flow path (km)
Hydropower structure, fully damaged
Bridge destroyed (65)
Bridge damaged (13)
Bridge intact (28)
No information (12)
