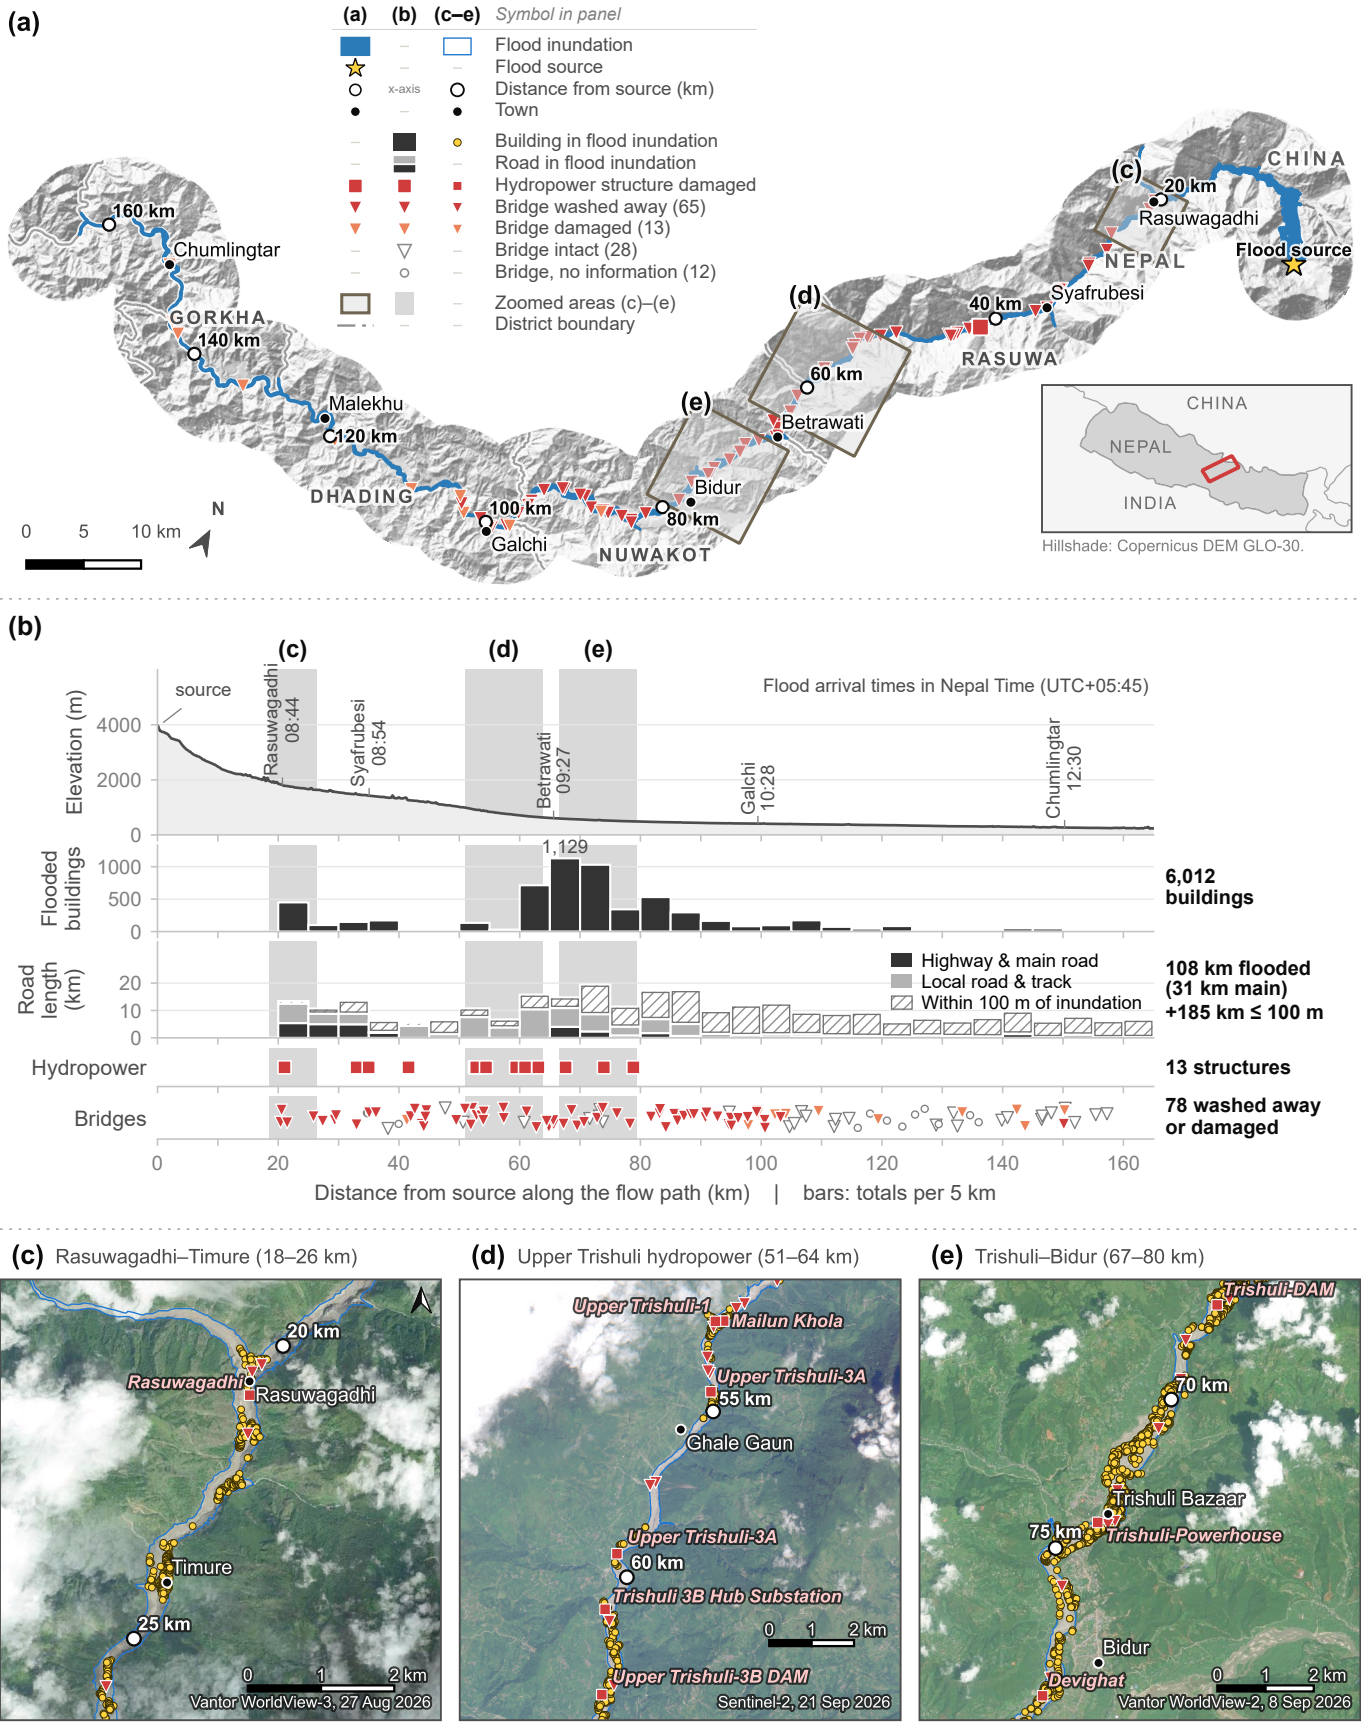
(a)
(a) (b) (c–e) Symbol in panel
Flood inundation
Flood source
x-axis
Distance from source (km)
Town
Building in flood inundation
Road in flood inundation
Hydropower structure damaged
Bridge washed away (65)
Bridge damaged (13)
Bridge intact (28)
Bridge, no information (12)
Zoomed areas (c)–(e)
District boundary
160 km
Chumlingtar
GORKHA
140 km
Malekhu
120 km
DHADING
100 km
Galchi
NUWAKOT
80 km
Bidur
(e)
60 km
Betrawati
(d)
40 km
Syafrubesi
RASUWA
(c)
20 km
Rasuwagadhi
NEPAL
CHINA
Flood source
0 5 10 km
N
CHINA
NEPAL
INDIA
Hillshade: Copernicus DEM GLO-30.
(b)
(c)
(d)
(e)
source
Rasuwagadhi 08:44
Syafrubesi 08:54
Betrawati 09:27
Galchi 10:28
Chumlingtar 12:30
Flood arrival times in Nepal Time (UTC+05:45)
Elevation (m)
4000
2000
0
Flooded buildings
1,129
1000
500
0
6,012 buildings
Road length (km)
20
10
0
Highway & main road
Local road & track
Within 100 m of inundation
108 km flooded (31 km main) +185 km ≤ 100 m
Hydropower
13 structures
Bridges
78 washed away or damaged

0 20 40 60 80 100 120 140 160
Distance from source along the flow path (km) | bars: totals per 5 km
(c) Rasuwagadhi–Timure (18–26 km)
20 km
Rasuwagadhi
Rasuwagadhi
Timure
25 km
0 1 2 km
Vantor WorldView-3, 27 Aug 2026

(d) Upper Trishuli hydropower (51–64 km)
Upper Trishuli-1
Mailun Khola
Upper Trishuli-3A
55 km
Ghale Gaun
Upper Trishuli-3A
60 km
Trishuli 3B Hub Substation
0 1 2 km
Upper Trishuli-3B DAM
Sentinel-2, 21 Sep 2026

(e) Trishuli–Bidur (67–80 km)
Trishuli-DAM
70 km
Trishuli Bazaar
75 km
Trishuli-Powerhouse
Bidur
Devighat
0 1 2 km
Vantor WorldView-2, 8 Sep 2026
