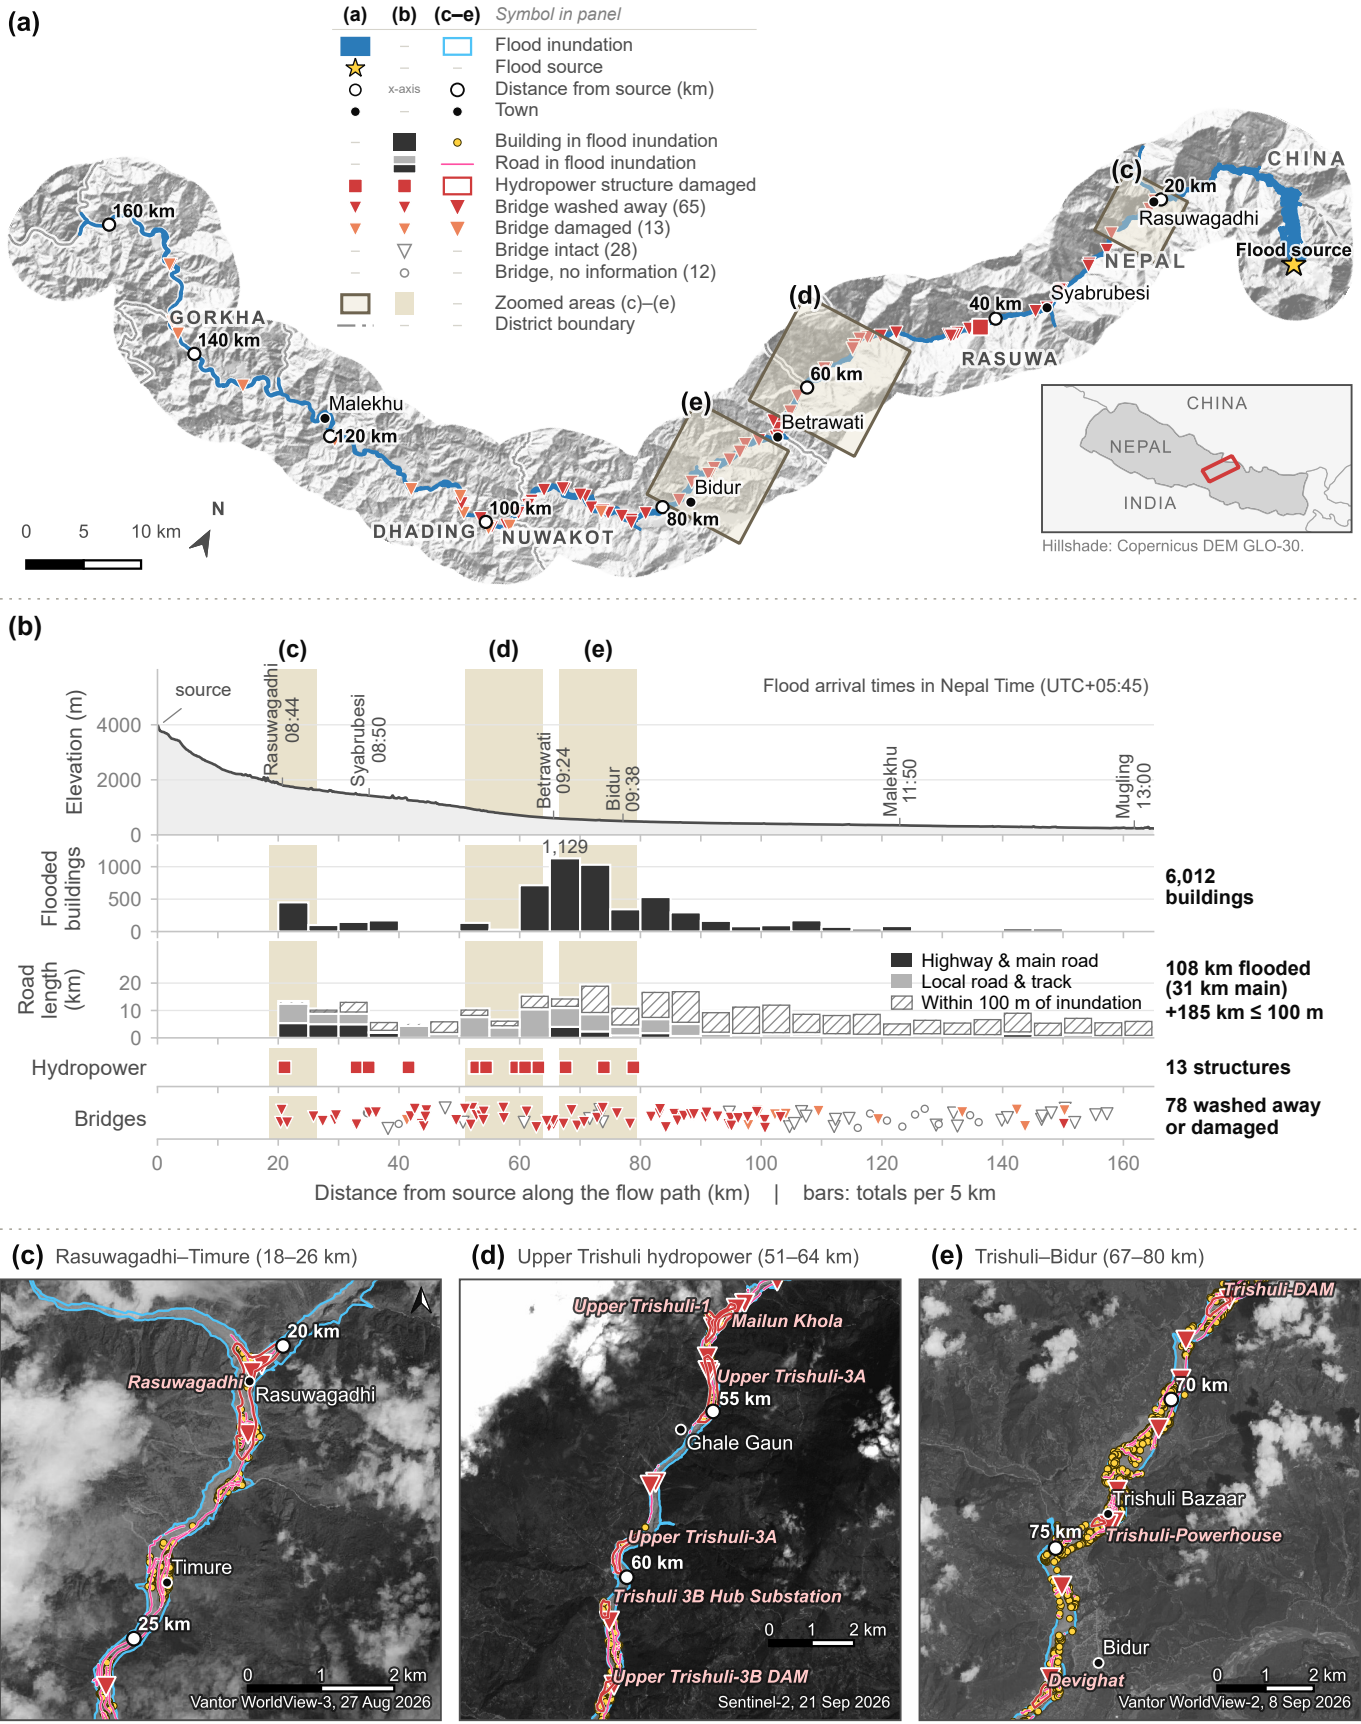
(a)
(a) (b) (c–e) Symbol in panel
Flood inundation
Flood source
x-axis
Distance from source (km)
Town
Building in flood inundation
Road in flood inundation
Hydropower structure damaged
Bridge washed away (65)
Bridge damaged (13)
Bridge intact (28)
Bridge, no information (12)
Zoomed areas (c)–(e)
District boundary
160 km
GORKHA
140 km
Malekhu
120 km
DHADING
100 km
NUWAKOT
80 km
Bidur
(e)
60 km
Betrawati
(d)
40 km
Syabrubesi
RASUWA
(c)
20 km
Rasuwagadhi
NEPAL
CHINA
Flood source
0 5 10 km
N
CHINA
NEPAL
INDIA
Hillshade: Copernicus DEM GLO-30.
(b)
(c)
(d)
(e)
source
Rasuwagadhi 08:44
Syabrubesi 08:50
Betrawati 09:24
Bidur 09:38
Malekhu 11:50
Mugling 13:00
Flood arrival times in Nepal Time (UTC+05:45)
Elevation (m)
4000
2000
0
Flooded buildings
1,129
1000
500
0
6,012 buildings
Road length (km)
20
10
0
Highway & main road
Local road & track
Within 100 m of inundation
108 km flooded (31 km main) +185 km ≤ 100 m
Hydropower
13 structures
Bridges
78 washed away or damaged
0 20 40 60 80 100 120 140 160

Distance from source along the flow path (km) | bars: totals per 5 km
(c) Rasuwagadhi–Timure (18–26 km)
20 km
Rasuwagadhi
Rasuwagadhi
Timure
25 km
0 1 2 km
Vantor WorldView-3, 27 Aug 2026

(d) Upper Trishuli hydropower (51–64 km)
Upper Trishuli-1
Mailun Khola
Upper Trishuli-3A
55 km
Ghale Gaun
Upper Trishuli-3A
60 km
Trishuli 3B Hub Substation
0 1 2 km
Upper Trishuli-3B DAM
Sentinel-2, 21 Sep 2026

(e) Trishuli–Bidur (67–80 km)
Trishuli-DAM
70 km
Trishuli Bazaar
75 km
Trishuli-Powerhouse
Bidur
Devighat
0 1 2 km
Vantor WorldView-2, 8 Sep 2026
