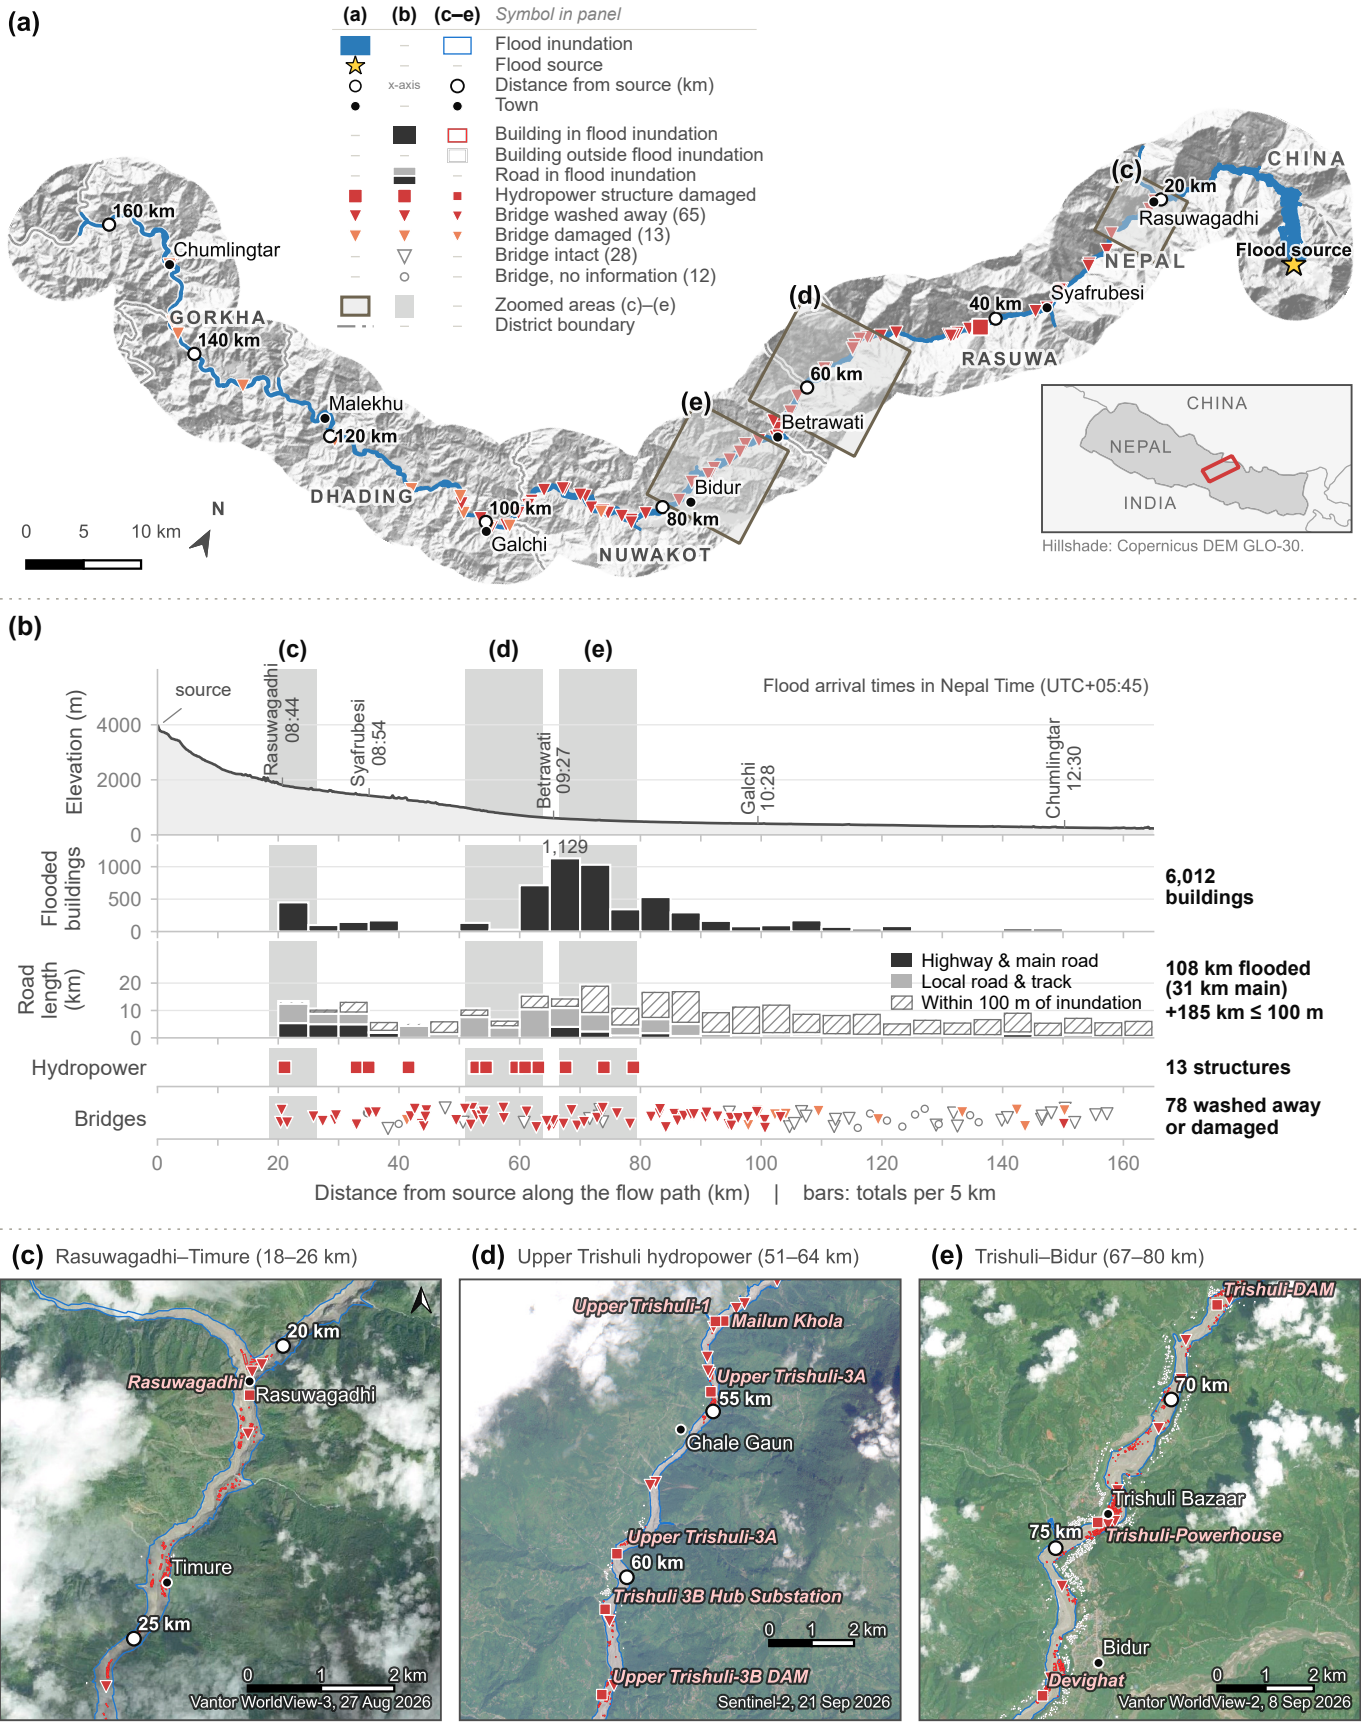
(a)
(a) (b) (c–e) Symbol in panel
Flood inundation
Flood source
x-axis
Distance from source (km)
Town
Building in flood inundation
Building outside flood inundation
Road in flood inundation
Hydropower structure damaged
Bridge washed away (65)
Bridge damaged (13)
Bridge intact (28)
Bridge, no information (12)
Zoomed areas (c)–(e)
District boundary
160 km
Chumlingtar
GORKHA
140 km
Malekhu
120 km
DHADING
100 km
Galchi
NUWAKOT
80 km
Bidur
(e)
60 km
Betrawati
(d)
40 km
Syafrubesi
RASUWA
20 km
Rasuwagadhi
(c)
NEPAL
CHINA
Flood source
0 5 10 km
N
CHINA
NEPAL
INDIA
Hillshade: Copernicus DEM GLO-30.
(b)
(c)
(d)
(e)
source
Rasuwagadhi 08:44
Syafrubesi 08:54
Betrawati 09:27
Galchi 10:28
Chumlingtar 12:30
Flood arrival times in Nepal Time (UTC+05:45)
Elevation (m)
4000
2000
0
Flooded buildings
1,129
1000
500
0
6,012 buildings
Road length (km)
20
10
0
Highway & main road
Local road & track
Within 100 m of inundation
108 km flooded (31 km main) +185 km ≤ 100 m
Hydropower
13 structures

Bridges
78 washed away or damaged
0 20 40 60 80 100 120 140 160
Distance from source along the flow path (km) | bars: totals per 5 km
(c) Rasuwagadhi–Timure (18–26 km)
20 km
Rasuwagadhi
Rasuwagadhi
Timure
25 km
0 1 2 km
Vantor WorldView-3, 27 Aug 2026

(d) Upper Trishuli hydropower (51–64 km)
Upper Trishuli-1
Mailun Khola
Upper Trishuli-3A
55 km
Ghale Gaun
Upper Trishuli-3A
60 km
Trishuli 3B Hub Substation
0 1 2 km
Upper Trishuli-3B DAM
Sentinel-2, 21 Sep 2026

(e) Trishuli–Bidur (67–80 km)
Trishuli-DAM
70 km
Trishuli Bazaar
75 km
Trishuli-Powerhouse
Bidur
Devighat
0 1 2 km
Vantor WorldView-2, 8 Sep 2026
