Summit Hood Service Co.

ACCESS EXCEPTION PACKET

Main cookline exhaust system. Customer-facing packet prepared after service for records, access handling, and next-cycle confirmation.

Service window	Apr 14, 2026 I 01:10-03:05
Service type	Kitchen exhaust cleaning completion packet
Technician	SH-114 / certified hood tech
Report status	Completed with access exception
On-site label status	Exception notice applied at close-out
Report ID	HDS-MASKED-0414

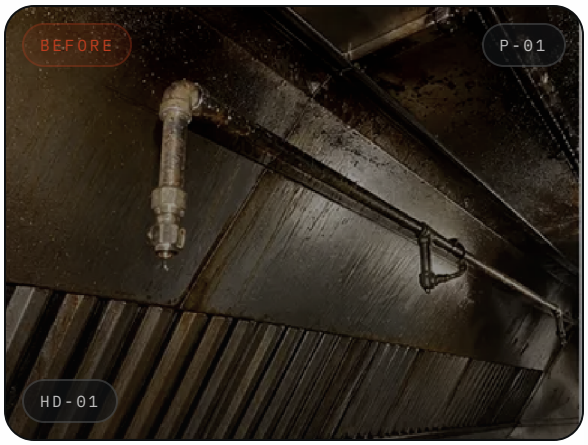
Hood interior before clean

Grease load and surface condition captured before work began.

Hood interior after clean

Same system photographed after reachable surfaces were cleaned.

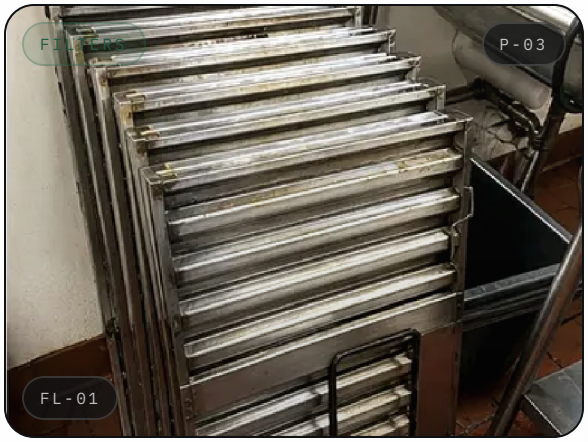
Baffle filter reset

Filters are shown removed and staged as part of the documented service flow.

Duct access work

Active access work is shown when interior duct service is performed.

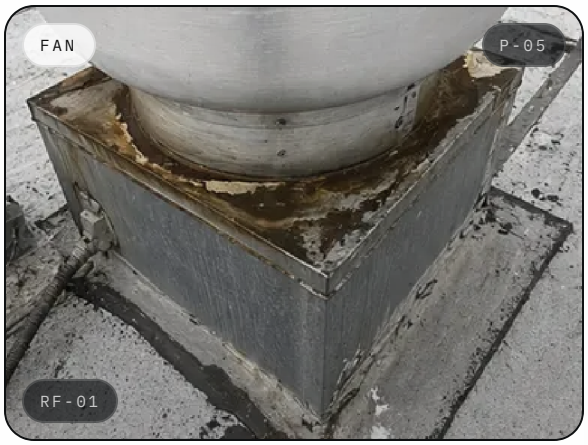
Rooftop fan line

Visible exhaust fan area is tied back to the customer record.

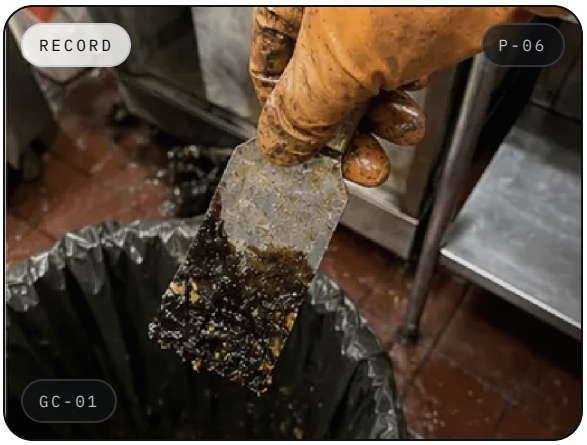
Grease removed

Removed buildup is recorded as proof of work, not just claimed.
