Summit Hood Service Co.

ACCESS EXCEPTION PACKET

Main cookline exhaust system. Customer-facing packet prepared after service for records, access handling, and next-cycle confirmation.

Service window	Apr 14, 2026 I 01:10-03:05
Service type	Kitchen exhaust cleaning completion packet
Technician	SH-114 / certified hood tech
Report status	Completed with access exception
On-site label status	Exception notice applied at close-out
Report ID	HDS-MASKED-0414

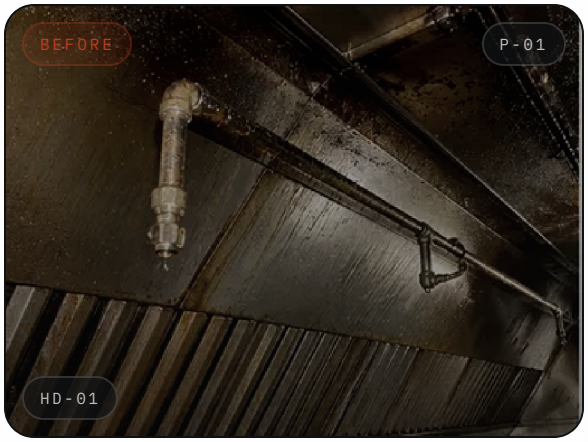
Hood interior before clean

Grease load and surface condition captured before work began.

Hood interior after clean

Same system photographed after reachable surfaces were cleaned.

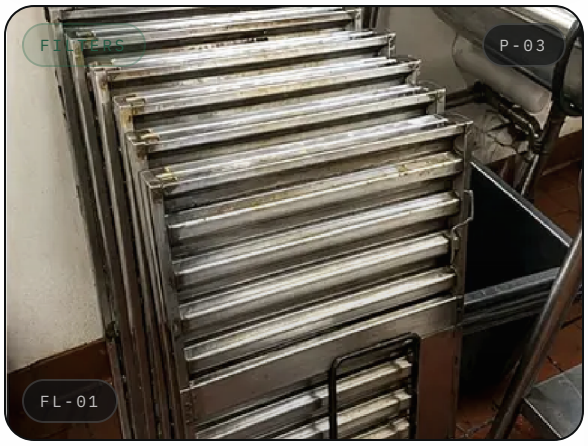
Baffle filter reset

Filters are shown removed and staged as part of the documented service flow.

Duct access work

Active access work is shown when interior duct service is performed.
