ORNL-2337

INTERIM REPORT ON CORROSION

BY ALKALI-METAL FLUORIDES:

WORK TO MAY 1, 1953

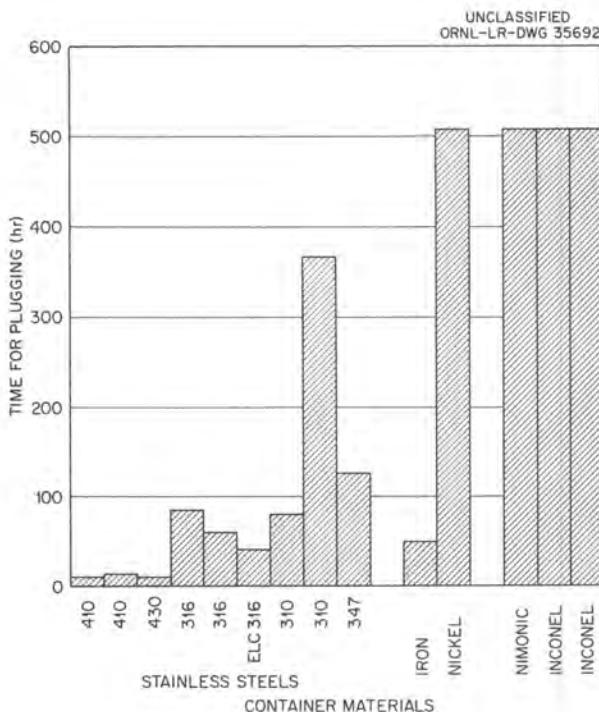
It was apparent from these data that the material selected must be one which would not cause plugging in the loop. The depth of corrosion was necessarily of secondary consideration. Nickel and Monel, which had been rated as the most likely containers in the static tests, had to be rejected because the thermal loop tests revealed excessive mass transfer of metal from the hot-leg surface to the cold leg. Figure 6 is a photograph of a mass of nickel crystals that had collected on a small flat sample inserted in the bottom of the cold leg of a nickel loop.

Fig. 4. Times for Plugging of Thermal-Convection Loops Made of Various Materials.

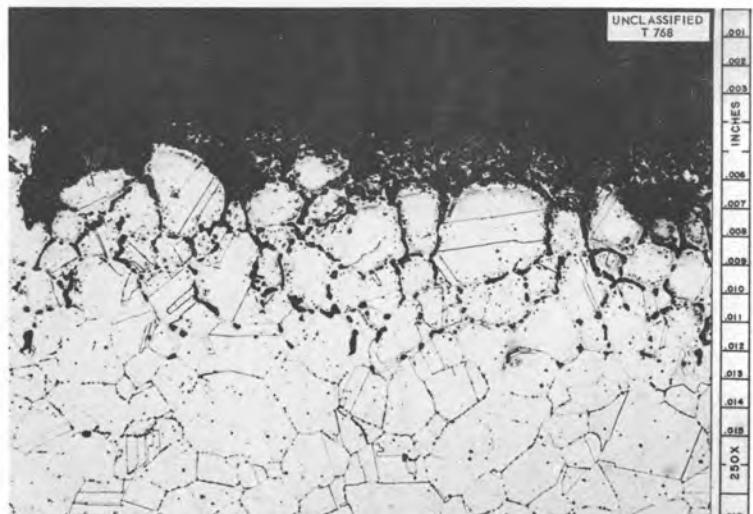
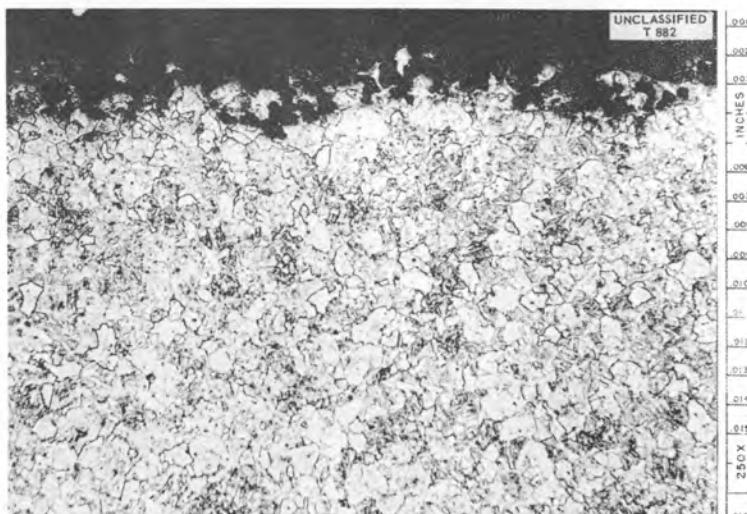
INCONEL, 500 HOURS

NICKEL, 500 HOURS

316 STAINLESS STEEL, 82 HOURS

410 STAINLESS STEEL, 12 HOURS

Fig. 5. Typical Hot-Leg Sections from Thermal Loops Made of Various Materials After Circulating Alkali-Metal Fluorides. 250X. Reduced 39%.
[redacted with caption]

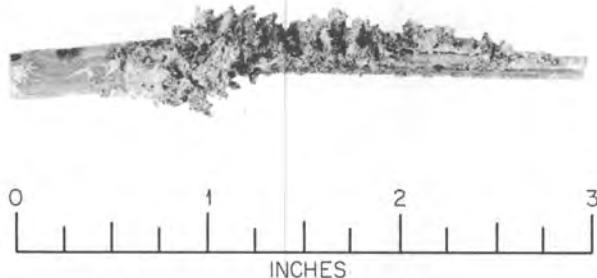
Fig. 6. Nickel Crystals Mass-Transferred in a Thermal Loop Circulating Fluoride 14 for 500 hr at 1500°F. (with caption)

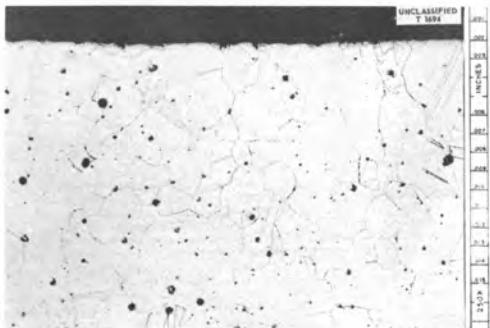
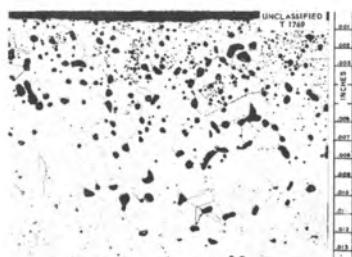
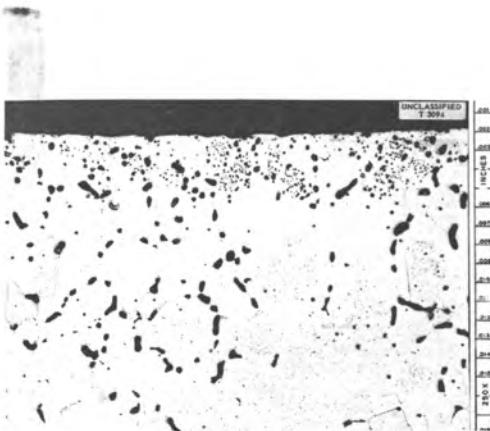
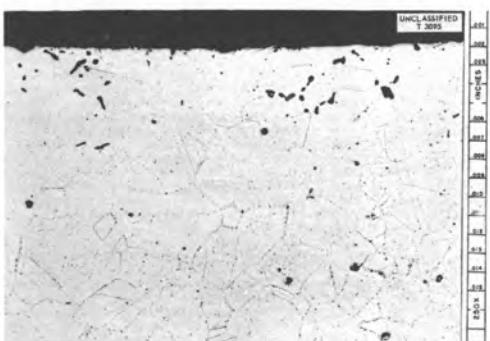
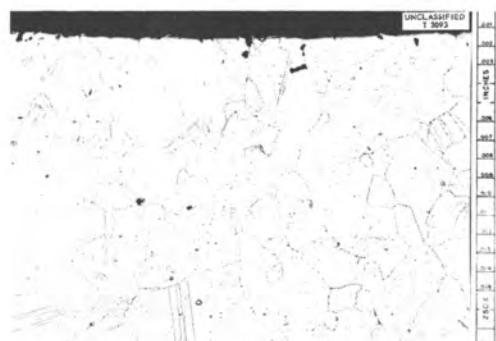
The following detailed description of loop 229 is presented as typical of the standard loops. Photomicrographs of various sections showing the distribution of attack around the loop are presented in Fig. 7. Sections 3 and 4 show that once the attack started it proceeded quite rapidly. The maximum depth of penetration increased only slightly in moving up the hot leg from section 3 to section 1, but the concentration of voids increased considerably. In the upper hot-leg section more general attack was found. It can be noted that the deepest penetration and the first sign of attack always occurred in the grain boundaries but that voids occurred frequently within the grains of the metal.

229	500	Scheduled	Moderate to heavy subsurface voids up to 0.018 in. and averaging 0.008 in.	Thin layer at least partially nonmetallic	Cr increased, Fe decreased, Ni and U unchanged in fluorides; Cr leached from wall

TOP OF VERTICAL HOT LEG
SECTION 4MIDDLE OF VERTICAL HOT LEG
SECTION 3LOWER VERTICAL HOT LEG
SECTION 4HOT HORIZONTAL LEG
SECTION 7LOWER COLD LEG
SECTION 8

Fig. 7. Variation in Attack Around a Standard Loop. 250X. Reduced 61%. [Section with caption]

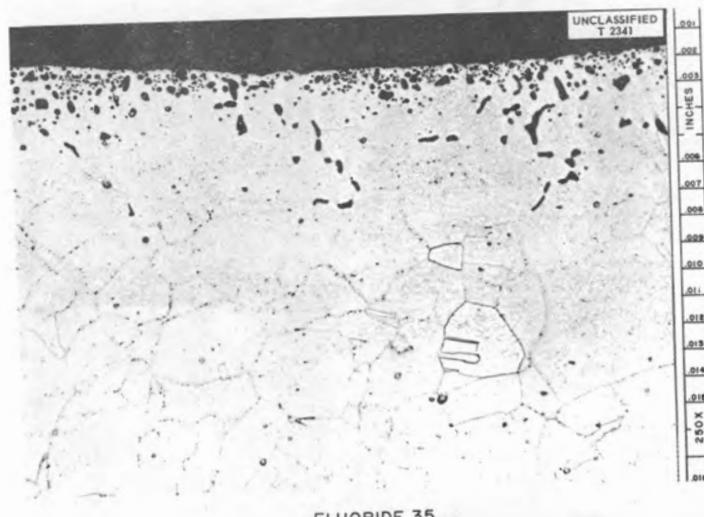
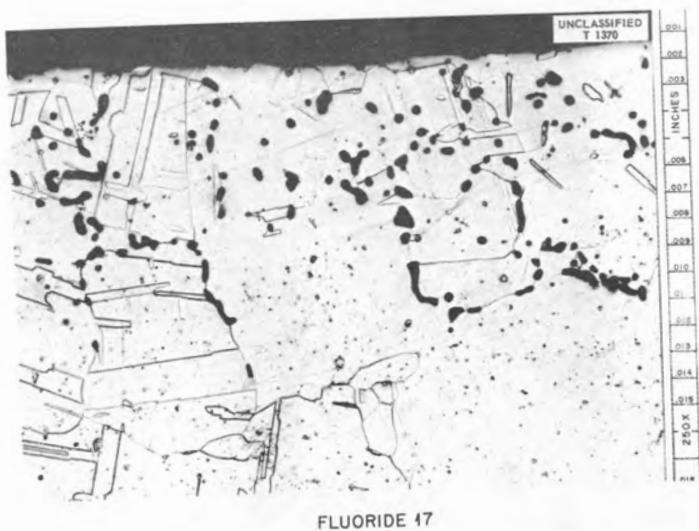
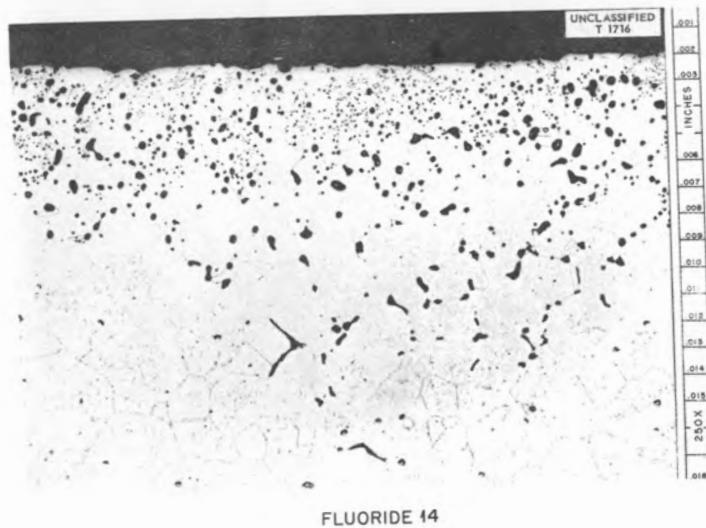
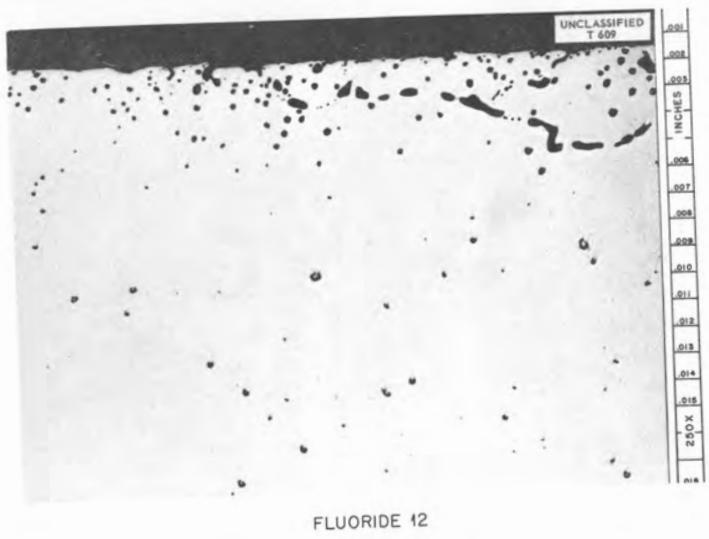
Table 5 lists the corrosive effects found in Inconel loops after they had circulated various fluoride mixtures (see Table 1 for compositions). The variation in attack is shown by the typical hot-leg sections presented in Figs. 8 and 9. These loops were operated not necessarily to give a minimum amount of corrosion but to be as nearly comparable as possible. In the case of fluoride 30, it was shown that lower corrosion rates were possible with changes in the production procedure, and it seemed likely that similar reductions could be made with the other compositions.

From the data in Table 5 it is apparent that the maximum depth of attack did not vary greatly with the different fluoride mixtures. An average maximum penetration of about 0.010 in. was typical. The variation in the intensity of attack and in the size of the voids in the metal resulting from corrosion found with different mixtures was thought to be caused mainly by differences in batch purity. The mechanism of attack appeared to be the same for all these fluoride mixtures and is discussed in detail in the section "Mechanism of Corrosive Attack." This single mechanism was evidenced by both the similarity in the voids and the similar variations in chemical analysis.

Fig. 8. Corrosion of Inconel by Various Fluoride Mixtures. 250X. Reduced 43.5%. [Redacted with caption]

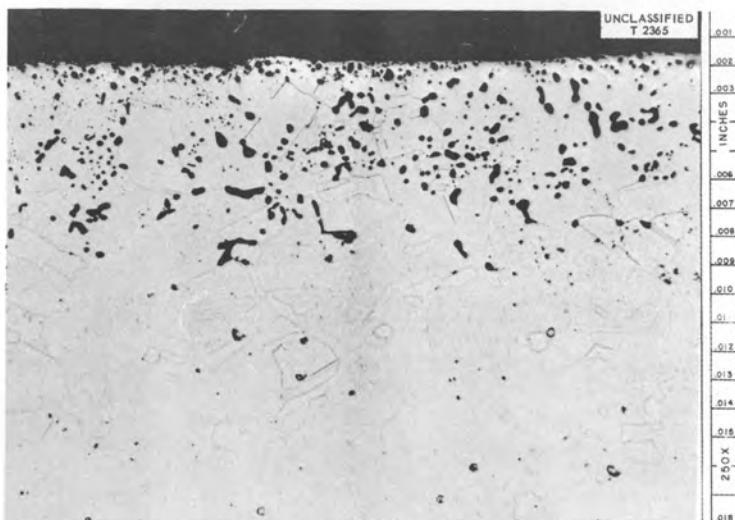
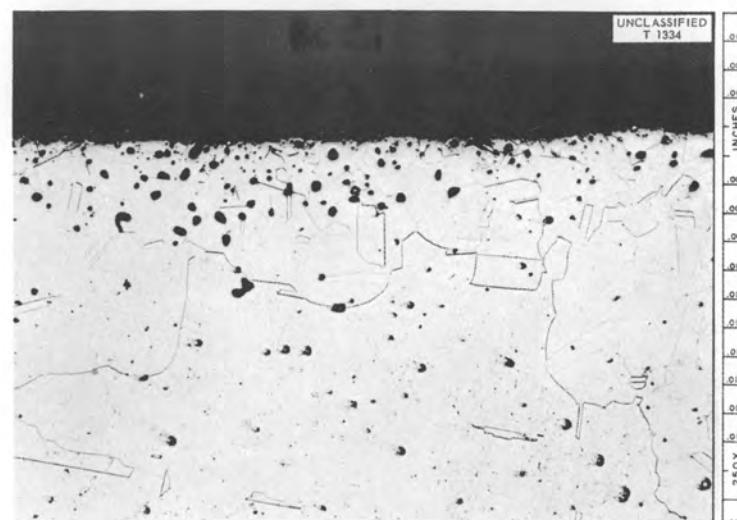
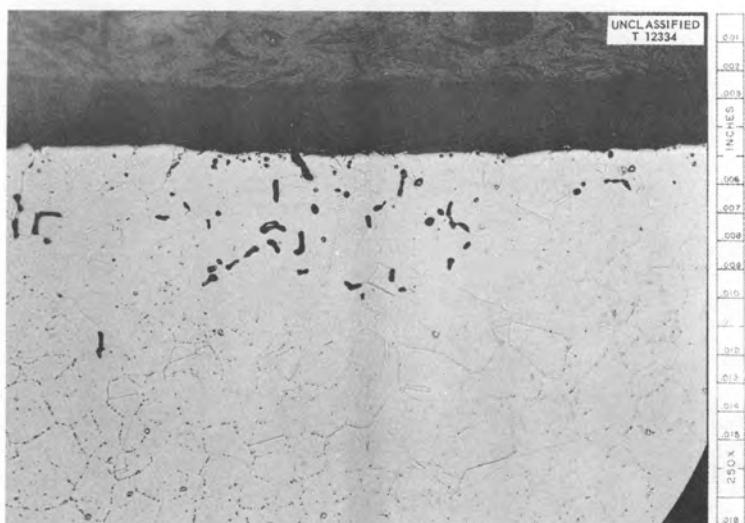
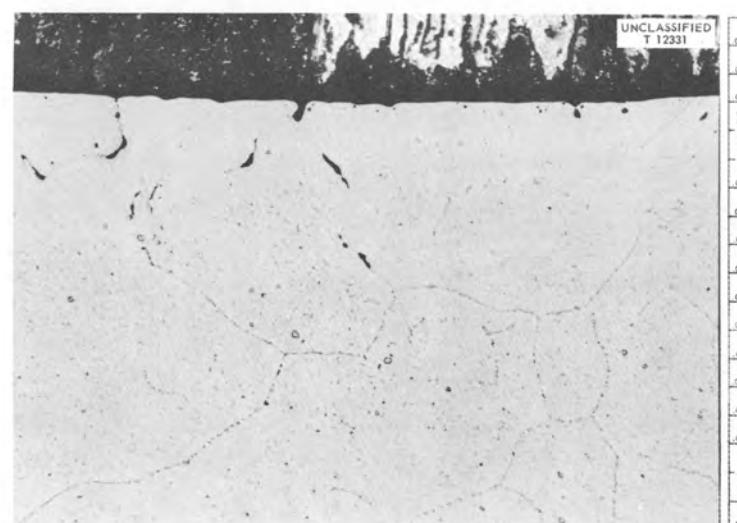
FLUORIDE 27

FLUORIDE 21

FLUORIDE 32

FLUORIDE 24

Fig. 9. Corrosion of Inconel by Various Zirconium Fluoride-Base Fluoride Mixtures. 250X. Reduced 40%. [redacted with caption]

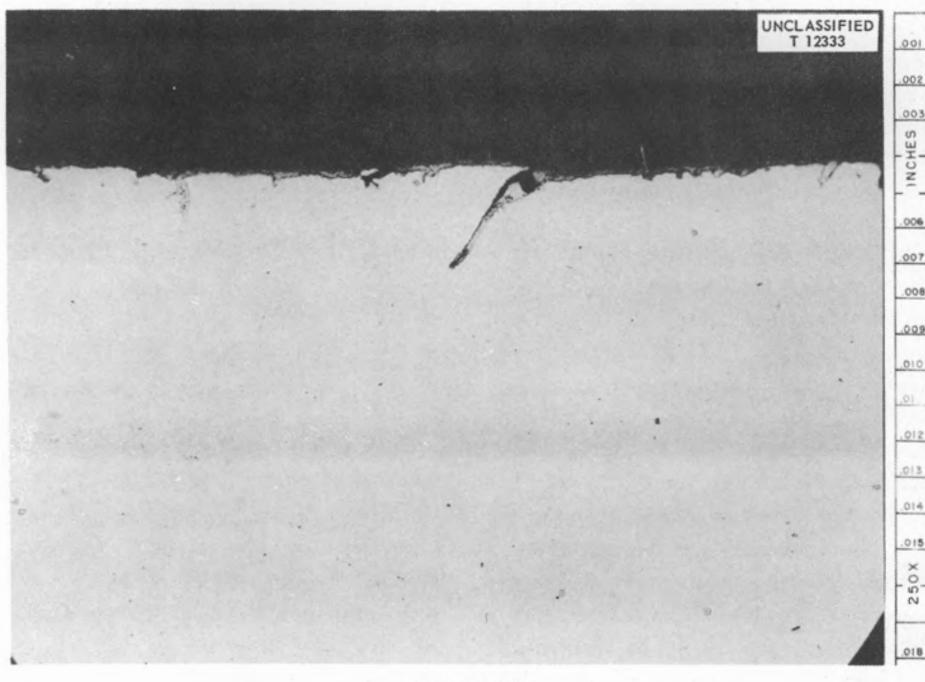
The zirconium hydride addition to fluoride 14 almost completely eliminated the corrosion of Inconel. The first photomicrograph in Fig. 10 shows the hot leg of loop 225. Some surface roughness was found, but none of the usual subsurface voids were present. An intermittent metallic-appearing layer was found on the surface of the

hot leg and in some of the grain boundaries near the surface. The second photomicrograph in Fig. 10 shows the cold leg of a duplicate loop (242). A well-bonded layer on the surface filled up what fabrication cracks were present. Unsuccessful attempts were made by both x-ray diffraction and spectrographic means to identify these layers. When the fluorides from these loops were analyzed, it was found that iron, nickel, and chromium had decreased in concentration during the circulation.

Fig. 10. Effect of Zirconium Hydride Additions on Fluoride Corrosion in Inconel. 250X. Reduced 25%. (SECRET with caption)

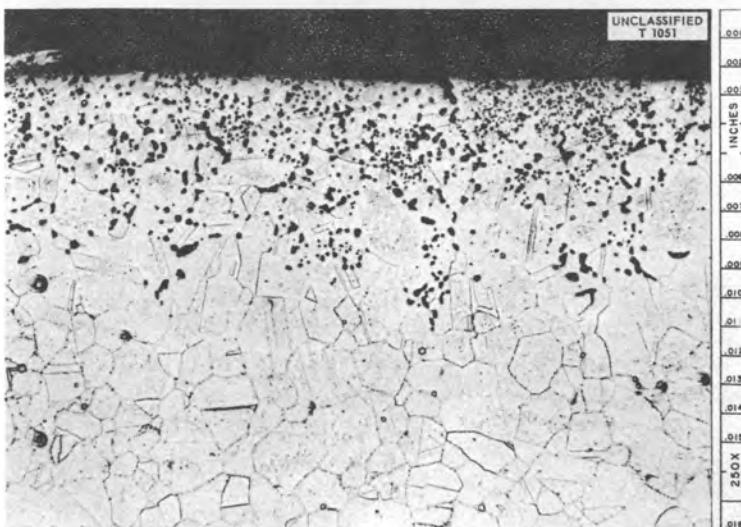
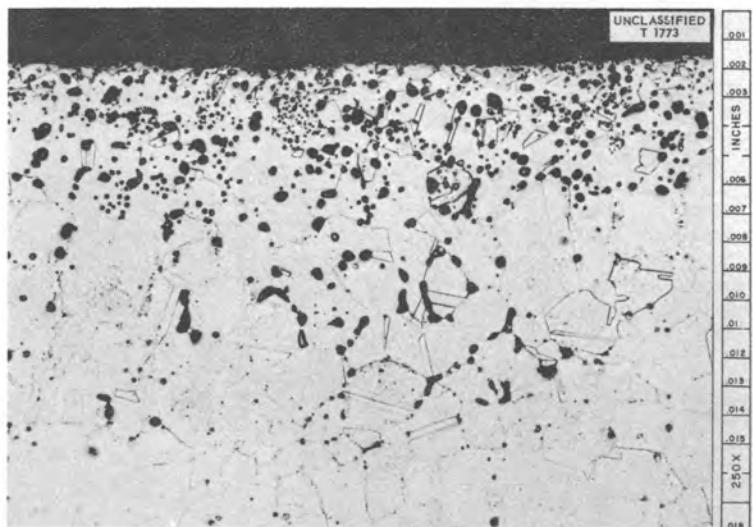
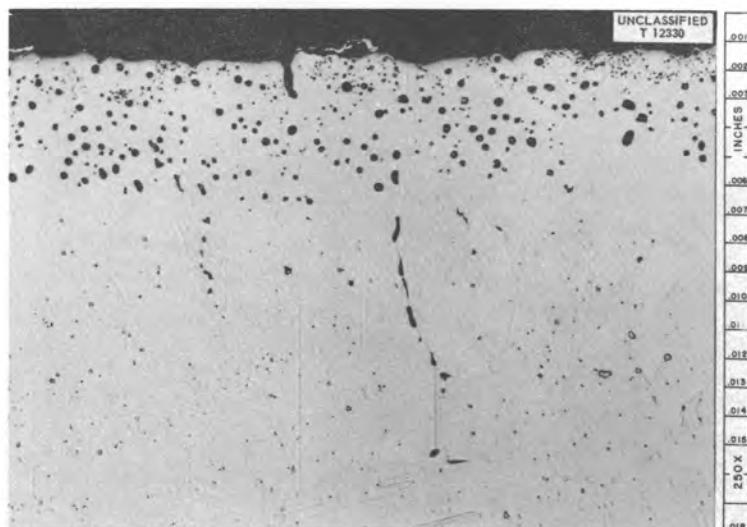
229 are presented in Fig. 12. Some increase in depth of attack was noted with increasing temperature: from a maximum of 0.010 in. at 1300°F to 0.015 in. at 1500°F and to 0.018 in. at 1650°F . At the higher temperature fewer voids were found, but they were much larger and showed more tendency to migrate to the grain boundaries. Considerable grain growth also was noted.

LOOP 218, 1300°F

LOOP 229, 1500°F

LOOP 222, 1650°F

Fig. 12. Effect of Hot-Leg Temperature on Fluoride Corrosion in Inconel. 250X. Reduced 39%. [Redacted with caption)

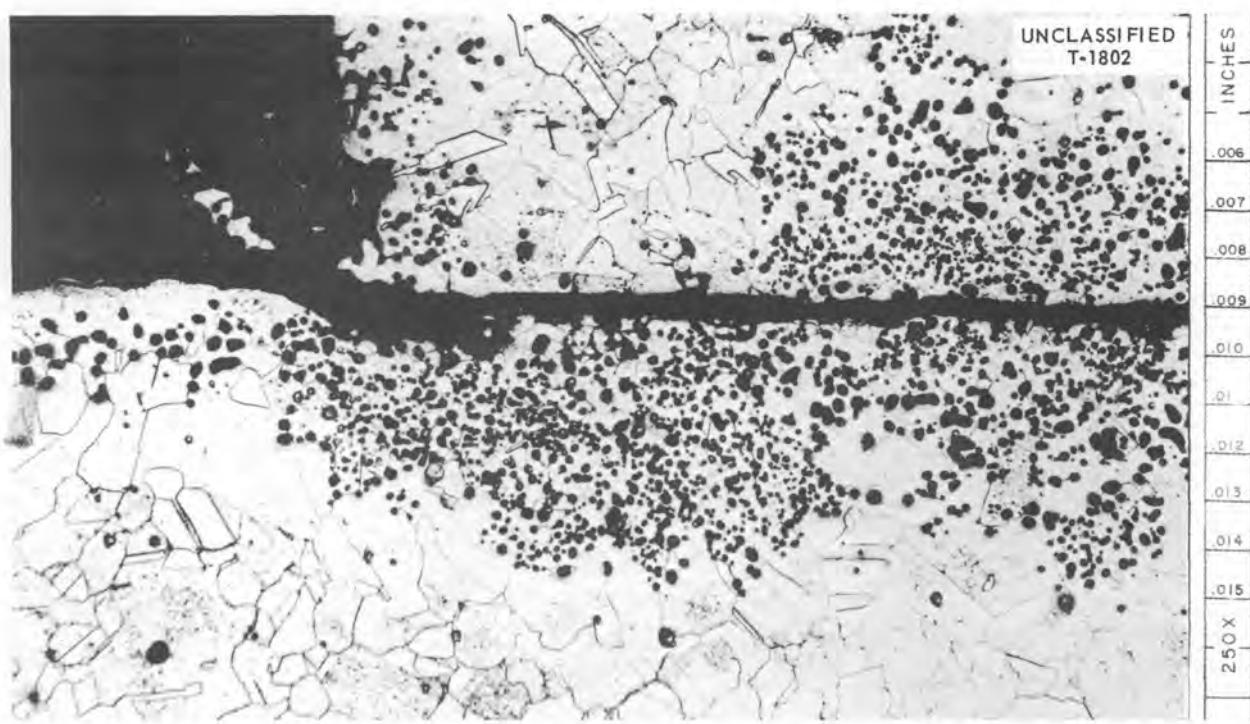
Fig. 13. Increase in Attack in a Crevice of an Inconel Loop. 250X.

the air was not complete. The oxides in the crevice reacted with the fuel and caused the increase in attack in the crevice. In the loop itself, sufficient fuel and agitation were present to dilute any effect caused by the weld scale on the pipe surfaces.

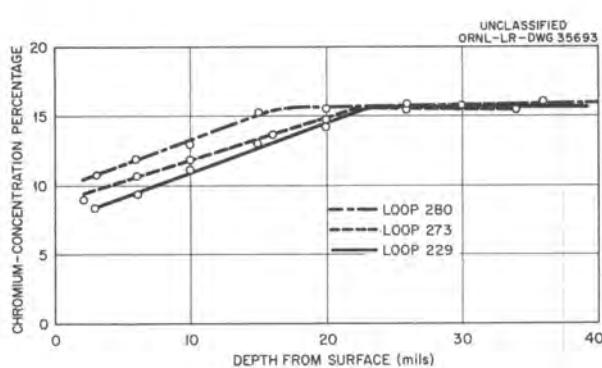
Fig. 14. Change in Chromium Concentration in Wall of an Inconel Thermal-Convection Loop.

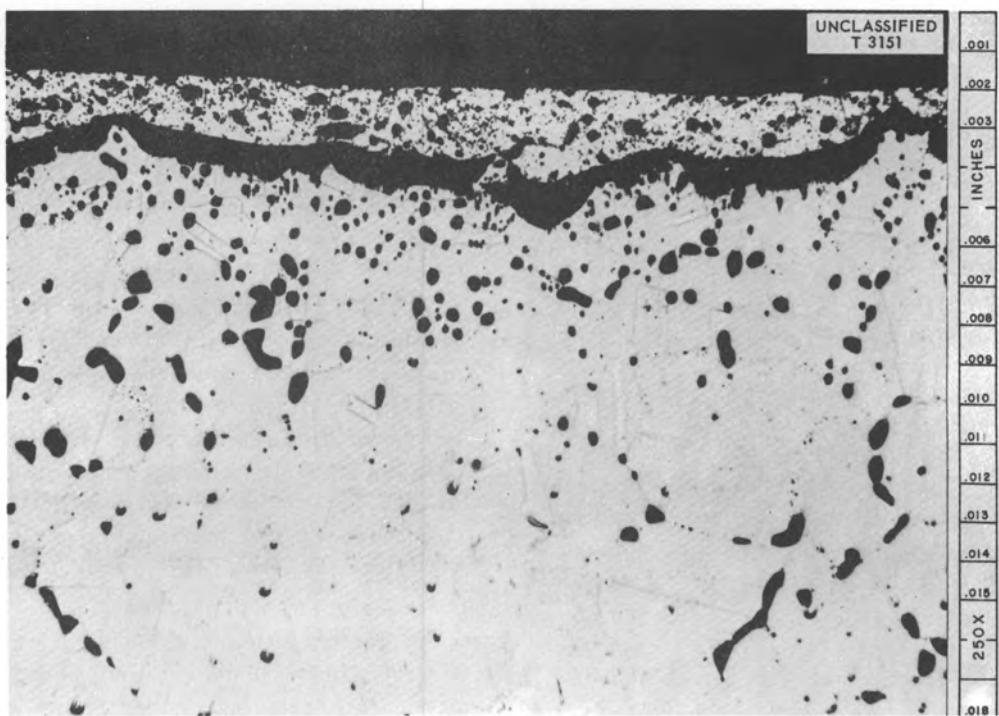
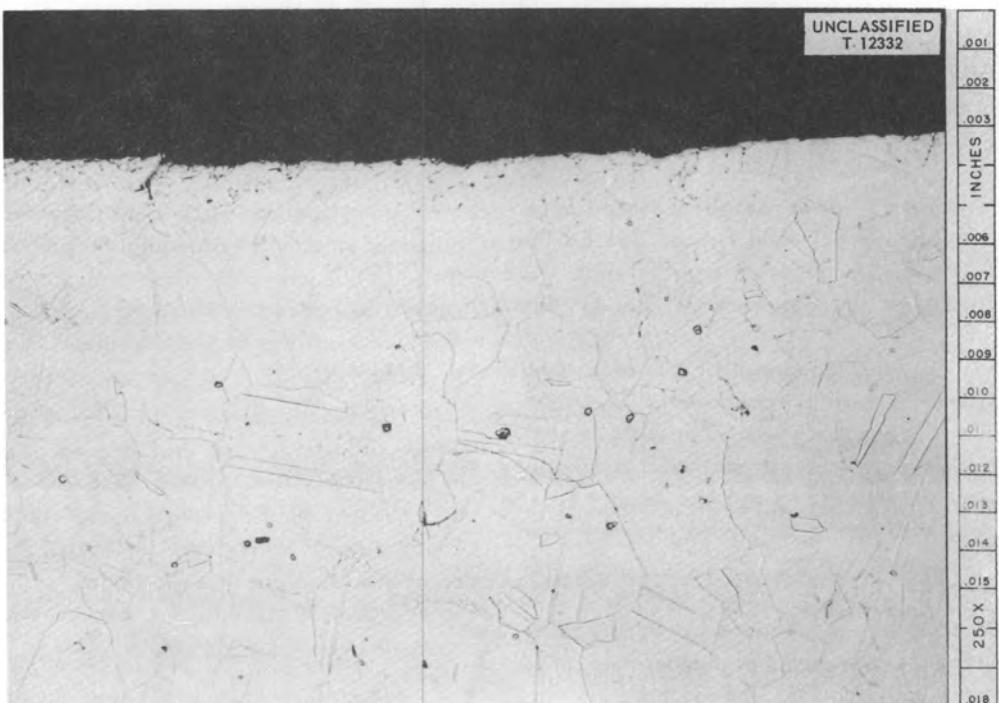
HOT LEG

COLD LEG

Fig. 15. Magnetic Areas on Sections from the Hot and Cold Legs of an Inconel Loop. 250X. Reduced 19%.

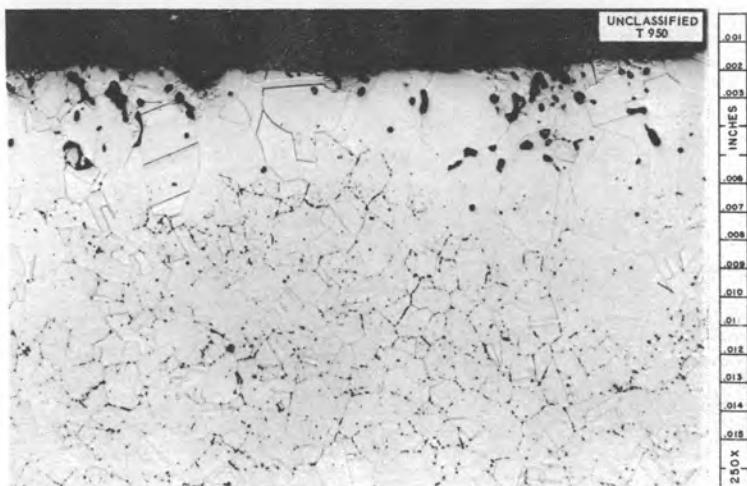
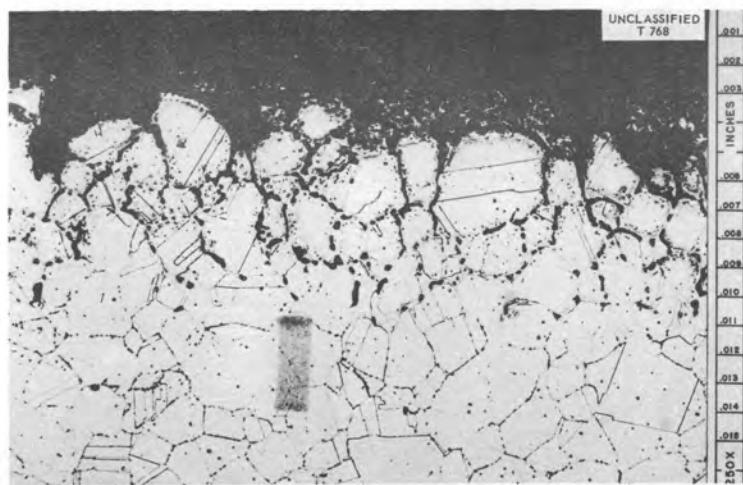
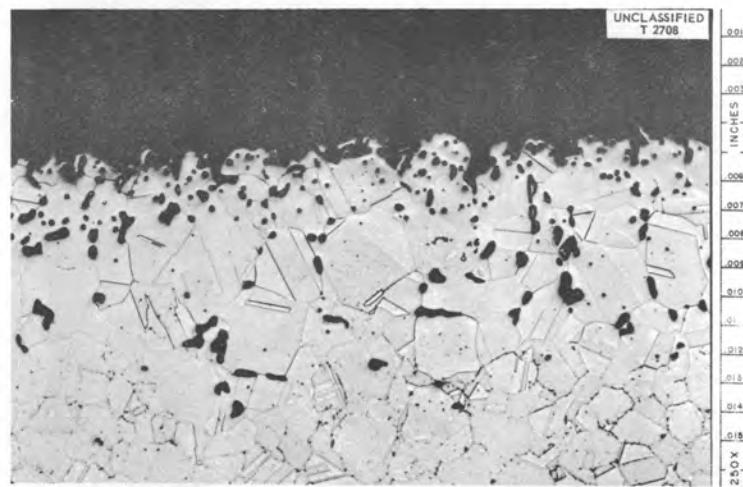
FLUORIDE 12

FLUORIDE 14

FLUORIDE 30

photomicrograph in Fig. 16 which shows the corrosion by fluoride 12 indicates that NaK reduced the attack on type 316 stainless steel, as well as on Inconel.

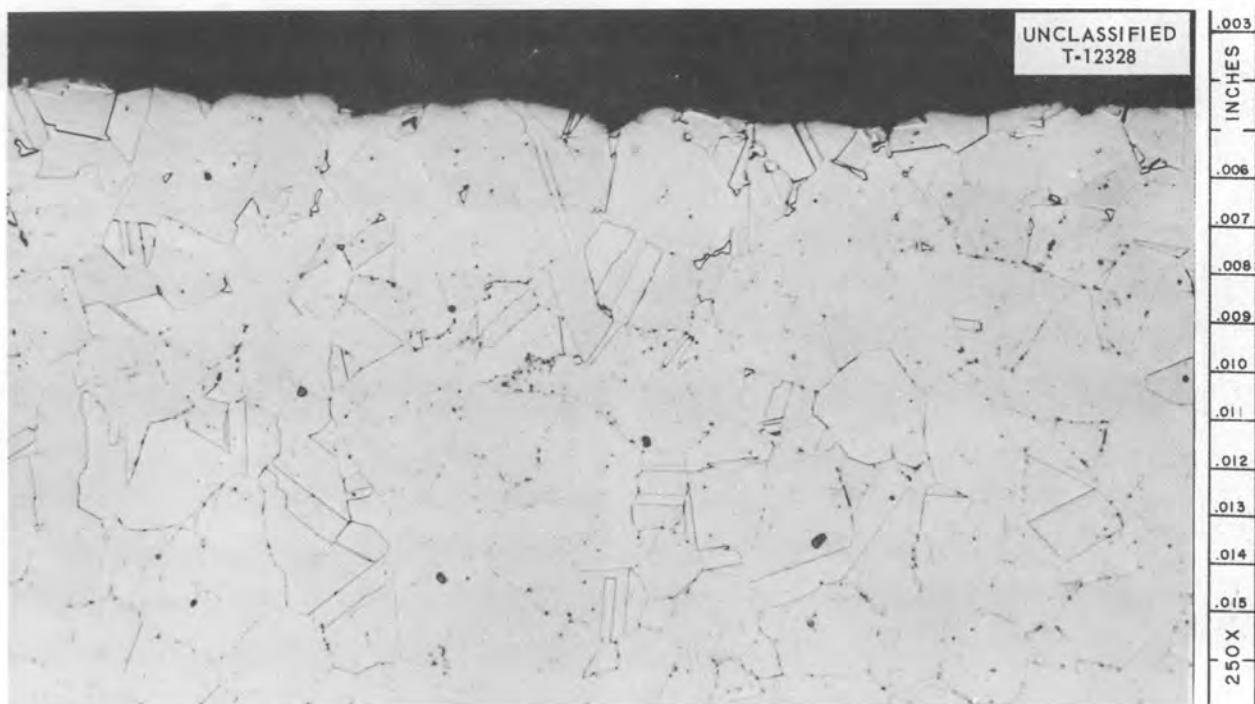
Fig. 17. Hot-Leg Section from a Type 316 Stainless Steel Loop After Circulating Fluoride 12 with a Small NaK Addition. 250X. [Redacted with caption]

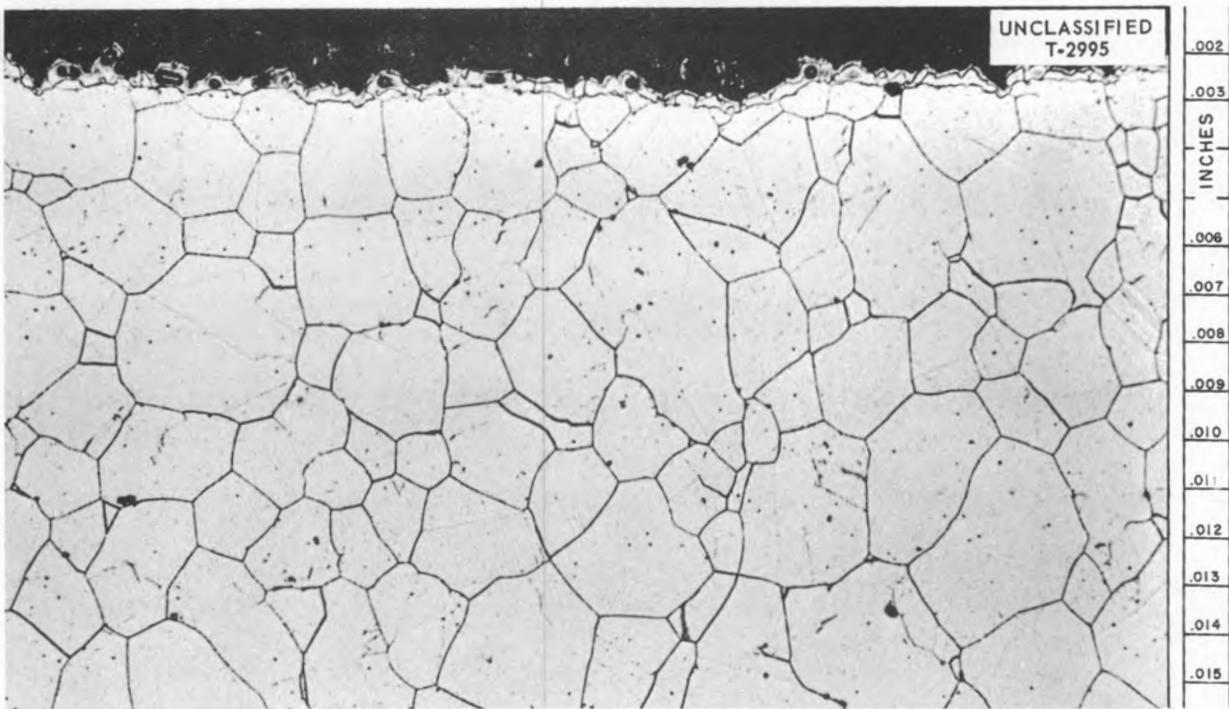
Fig. 18. Cold-Leg Section from a Type 316 Stainless Steel Loop After Circulating Fluoride 30. 250X. (with caption)
