# **CIRCUIT** INSPECTION

DI6P3-15

DTC	B0100/13[]	Short[]n[D[\$quib[Circuit
-----	------------	---------------------------

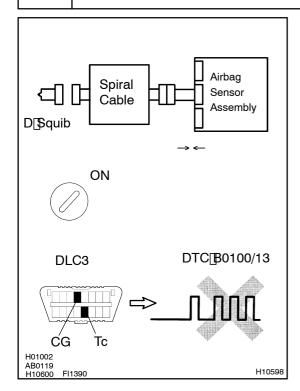
2 | Check D squib circuit.

For the orange connector (on the spiral cable side) between the spiral cable and the steering wheel pad, measure the resistance between D+ and D-.

Resistance: 1 M $\Omega$  or Higher

NG Go to step 5.

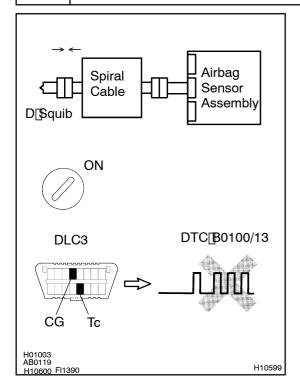
# 3 Checkairbagsensorassembly.

### DTC B0100/13 is not output.

Codes other than code B0100/13 may be output at this time, but they are not relevant to this check.

Replace airbag sensor assembly.
