B1279

Rain sensor communication stop

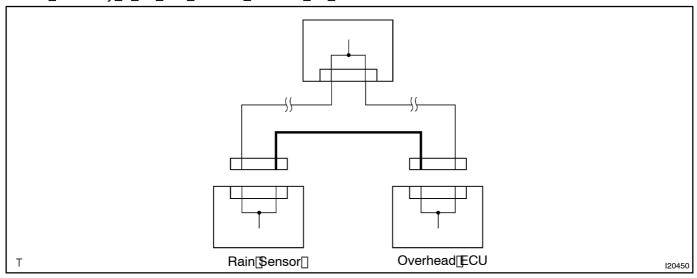
2 Check wire harness.

Wire harness side connector of ECU	Terminal
Rain sensor – Overhead J/B	MPX (R8-2) - MPX1 (O6-30)

$Check \verb|[]continuity|| \verb|[]df|| \verb|] he \verb|[]wire|| \verb|]harness|| \verb|[]between|| \verb|]| he \verb|[]connectors|.$

$There \cite{like} \cite{like$

If here is OPEN in any wire harness, please repair it.

Replace rain sensor See page N-35).
