DI8KM-01

Navigation ECU Communication Circuit

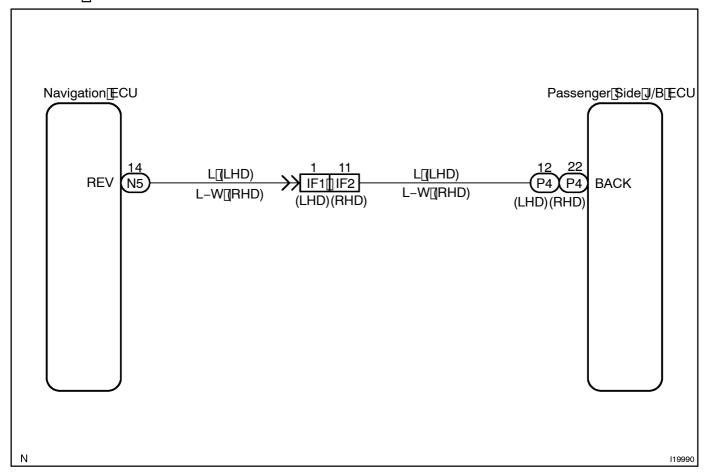
WIRING DIAGRAM

Passenger[\$ide]]/B[ECU[\$ends[A/T[]everse[]position[\$ignal[]o[]the[]Navigation[ECU.

Replace[he_navigation[ECU[See_page IN-35).

Repair or replace wire harness or connector.
