stm32-blinky — Design Document

PCB-0001-A

hwde v1 pipeline

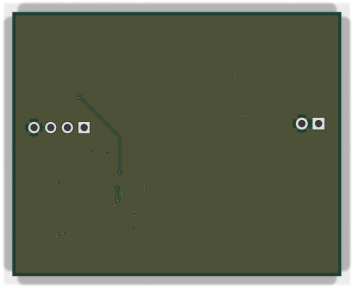
`reports/renders/stm32-blinky_top.png`

ERROR 1 - J1 power input has no polarity legend on silk (requirements miss)

requirements.md sec 2 and architecture/blocks.md both promise the 5 V input "polarity marked on silkscreen" (J1 pin 1 = +5 V, pin 2 = GND). The as-built board has NO text or +/- legend anywhere: silk carries refdes only (there is not a single gr_text on the board). What exists at J1 is a pin-1 dot and a square pad (see crop_j1_d1.png) - and the dot sits on the header body outline,

so after the header is soldered the plastic covers it. Post assembly the top side shows nothing but "J1"; the square pad is visible only from the bottom.

Consequence: the unkeyed 2-pin input can be plugged backwards with no on-board hint. D1 (series SS34) prevents damage - reversed input just does not conduct - but the user gets a dead board and no way to know why or which way is right without opening the design files. This is the board's primary human interface and an explicit requirements promise. Fix is two silk texts ("5V", "GND" or "+", "-") next to the holes, outside the header body. Must fix before fab; there is ample empty silk area (left region is empty).
