ESTIMATE

Est. No: IRE-2026-0613

Driveway Repair, Decorative Walkways & Drainage Upgrade

2433 Chesterwood Drive, Little Elm, TX

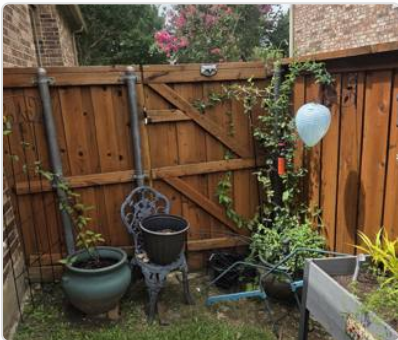
CURRENT CONDITION — Side yard — bare soil, water pooling area along fence line

Excavation and removal of existing soil, overgrown vegetation, and debris along both sides of the house. Grading, leveling, and installation of compacted crushed-stone base. Steel landscape edging installed on all borders for clean, permanent containment.

Supply and installation of 24" × 24" concrete pavers (buff/light tone) along the full length of both side yards, matching the front walkway design. Set on polymeric sand bed, level and evenly spaced.

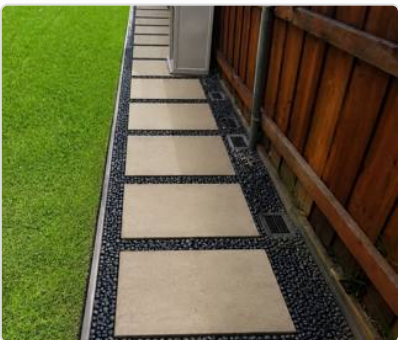
CURRENT CONDITION — Side yard — mud accumulation when it rains; drains clogged with debris

#	DESCRIPTION OF WORK	AREA / DETAIL	EST. COST
	• Approx. 9–10 pavers per side (18–20 total) • Centered path layout with consistent joints • Matching finish to front entry walkway		
11	Black River Rock Infill — Both Sides Supply and installation of black polished river rock filling all spaces between and alongside pavers on both side yards. Installed over weed barrier at 2–3 inch depth. Total coverage approx. 220–240 sq ft.	Both Side Yards	\$900 – \$1,400
12	Drainage Channel (Drain) Cleaning, Repair & Upgrade — Both Sides Full service of all existing drainage grates and channels on both sides of the house to prevent rainwater accumulation and flooding. Work includes: • Complete cleaning and debris removal from all drain channels • Inspection and repair of existing drain bodies and outlet connections • Installation of heavy-duty catch basin grates (debris-blocking design) integrated flush into the river rock surface • Channel slope correction where needed to ensure proper water flow away from foundation • Final flow test with water to confirm all drains are fully functional	Left Side Right Side Drainage	\$800 – \$1,200
