ESTIMATE

Est. No: IRE-2026-0613

Driveway Repair, Decorative Walkways & Drainage Upgrade

2433 Chesterwood Drive, Little Elm, TX

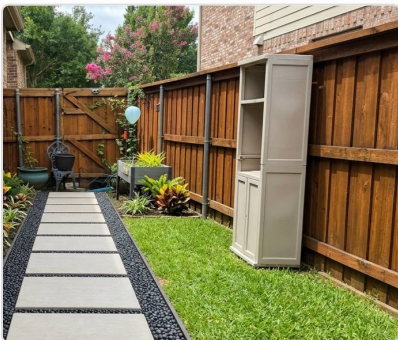
CURRENT CONDITION — Side yard — mud accumulation when it rains; drains clogged with debris

#	DESCRIPTION OF WORK	AREA / DETAIL	EST. COST
	• Approx. 9–10 pavers per side (18–20 total) • Centered path layout with consistent joints • Matching finish to front entry walkway		
11	Black River Rock Infill — Both Sides Supply and installation of black polished river rock filling all spaces between and alongside pavers on both side yards. Installed over weed barrier at 2–3 inch depth. Total coverage approx. 220–240 sq ft.	Both Side Yards	\$900 – \$1,400
12	Drainage Channel (Tragante) Cleaning, Repair & Upgrade — Both Sides Full service of all existing drainage grates and channels on both sides of the house to prevent rainwater accumulation and flooding. Work includes: • Complete cleaning and debris removal from all drain channels • Inspection and repair of existing drain bodies and outlet connections • Installation of heavy-duty catch basin grates (debris-blocking design) integrated flush into the river rock surface • Channel slope correction where needed to ensure proper water flow away from foundation • Final flow test with water to confirm all drains are fully functional	Left Side Right Side Drainage	\$800 – \$1,200
