RED BANNER ALERT

SHW Serious Incident (SI) – Preliminary Notice

Incident Short Description	Worker sustained a crush injury whilst leveling a storm water pit lid.
-----------------------------------	--

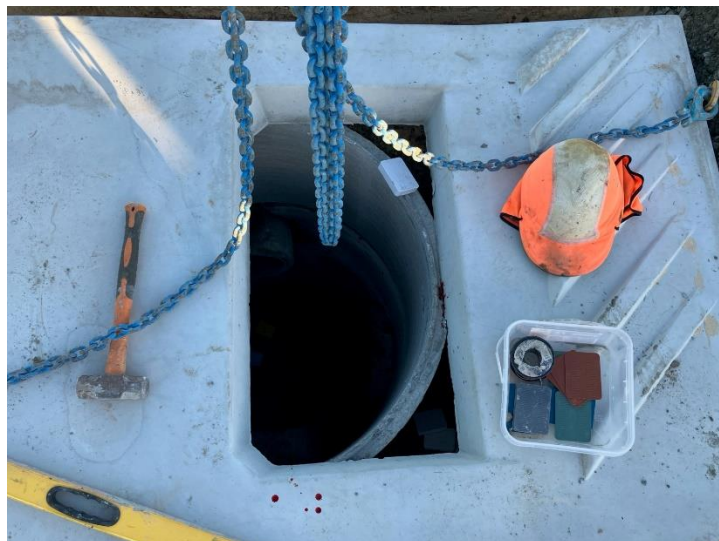
A worker was leveling a storm water pit lid (weighing 768kg) using a lifting bar and packers. In the process of leveling the lid the packers have slipped causing the pit lid to move. The Injured Person's (IP) fingers have been pinned between the pit lid and liner. The IP has sustained a crush injury to 3 fingers. The pit lid was lifted by a nearby excavator and slings to free the IP's fingers.

Pit lid, liner and packers (Please note slings were used to free the fingers (incident not involving crane operations))
