mainroads
WESTERN AUSTRALIA

SHW Serious Incident (SI) – Final Notice

Incident Short Description:	Worker on foot within 1.2m of a live trafficable lane
------------------------------------	---

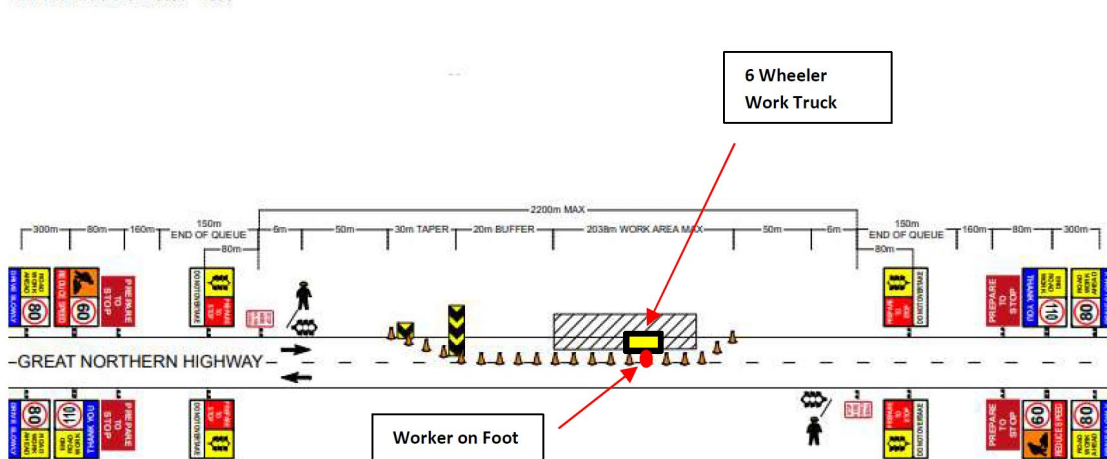
Whilst travelling through the northern worksite at approximately 10.00am on Saturday 10 June, a Main Roads worker has witnessed a works supervisor talking to the driver of a 6-wheeler work truck that was stopped in the working lane.

The supervisor was standing on the centre line whilst the live lane was open to traffic with a set speed of 60km/hr and had no escape route from live traffic.

Position of worker on foot and 6-wheeler within traffic management set up.

Contributing Factors:	
• Failure to include exclusion zones from live traffic lanes within the site-specific induction for all sub-contractors. • Complacency of individual. • Supervisor did not assess the risk of approaching water cart driver from the driver's side of vehicle. • Lack of information around traffic management requirements for those that do not hold or have not held traffic management accreditations. • SWMS does not contain information regarding exclusion zones from traffic at 40 or 60km/h restrictions. • Traffic Management personnel and truck driver did not warn Supervisor of oncoming traffic.	
Corrective Actions:

• Pre-start to discuss statistics, exclusion zones, and escape routes, and the importance of following traffic management procedures. • Review site-specific inductions and include information regarding exclusion zones and speed restrictions. • Update SWMS to include information regarding exclusion zones and speed restrictions.	
Additional Issues/Learnings:	
The project induction lacked information regarding the exclusion zones for working next to live traffic. The induction paid more attention to the types of live traffic present within the work site and there was no information on how close the workers on foot are to be working next to live traffic. Making this information part of the induction process gives confidence that all road workers working on the project will have an awareness and understanding of the exclusion zone requirements prior to working on site.	
 Critical Risk: This serious potential incident aligns with the Main Roads Critical Risk Profile relating to Interaction With Live Traffic.
