SHW Serious Incident (SI) – Final Notice

Incident Short Description	Follow Me Vehicle attempted U-turn in front of road train
-----------------------------------	---

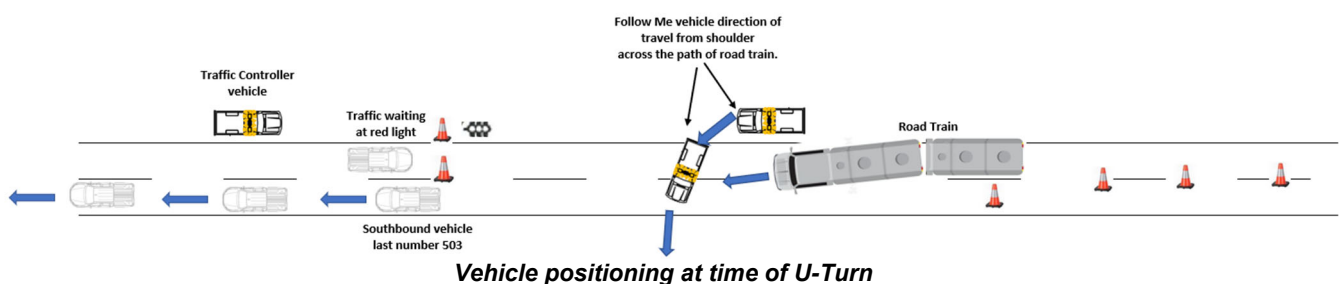
The Follow Me vehicle escorted the queued traffic southbound, and then pulled onto the right traffic shoulder to let the traffic pass. The driver then saw vehicle 503 pass and had then attempted to conduct a U-turn from the shoulder. The driver did not see the road train that had been added on, as the view from the passenger side mirror was obscured by sun glare.

Approximate Taper Location and U-Turn direction

- Update and release for use SWMS that covers Pilot Vehicle Operations.
- Communicate with all staff that U-Turns are only permitted at designated turning areas or under the supervision/direction of a suitably qualified TC.
- Risk assess and create a Pilot Vehicle Operation procedure which is then issued for use.
- Communicate with all staff that the act of "Adding On" is to cease.
- Carry out positive communications training with all staff. Positive Communications training is to include getting a suitable response from the responder that they have understood your information.
