mainroads WESTERN AUSTRALIA

SHW Serious Incident (SI) – Final Notice

Incident Short Description	Worker tripped over parking bay wheel stop bar

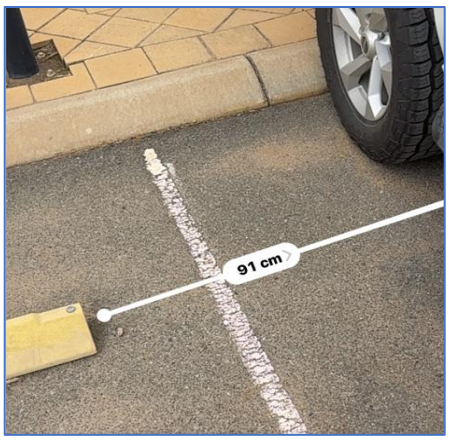
Reenactment of trip over parking bay wheel stop bar

Measurement of Vehicle Door to Wheel Stop (91 cm)

Contributing Factors
• While Main Roads has installed signage and markings within parking bays, there is currently no signage specifically identifying the presence of a tripping hazard. • The worker was unaware of the hazard when walking back to the office. • The worker believed their foot had cleared the parking bay wheel stop bar. Although the worker was wearing sandals, it is believed that different footwear would not have prevented the incident, as the foot was still required to fully clear the height of stop bar. • The worker was requested at short notice to collect and deliver supplies. • The colour marking on the parking bay wheel stop bar had faded over time reducing its effectiveness.

Corrective Actions
• At the next Office Toolbox, revisit the *Slips, Trips, & Falls* PowerPoint slides which were the corporate monthly focus for February 2026. • Review existing signage and markings and, where required, replace signage and refresh colour markings on all parking bay wheel stop bars. • Install clear and visible signage identifying the tripping hazard within the parking bays to improve hazard awareness and reduce the risk of trips and falls.
