RED BANNER ALERT

SHW Serious Incident (SI) – Preliminary Notice

Incident Short Description	Chain used for recovery of maintenance truck, snaps and recoils, smashing through mesh guard and windscreen.

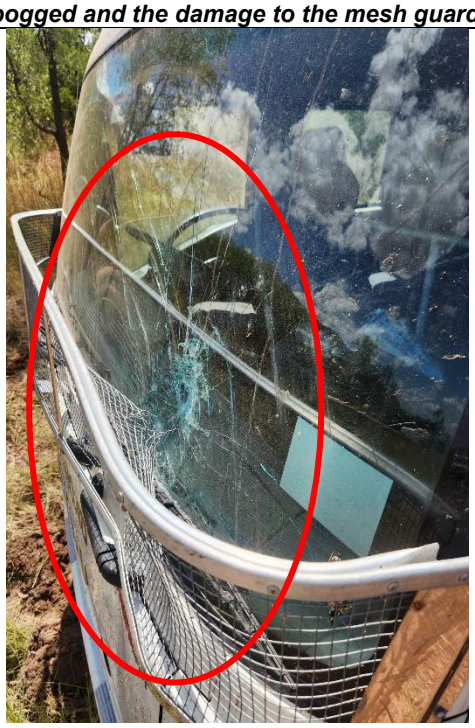
The posi-track was positioned approximately 6 metres from the flocon when the chain has failed under the load, snapping, recoiling and smashing through the mesh windscreen guard and then the windscreen. There was no one on foot at the time (one driver in the flocon, one in the posi-track and another approximately 20 metres away in a light vehicle). Had there been workers on foot, this incident may have had the potential for serious injury or fatality due to chain strike.

Images of truck bogged and the damage to the mesh guard and windscreen
