**TITLE: FUSELAGE - REAR FUSELAGE - APPLY COLD WORKING AND
REPLACE RIVETS IN THE WASTE WATER SERVICE PANEL AREA AT
S18**

MODIFICATION No.: 153073G0790

SERVICE BULLETIN No.: A320-53-1267

REVISION No.: 05 - Nov 29/16

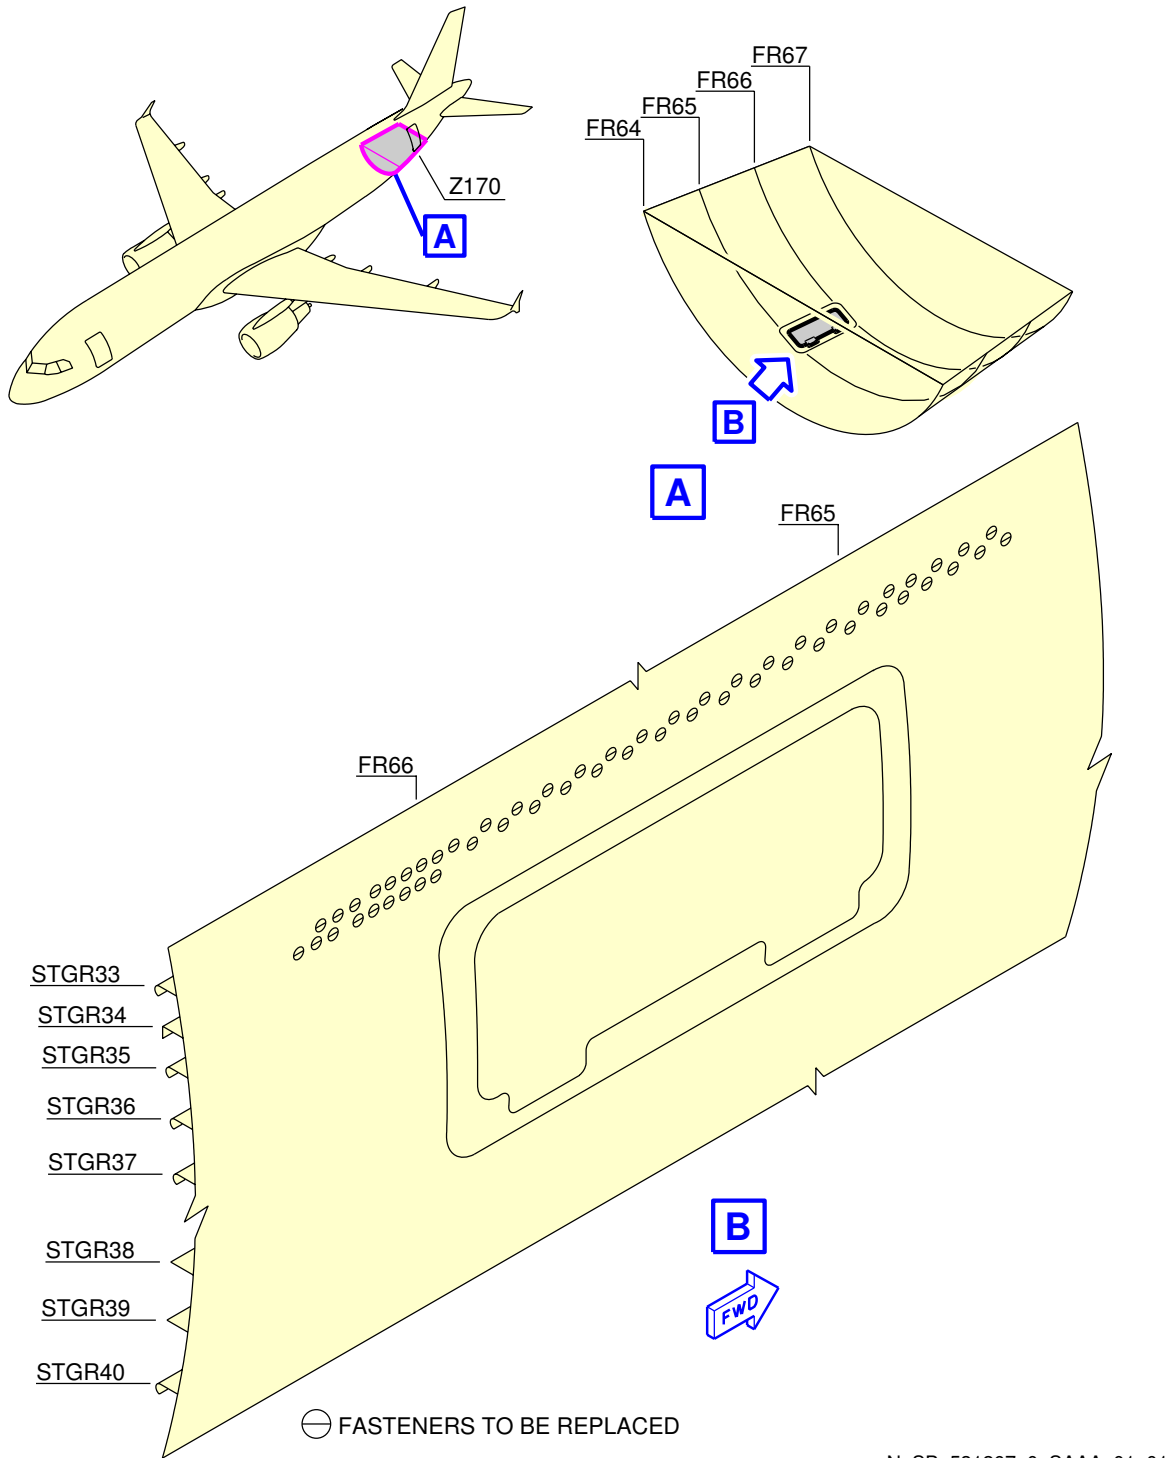
N_SB_531267_0_SAAA_01_01

The accomplishment of this Service Bulletin will reinforce the specified area to prevent from crack initiation and meet the requirements for fatigue and damage tolerance.
