Shoreline Situation Report
NEWPORT NEWS, VIRGINIA

Special Report In Applied Marine Science and Ocean Engineering Number 55
Chesapeake Research Consortium Report Number 10

VIRGINIA INSTITUTE OF MARINE SCIENCE
Gloucester Point, Virginia 23062

1974

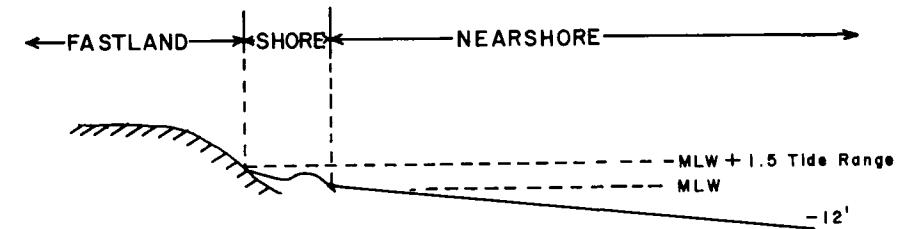
FIGURE 1

An illustration of the definition of the three components of the shorelands.

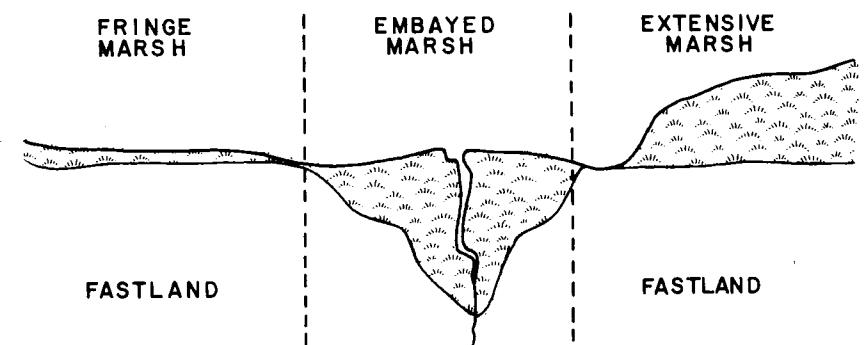
FIGURE 2

A generalized illustration of the three different marsh types.

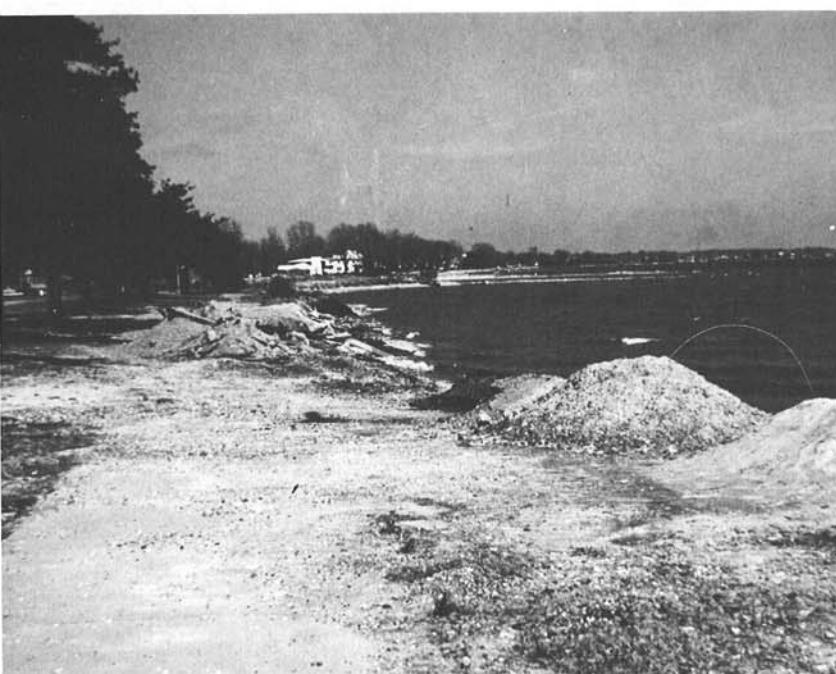
Figure 5

Figure 6: Ground view of the area shown in Figure 5. Shoreline erosion is threatening the paved walkway.

Excluding water quality considerations the beaches at Lincoln Park and Anderson (Figure 4 and 5) could be enhanced through a program of artificial nourishment and of replacing the unsightly, dumped construction-rubble and trash riprap with either properly placed stone riprap or a seawall.

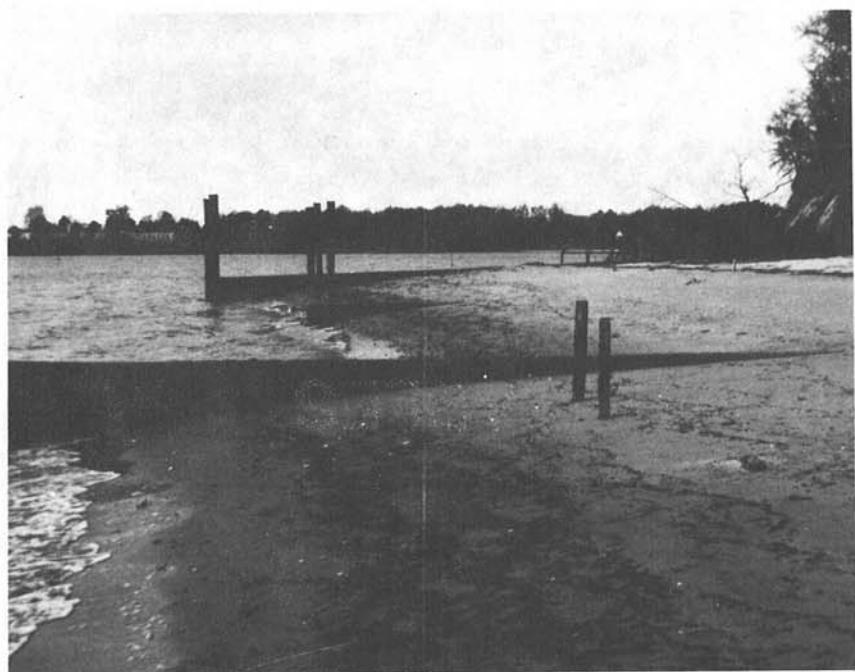
Figure 11

Figure 11: The two long, high, impermeable groins in Figure 9. These two major groins and the lesser intermediate groin have trapped a significant fill and are protecting the fastland.
